Profile/Photo Observation Report

Date: 05/03/2018 Weather: **PACP 4.2** Coding: Pipe Length (ft): 40.5 Owner: **City of Hobart** Pre Clean: No Pre-Cleaning P.O.#: 2004 PSR: P-804-031-030 Surveyor: SAN **Red Zone** Customer: Clean Date: Shape: 1508 Hickey St Flow Control: **Not Controlled** Street: City: **Hobart In** Year Renewed: Tape/Media #: Deliverable 1 Location: **Parking Lot** Purpose: **Routine Assessment** Dia/Height: 10" Use: Sanitary Material: **VCP** Northeast Drain Area: Lining: NA Category: Comment: 442-1/10" diameter pipe. **Location Details:** Flows through easement Direction of Survey: **Downstream** M-804-031 US MH: DS MH: M-804-030 Total Length Surveyed (ft): 40.5 0.00 0000 0.00 O&M Index: O&M Quick: O&M Rating:

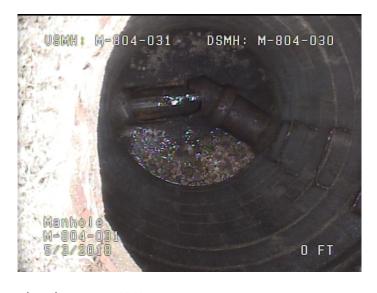
Code:	AMH	
Description:	Manhole	
Distance (ft):	.0	
Structural Grade:	0	
O&M Grade:	0	
Clock Start/From:		
Clock To:		
1st Value:		
2nd Value:		
Value Percent:		
Continuous Index:		
Within 8" of Joint:	NO	
Remarks:	M-804-031

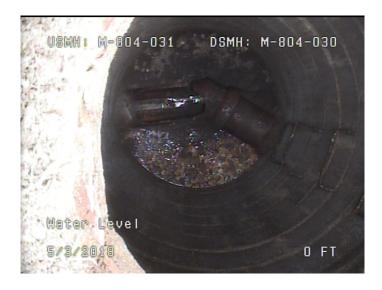
Code: MWL
Description: Water Level

Distance (ft): .0
Structural Grade: 0
O&M Grade: 0

Value Percent: 5.000

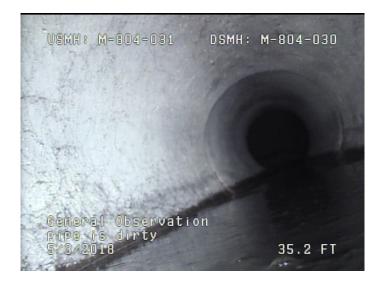
Code: MGO

Description: General Observation

Distance (ft): 35.2
Structural Grade: 0

Remarks: pipe is dirty

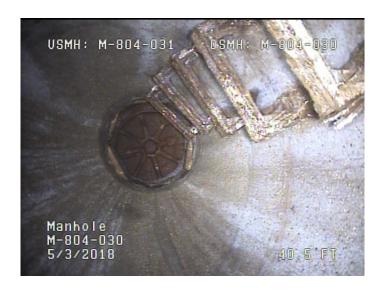
Code: AMH
Description: Manhole

Distance (ft): 40.5
Structural Grade: 0

Remarks: M-804-030
