## Profile/Photo Observation Report

Date:	<b>05/03/2018</b>	Weather:		Coding:	<b>PACP 4.2</b>
Pipe Length (ft):	<b>.0</b>	Owner:	<b>City of Hobart</b>	Pre Clean:	<b>No Pre-Cleaning</b>
P.O.#:	<b>2004</b>	Surveyor:	<b>SAN</b>	PSR:	<b>P-804-OSL-031</b>
Customer:	<b>Red Zone</b>	Clean Date:		Shape:	<b>C</b>

Street:	<b>1508 Hickey St</b>	Flow Control:	<b>Not Controlled</b>
City:	<b>Hobart In</b>	Year Renewed:	
Location:	<b>Parking Lot</b>	Tape/Media #:	<b>Deliverable 1</b>
Purpose:	<b>Routine Assessment</b>	Dia/Height:	<b>10"</b>
Use:	<b>Sanitary</b>	Material:	<b>VCP</b>
Drain Area:	<b>Northeast</b>	Lining:	
Category:	<b>NA</b>		
Comment:	<b>441-1/10" diameter pipe/Incomplete due to roots/ No reverse due to no access upstream.</b>		
Location Details:	<b>Flows through easement</b>	Direction of Survey:	<b>Upstream</b>
US MH:	<b>M-804-OSL</b>	DS MH:	<b>M-804-031</b>
		Total Length Surveyed (ft):	<b>31.4</b>

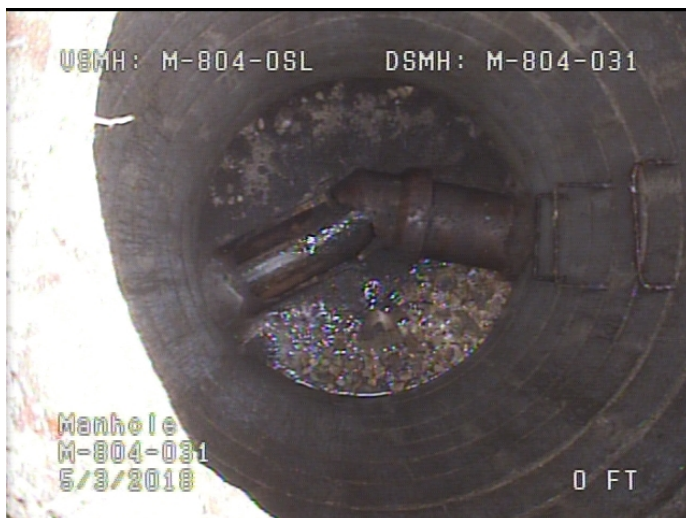
Code:	<b>AMH</b>
Description:	<b>Manhole</b>
Distance (ft):	<b>.0</b>
Structural Grade:	<b>0</b>
O&M Grade:	<b>0</b>
Clock Start/From:	
Clock To:	
1st Value:	
2nd Value:	
Value Percent:	
Continuous Index:	
Within 8" of Joint:	<b>NO</b>
Remarks:	<b>M-804-031</b>

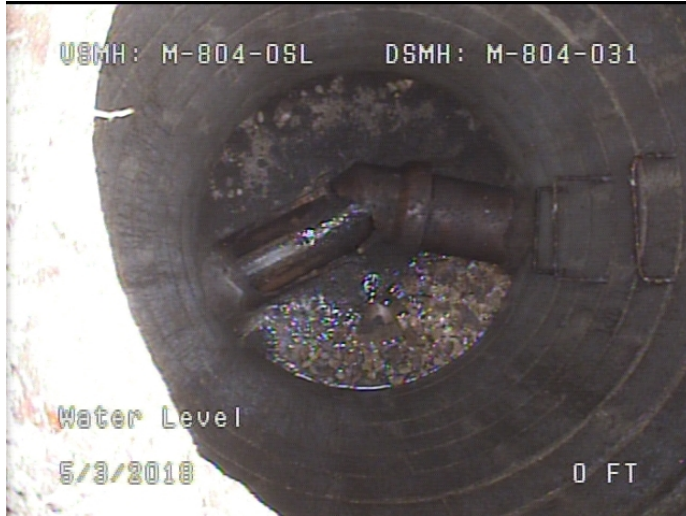
Code:	<b>MWL</b>
Description:	<b>Water Level</b>
Distance (ft):	<b>.0</b>
Structural Grade:	<b>0</b>
O&M Grade:	<b>0</b>
Clock Start/From:	
Clock To:	
1st Value:	
2nd Value:	
Value Percent:	<b>5.000</b>
Continuous Index:	
Within 8" of Joint:	<b>NO</b>
Remarks:

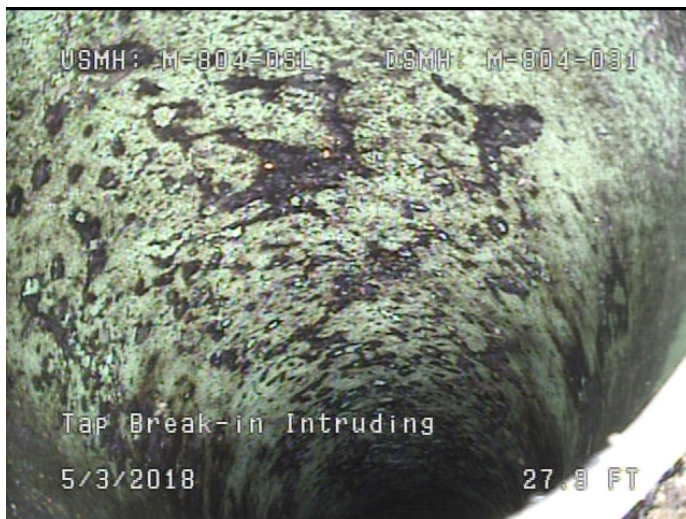
Code:	<b>TBI</b>
Description:	<b>Tap Break-in Intruding</b>
Distance (ft):	<b>27.9</b>
Structural Grade:	<b>0</b>
O&M Grade:	<b>2</b>
Clock Start/From:	<b>10</b>
Clock To:	
1st Value:	<b>6.000</b>
2nd Value:	<b>2.000</b>
Value Percent:	
Continuous Index:	
Within 8" of Joint:	<b>NO</b>
Remarks:

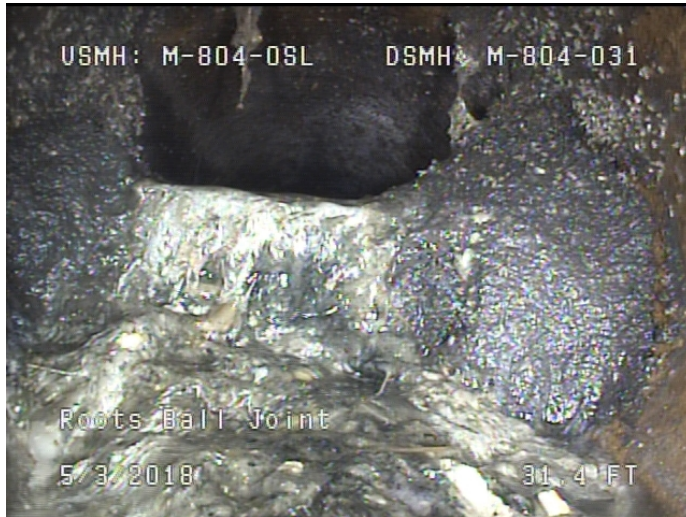
Code: **RBJ**  
 Description: **Roots Ball Joint**

Distance (ft): **31.4**  
 Structural Grade: **0**  
 O&M Grade: **4**  
 Clock Start/From: **2**  
 Clock To: **10**  
 1st Value:  
 2nd Value:  
 Value Percent: **55.000**  
 Continuous Index:  
 Within 8" of Joint: **YES**  
 Remarks:

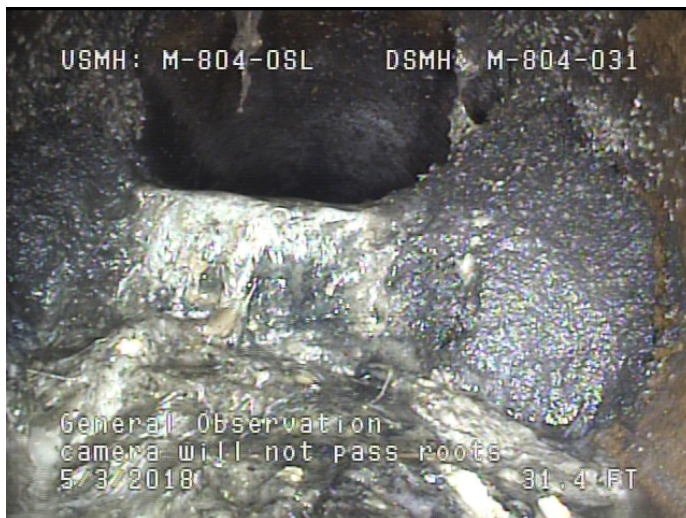
Code: **MGO**  
 Description: **General Observation**

Distance (ft): **31.4**  
 Structural Grade: **0**  
 O&M Grade: **0**  
 Clock Start/From:  
 Clock To:  
 1st Value:  
 2nd Value:  
 Value Percent:  
 Continuous Index:  
 Within 8" of Joint: **NO**  
 Remarks: **camera will not pass roots**

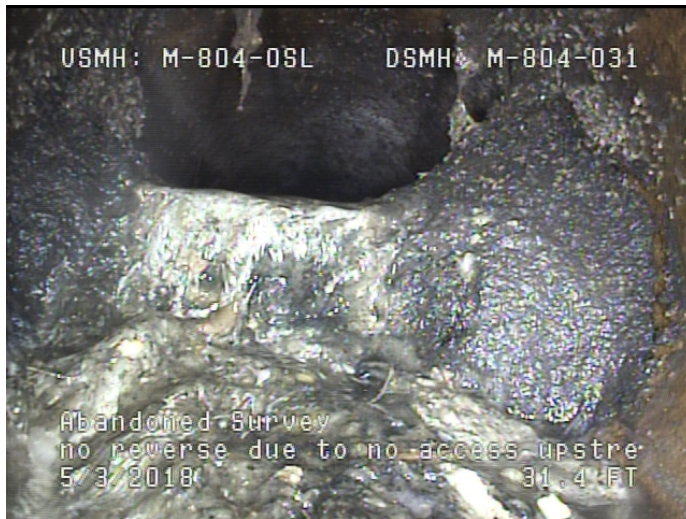
Code:	<b>MSA</b>
Description:	<b>Abandoned Survey</b>
Distance (ft):	<b>31.4</b>
Structural Grade:	<b>0</b>
O&M Grade:	<b>0</b>
Clock Start/From:	
Clock To:	
1st Value:	
2nd Value:	
Value Percent:	
Continuous Index:	
Within 8" of Joint:	<b>NO</b>
Remarks:	<b>no reverse due to no access upstream</b>
