## Profile/Photo Observation Report

Date:	<b>05/04/2018</b>	Weather:		Coding:	<b>PACP 4.2</b>
Pipe Length (ft):	<b>68.4</b>	Owner:	<b>City of Hobart</b>	Pre Clean:	<b>No Pre-Cleaning</b>
P.O.#:	<b>2004</b>	Surveyor:	<b>SAN</b>	PSR:	<b>P-804-062-032</b>
Customer:	<b>Red Zone</b>	Clean Date:		Shape:	<b>C</b>

Street:	<b>200 N Hobart Rd</b>	Flow Control:	<b>Not Controlled</b>
City:	<b>Hobart In</b>	Year Renewed:	
Location:	<b>Yard</b>	Tape/Media #:	<b>Deliverable 1</b>
Purpose:	<b>Routine Assessment</b>	Dia/Height:	<b>18"</b>
Use:	<b>Sanitary</b>	Material:	<b>VCP</b>
Drain Area:	<b>Northeast</b>	Lining:	
Category:	<b>NA</b>		
Comment:	<b>443-1/Incomplete due to debris.</b>		
Location Details:	<b>Grass at edge of street</b>	Direction of Survey:	<b>Upstream</b>
US MH:	<b>M-804-062</b>	DS MH:	<b>M-804-032</b>
		Total Length Surveyed (ft):	<b>20.3</b>

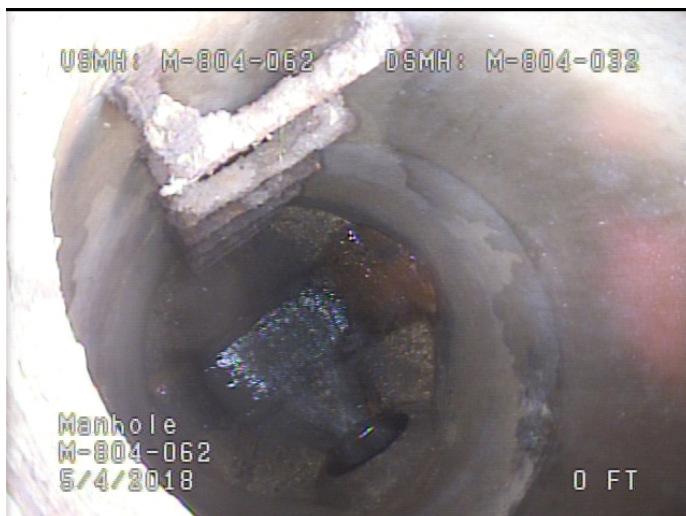
Code: **AMH**  
Description: **Manhole**

Distance (ft): **.0**  
Structural Grade: **0**  
O&M Grade: **0**  
Clock Start/From:  
Clock To:  
1st Value:  
2nd Value:  
Value Percent:  
Continuous Index:  
Within 8" of Joint: **NO**  
Remarks: **M-804-032**

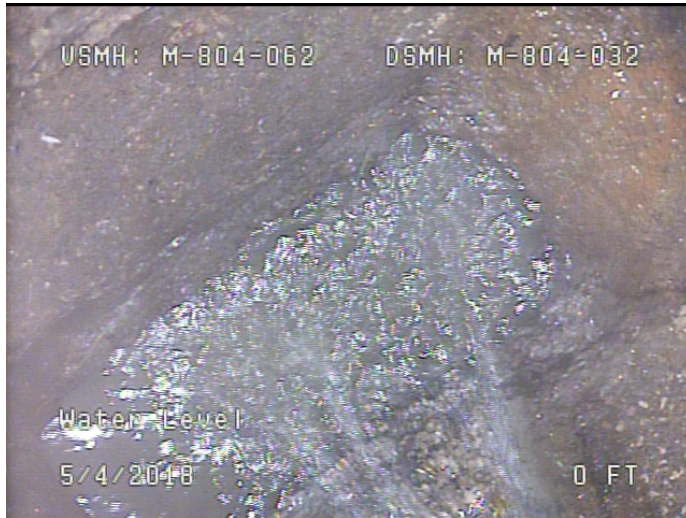
Code: **MWL**  
Description: **Water Level**

Distance (ft): **.0**  
Structural Grade: **0**  
O&M Grade: **0**  
Clock Start/From:  
Clock To:  
1st Value:  
2nd Value:  
Value Percent: **35.000**  
Continuous Index:  
Within 8" of Joint: **NO**  
Remarks:

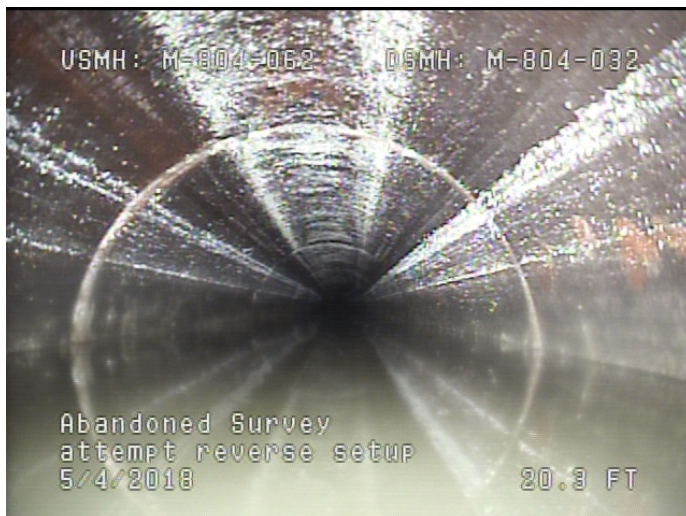
Code:	<b>MSA</b>
Description:	<b>Abandoned Survey</b>
Distance (ft):	<b>20.3</b>
Structural Grade:	<b>0</b>
O&M Grade:	<b>0</b>
Clock Start/From:	
Clock To:	
1st Value:	
2nd Value:	
Value Percent:	
Continuous Index:	
Within 8" of Joint:	<b>NO</b>
Remarks:	<b>attempt reverse setup</b>
