## Profile/Photo Observation Report

Date:	<b>04/18/2018</b>	Weather:		Coding:	<b>PACP 4.2</b>
Pipe Length (ft):	<b>132.0</b>	Owner:	<b>City of Hobart</b>	Pre Clean:	<b>No Pre-Cleaning</b>
P.O.#:	<b>2004</b>	Surveyor:	<b>SAN</b>	PSR:	<b>P-804-037-035</b>
Customer:	<b>Red Zone</b>	Clean Date:		Shape:	<b>C</b>

Street:	<b>1508 Division St</b>	Flow Control:	<b>Not Controlled</b>
City:	<b>Hobart In</b>	Year Renewed:	
Location:	<b>Light Highway</b>	Tape/Media #:	<b>Deliverable 1</b>
Purpose:	<b>Routine Assessment</b>	Dia/Height:	<b>18"</b>
Use:	<b>Sanitary</b>	Material:	<b>VCP</b>
Drain Area:	<b>Northeast</b>	Lining:	
Category:	<b>NA</b>		
Comment:	<b>414-1/Incomplete due to debris/Reverse setup required.</b>		
Location Details:	<b>Edge of street</b>	Direction of Survey:	<b>Downstream</b>
US MH:	<b>M-804-037</b>	DS MH:	<b>M-804-035</b>
		Total Length Surveyed (ft):	<b>10.0</b>

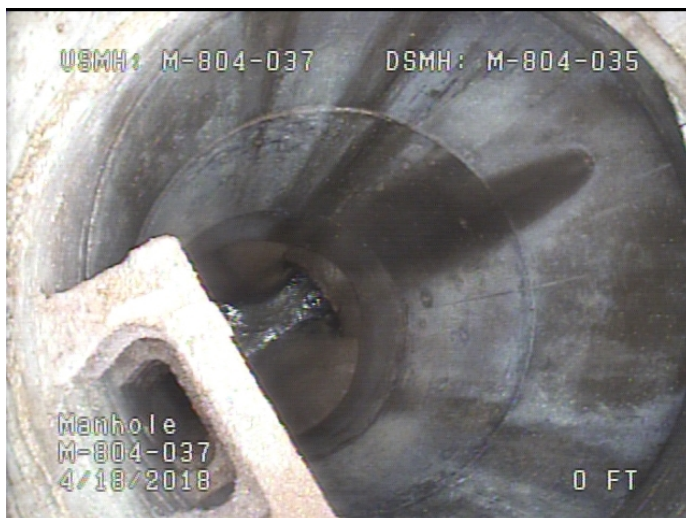
Code:	<b>AMH</b>
Description:	<b>Manhole</b>
Distance (ft):	<b>.0</b>
Structural Grade:	<b>0</b>
O&M Grade:	<b>0</b>
Clock Start/From:	
Clock To:	
1st Value:	
2nd Value:	
Value Percent:	
Continuous Index:	
Within 8" of Joint:	<b>NO</b>
Remarks:	<b>M-804-037</b>

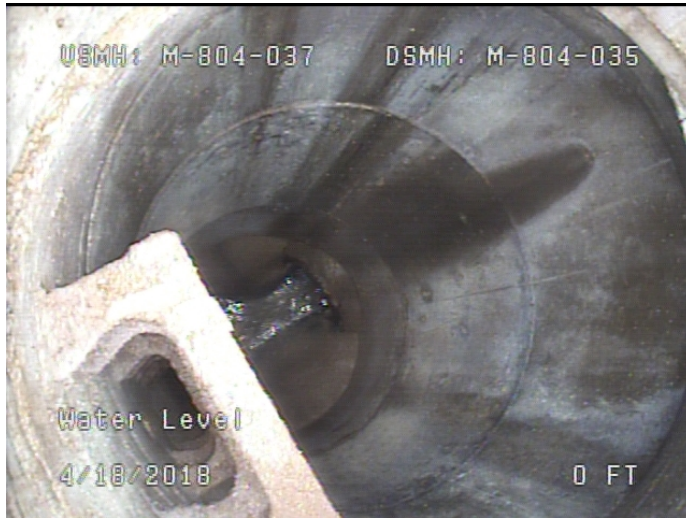
Code: **MWL**  
 Description: **Water Level**

Distance (ft): **.0**  
 Structural Grade: **0**  
 O&M Grade: **0**  
 Clock Start/From:  
 Clock To:  
 1st Value:  
 2nd Value:  
 Value Percent: **35.000**  
 Continuous Index:  
 Within 8" of Joint: **NO**  
 Remarks:

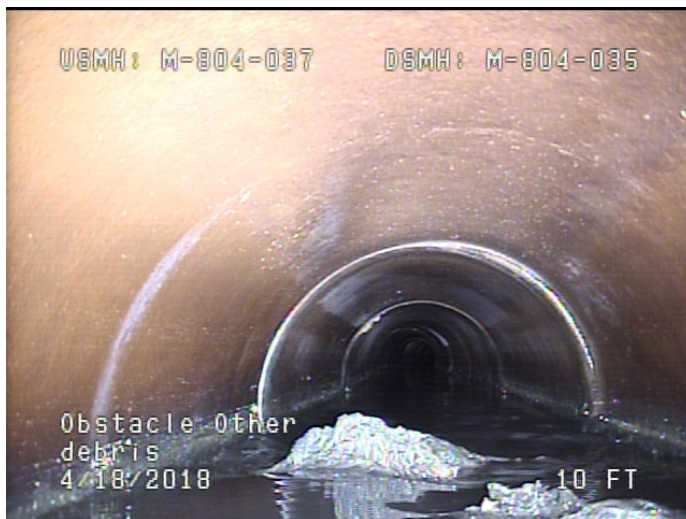
Code: **OBZ**  
 Description: **Obstacle Other**

Distance (ft): **10.0**  
 Structural Grade: **0**  
 O&M Grade: **5**  
 Clock Start/From: **4**  
 Clock To: **9**  
 1st Value:  
 2nd Value:  
 Value Percent: **45.000**  
 Continuous Index:  
 Within 8" of Joint: **NO**  
 Remarks: **debris**

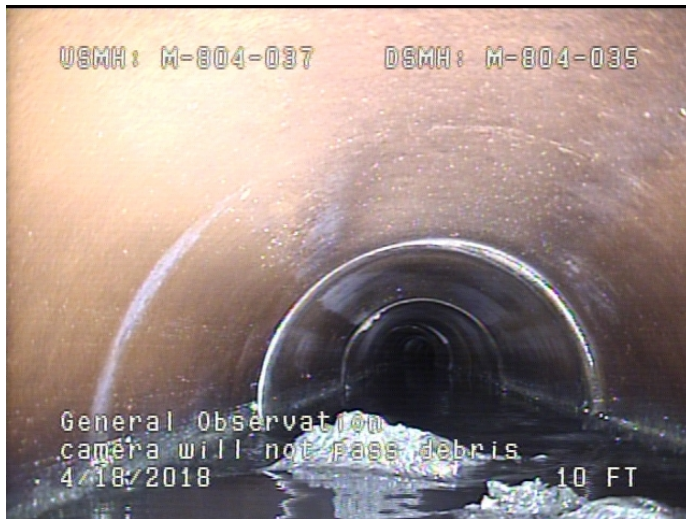
Code:	<b>MGO</b>
Description:	<b>General Observation</b>
Distance (ft):	<b>10.0</b>
Structural Grade:	<b>0</b>
O&M Grade:	<b>0</b>
Clock Start/From:	
Clock To:	
1st Value:	
2nd Value:	
Value Percent:	
Continuous Index:	
Within 8" of Joint:	<b>NO</b>
Remarks:	<b>camera will not pass debris</b>

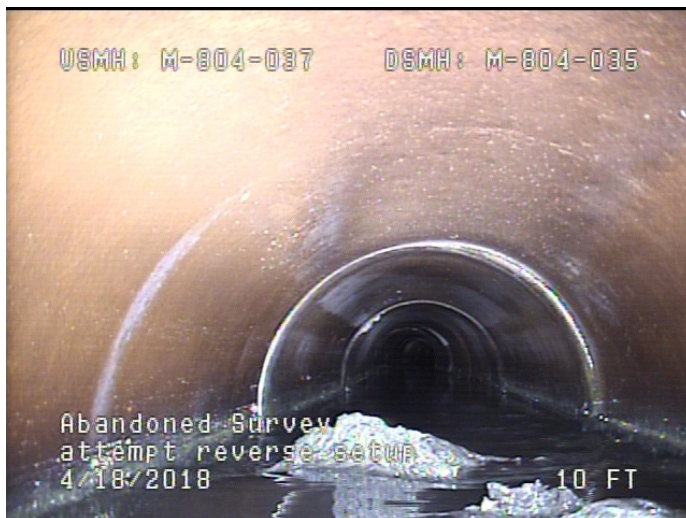
Code:	<b>MSA</b>
Description:	<b>Abandoned Survey</b>
Distance (ft):	<b>10.0</b>
Structural Grade:	<b>0</b>
O&M Grade:	<b>0</b>
Clock Start/From:	
Clock To:	
1st Value:	
2nd Value:	
Value Percent:	
Continuous Index:	
Within 8" of Joint:	<b>NO</b>
Remarks:	<b>attempt reverse setup</b>
