on Report			ROBOTI
Date:	01/17/2025	Weather:		Coding:	PACP 7.0
Pipe Length (ft)	: <b>132.0</b>	Owner:	City of Hobart	Pre Clean:	Heavy Cleaning
P.O.#:	YES502259	Surveyor:	S. Bucklin	PSR:	P-804-037-035
Customer:	City of Hobart	Clean Date:	11/21/2024	Shape:	С
Street:	<b>Division Street</b>		Flow Control:	Not Controlled	
City:	Hobart, IN		Year Renewed:		
Location:	Local rural street	s with light traffic,	t Tape/Media #:		
Purpose:	Sewer System Ev	aluation Survey (S	<b>S</b> Dia/Height:	18"	
Use:	Sanitary Sewage	Pipe	Material:	VCP	
Drain Area:			Lining:	None	
Category:	NA				
Comment:					
Location Details	s:		Direction of Surve	ey: Downstream	
US MH:	M-804-037	DS MH:	M-804-035	Total Length Surveyed (ft)	: <b>130.7</b>
D&M Index:	1.81	O&M Quick:	2A13	O&M Rating:	29.00
Structural Index:	2.00	Structural Qu	ick: 3111		4.00
Overall Index:	1.83	Overall Quick	. 312A		33.00

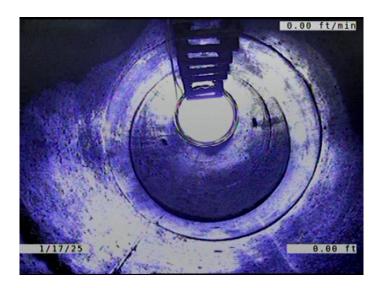
Code: Description:	AMH Manhole
Distance (ft):	.0
Structural Grade:	0
O&M Grade:	0
Clock Start/From:	
Clock To:	
1st Value:	
2nd Value:	
Value Percent:	
Continuous Index:	
Within 8" of Joint:	NO
Remarks:	M-804-037

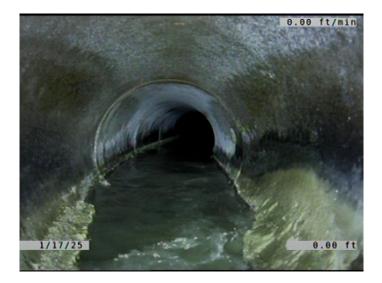
Code:	MWL
Description:	Miscellaneous Water Level
Distance (ft):	.0
Structural Grade:	0
O&M Grade:	0
Clock Start/From:	
Clock To:	
1st Value:	
2nd Value:	
Value Percent:	5.000
Continuous Index:	
Within 8" of Joint:	NO
Remarks:

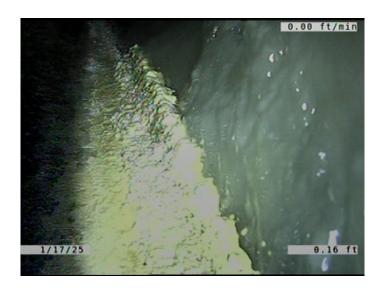
Code: Description:	DAGS Deposits Attached Grease
Distance (ft): Structural Grade: O&M Grade: Clock Start/From: Clock To: 1st Value: 2nd Value: Value Percent: Continuous Index: Within 8" of Joint:	.2 0 2 3 9 5.000
Within 8" of Joint: Remarks:	YES

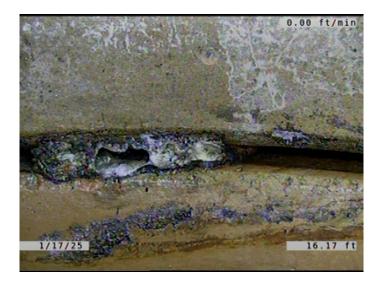
Code: Description:	DAE Deposits Attached Encrustation
Distance (ft):	16.2
Structural Grade:	0
O&M Grade:	2
Clock Start/From:	8
Clock To:	12
1st Value:	
2nd Value:	
Value Percent:	5.000
Continuous Index:	
Within 8" of Joint:	YES
Remarks:

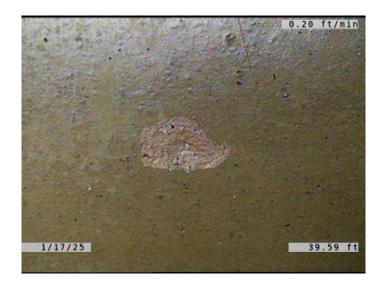
Code: Description:	SSC Surface Spalling of Damage Coating
Distance (ft): Structural Grade: O&M Grade: Clock Start/From: Clock To: 1st Value: 2nd Value: Value Percent: Continuous Index: Within 8" of Joint: Remarks:	39.6 1 0 3 YES

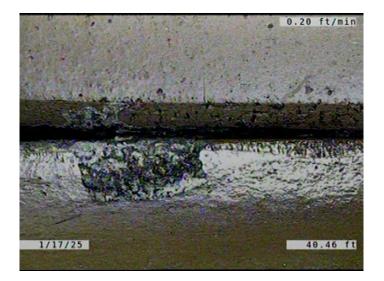
Code: Description:	DAE Deposits Attached Encrustation
Distance (ft):	40.4
Structural Grade:	0
O&M Grade:	2
Clock Start/From:	8
Clock To:	4
1st Value:	
2nd Value:	
Value Percent:	5.000
Continuous Index:	
Within 8" of Joint:	YES
Remarks:

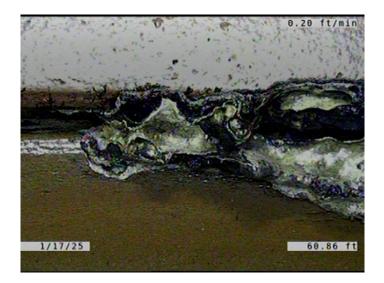
Code: Description:	DAE Deposits Attached Encrustation
Distance (ft): Structural Grade: O&M Grade: Clock Start/From: Clock To: 1st Value: 2nd Value: Value Percent: Continuous Index: Within 8" of Joint: Remarks:	60.8 0 2 8 4 5.000 YES

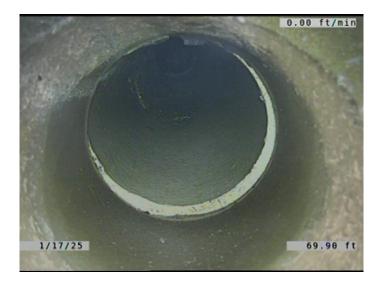
Code: Description:	TF Tap Factory
Distance (ft):	69.9
Structural Grade:	0
O&M Grade:	0
Clock Start/From:	11
Clock To:	
1st Value:	6.000
2nd Value:	
Value Percent:	
Continuous Index:	
Within 8" of Joint:	YES
Remarks:

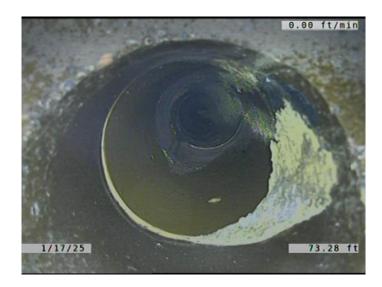
Code: Description:	TFC Tap Factory Capped
Distance (ft): Structural Grade: O&M Grade: Clock Start/From: Clock To: 1st Value: 2nd Value: Value Percent: Continuous Index:	73.3 0 0 1 6.000
Within 8" of Joint: Remarks:	YES ENCRUSTATION COMING FROM THE JOINTS INTO THE MAIN.

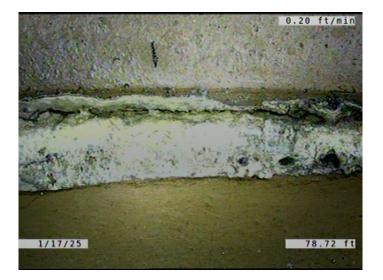
Code: Description:	DAE Deposits Attached Encrustation
Distance (ft):	78.7
Structural Grade:	0
O&M Grade:	2
Clock Start/From:	8
Clock To:	4
1st Value:	
2nd Value:	
Value Percent:	5.000
Continuous Index:	S01

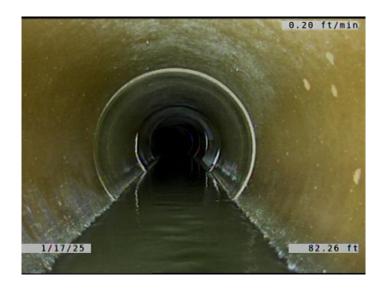
Code: Description:	LL Line Left
Distance (ft):	82.2
Structural Grade:	0
O&M Grade:	1
Clock Start/From:	
Clock To:	
1st Value:	
2nd Value:	
Value Percent:	5.000
Continuous Index:	
Within 8" of Joint:	NO
Remarks:

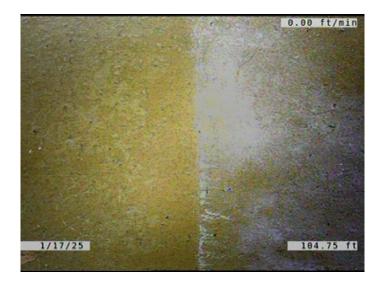
Code:	СМ
Description:	Crack Multiple
	104 7
Distance (ft):	104.7
Structural Grade:	3
O&M Grade:	0
Clock Start/From:	2
Clock To:	3
1st Value:	
2nd Value:	
Value Percent:	
Continuous Index:	
Within 8" of Joint:	YES
Remarks:

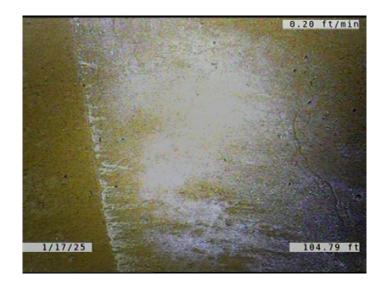
Code: Description:	ISB Infiltration Stain Barrel
Distance (ft): Structural Grade: O&M Grade: Clock Start/From: Clock To: 1st Value: 2nd Value: Value Percent: Continuous Index: Within 8" of Joint: Remarks:	104.8 0 1 2 5

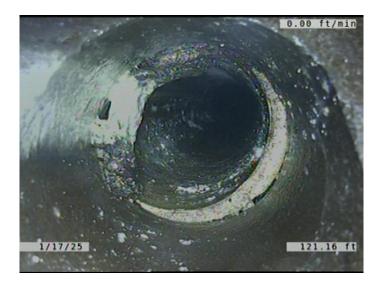
Code:	TF
Description:	Tap Factory
Distance (ft):	121.2
Structural Grade:	0
O&M Grade:	0
Clock Start/From:	11
Clock To:	
1st Value:	6.000
2nd Value:	
Value Percent:	
Continuous Index:	
Within 8" of Joint:	YES
Remarks:	SERVICE OFFSET FROM THE TAP.

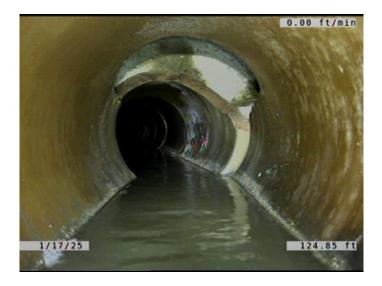
Code:	DAE
Description:	Deposits Attached Encrustation
Distance (ft):	124.8
Structural Grade:	0
O&M Grade:	2

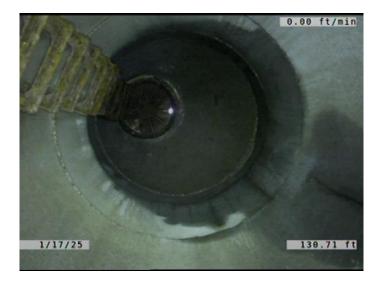
Code:	AMH
Description:	Manhole
Distance (ft): Structural Grade: O&M Grade: Clock Start/From: Clock To: 1st Value: 2nd Value: Value Percent: Continuous Index: Within 8" of Joint: Remarks:	130.7 0 0 NO M-804-035
