Profile/Photo Observation Report

Date:	04/10/2018	Weather:		Coding:	PACP 6.0
Pipe Length (ft):	196.9	Owner:	NA	Pre Clean:	Not Known
P.O.#:		Surveyor:	Mark Ruby	PSR:	P-804-039-038
Customer:		Clean Date:	01/01/1900	Shape:	C

Street:	OFF N HOBART RD	Flow Control:	Not Controlled
City:	Hobart, IN	Year Renewed:	
Location:	Other	Tape/Media #:	
Purpose:	Not Known	Dia/Height:	12"
Use:	Sanitary	Material:	VCP
Drain Area:	NA	Lining:	
Category:	NA		
Comment:

Location Details:		Direction of Survey:	Upstream
US MH:	M-804-038	DS MH:	M-804-039
		Total Length Surveyed (ft):	75.2

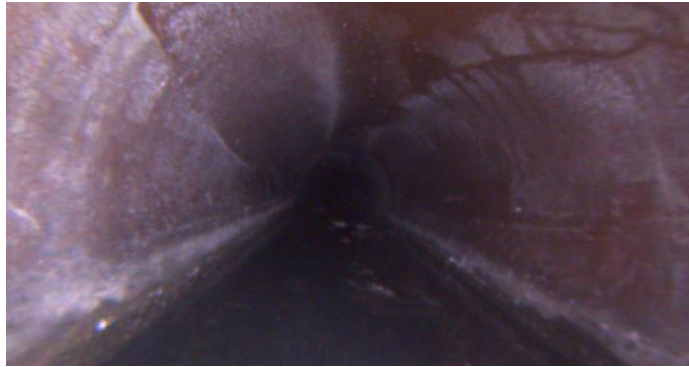
Code: **MWL**
Description: **Water Level**

Distance (ft): **.0**
Structural Grade: **0**
O&M Grade: **0**
Clock Start/From:
Clock To:
1st Value:
2nd Value:
Value Percent: **10.000**
Continuous Index:
Within 8" of Joint: **NO**
Remarks:

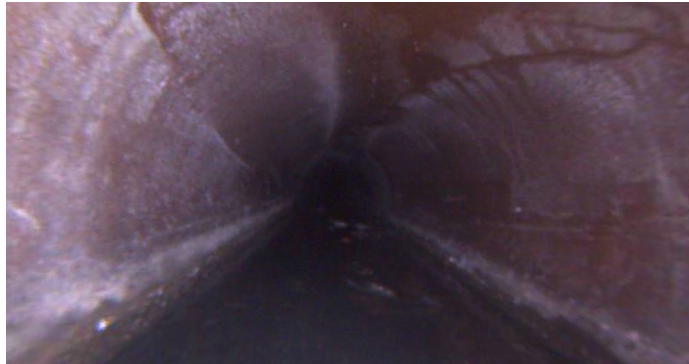
Code: **FM**
Description: **Fracture Multiple**

Distance (ft): **.0**
Structural Grade: **4**
O&M Grade: **0**
Clock Start/From: **7**
Clock To: **5**
1st Value:
2nd Value:
Value Percent:
Continuous Index: **S01**
Within 8" of Joint:
Remarks:

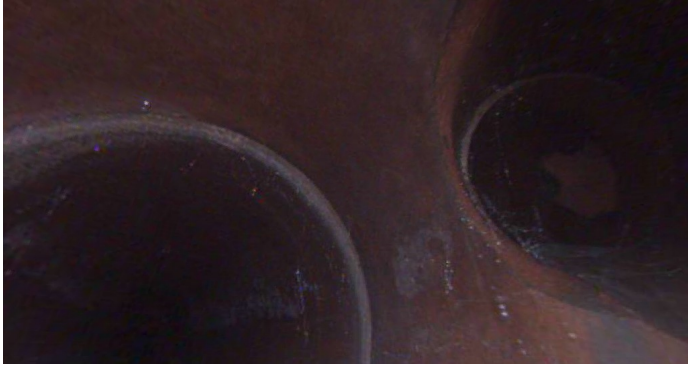
Code: **TF**
Description: **Tap Factory**

Distance (ft): **28.5**
Structural Grade: **0**
O&M Grade: **0**
Clock Start/From: **9**
Clock To:
1st Value: **4.000**
2nd Value:
Value Percent:
Continuous Index:
Within 8" of Joint:
Remarks:

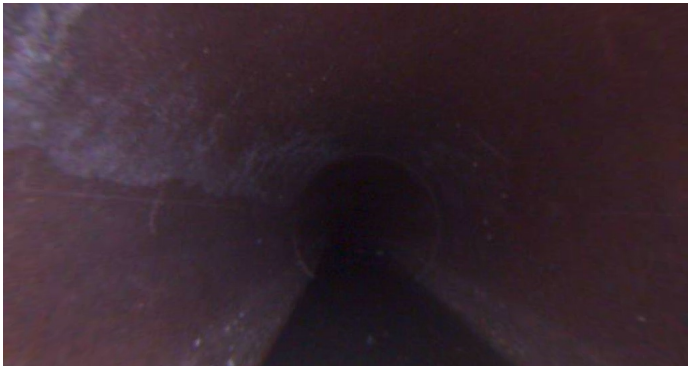
Code: **FM**
Description: **Fracture Multiple**

Distance (ft): **28.5**
Structural Grade: **4**
O&M Grade: **0**
Clock Start/From: **7**
Clock To: **5**
1st Value:
2nd Value:
Value Percent:
Continuous Index: **F01**
Within 8" of Joint:
Remarks:

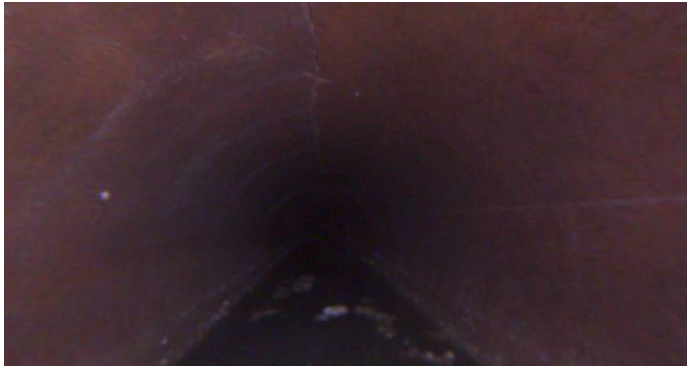
Code: **FM**
Description: **Fracture Multiple**

Distance (ft): **33.6**
Structural Grade: **4**
O&M Grade: **0**
Clock Start/From: **7**
Clock To: **5**
1st Value:
2nd Value:
Value Percent:
Continuous Index: **S02**
Within 8" of Joint:
Remarks:

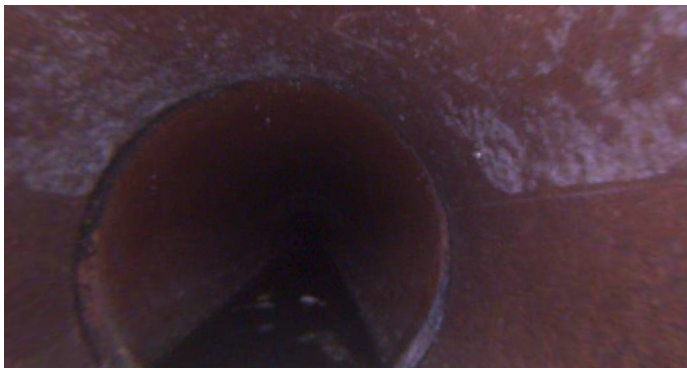
Code: **FM**
Description: **Fracture Multiple**

Distance (ft): **44.5**
Structural Grade: **4**
O&M Grade: **0**
Clock Start/From: **7**
Clock To: **5**
1st Value:
2nd Value:
Value Percent:
Continuous Index: **F02**
Within 8" of Joint:
Remarks:

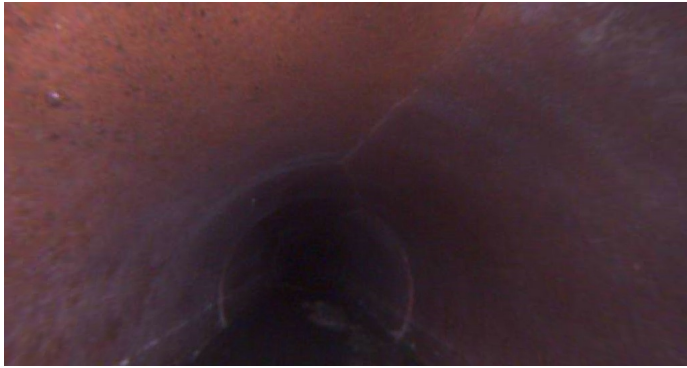
Code: **FM**
Description: **Fracture Multiple**

Distance (ft): **61.4**
Structural Grade: **4**
O&M Grade: **0**
Clock Start/From: **7**
Clock To: **5**
1st Value:
2nd Value:
Value Percent:
Continuous Index: **S03**
Within 8" of Joint:
Remarks:

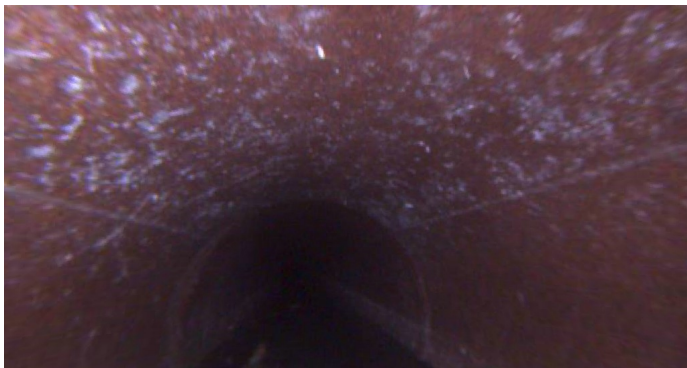
Code: **FM**
Description: **Fracture Multiple**

Distance (ft): **73.5**
Structural Grade: **4**
O&M Grade: **0**
Clock Start/From: **7**
Clock To: **5**
1st Value:
2nd Value:
Value Percent:
Continuous Index: **F03**
Within 8" of Joint:
Remarks:

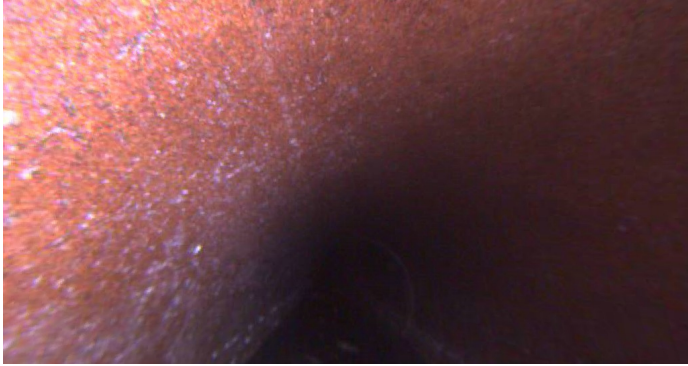
Code:	MSA
Description:	Abandoned Survey
Distance (ft):	75.2
Structural Grade:	0
O&M Grade:	0
Clock Start/From:	
Clock To:	
1st Value:	
2nd Value:	
Value Percent:	
Continuous Index:	
Within 8" of Joint:	NO
Remarks:	Debris under water
