## Profile/Photo Observation Report

Street:	<b>N Liberty St.</b>	Flow Control:	<b>Not Controlled</b>
City:	<b>Hobart, IN</b>	Year Renewed:	
Location:	<b>Other</b>	Tape/Media #:	
Purpose:	<b>Not Known</b>	Dia/Height:	<b>12"</b>
Use:	<b>Sanitary</b>	Material:	<b>VCP</b>
Drain Area:	<b>NA</b>	Lining:	
Category:	<b>NA</b>		
Comment:

Location Details:		Direction of Survey:	<b>Upstream</b>
US MH:	<b>M-804-038</b>	DS MH:	<b>M-804-039</b>
		Total Length Surveyed (ft):	<b>75.2</b>

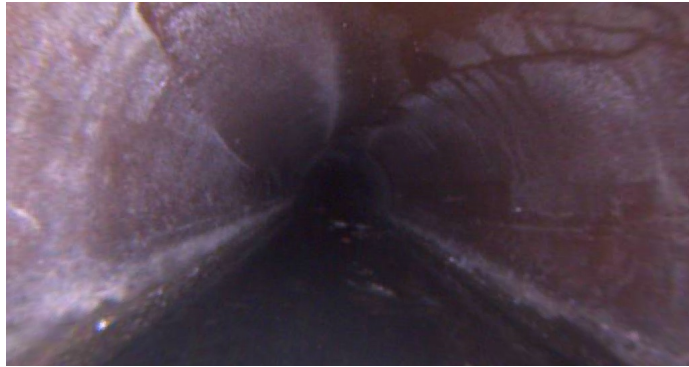
Code: **MWL**  
Description: **Water Level**

Distance (ft): **.0**  
Structural Grade: **0**  
O&M Grade: **0**  
Clock Start/From:  
Clock To:  
1st Value:  
2nd Value:  
Value Percent: **10.000**  
Continuous Index:  
Within 8" of Joint: **NO**  
Remarks:

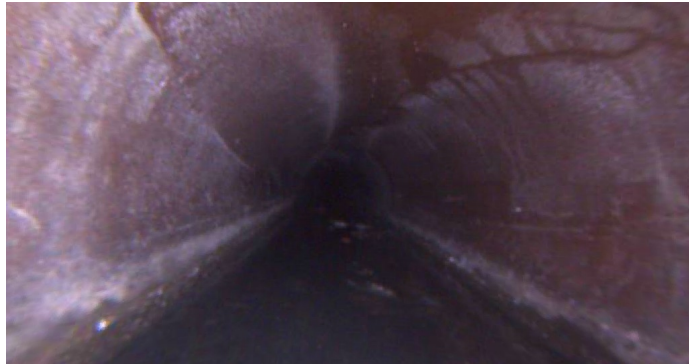
Code: **FM**  
Description: **Fracture Multiple**

Distance (ft): **.0**  
Structural Grade: **4**  
O&M Grade: **0**  
Clock Start/From: **7**  
Clock To: **5**  
1st Value:  
2nd Value:  
Value Percent:  
Continuous Index: **S01**  
Within 8" of Joint:  
Remarks:

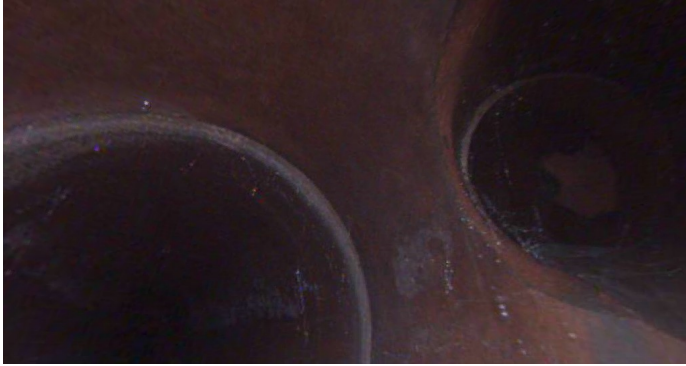
Code: **TF**  
Description: **Tap Factory**

Distance (ft): **28.5**  
Structural Grade: **0**  
O&M Grade: **0**  
Clock Start/From: **9**  
Clock To:  
1st Value: **4.000**  
2nd Value:  
Value Percent:  
Continuous Index:  
Within 8" of Joint:  
Remarks:

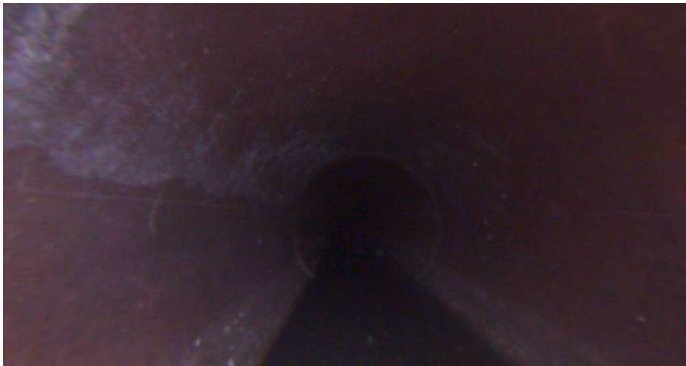
Code: **FM**  
Description: **Fracture Multiple**

Distance (ft): **28.5**  
Structural Grade: **4**  
O&M Grade: **0**  
Clock Start/From: **7**  
Clock To: **5**  
1st Value:  
2nd Value:  
Value Percent:  
Continuous Index: **F01**  
Within 8" of Joint:  
Remarks:

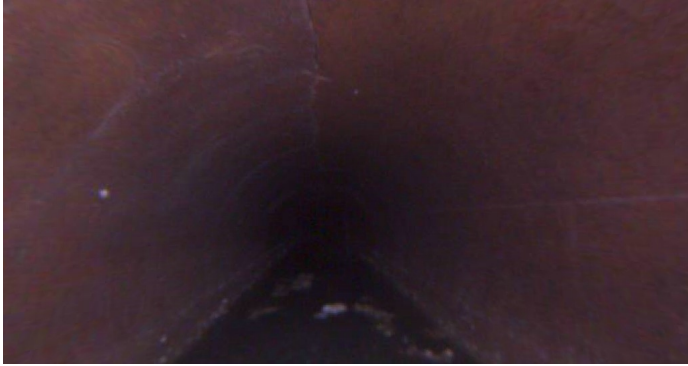
Code: **FM**  
Description: **Fracture Multiple**

Distance (ft): **33.6**  
Structural Grade: **4**  
O&M Grade: **0**  
Clock Start/From: **7**  
Clock To: **5**  
1st Value:  
2nd Value:  
Value Percent:  
Continuous Index: **S02**  
Within 8" of Joint:  
Remarks:

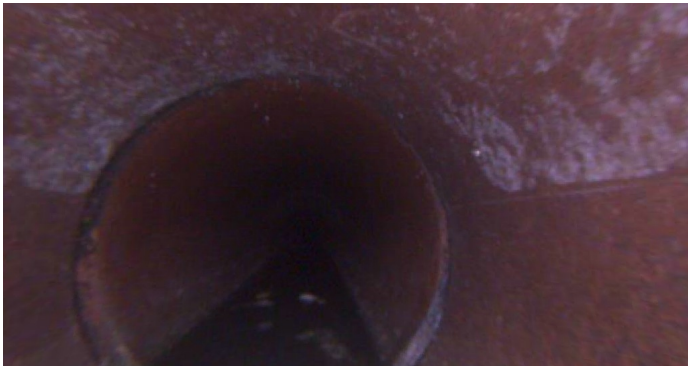
Code: **FM**  
Description: **Fracture Multiple**

Distance (ft): **44.5**  
Structural Grade: **4**  
O&M Grade: **0**  
Clock Start/From: **7**  
Clock To: **5**  
1st Value:  
2nd Value:  
Value Percent:  
Continuous Index: **F02**  
Within 8" of Joint:  
Remarks:

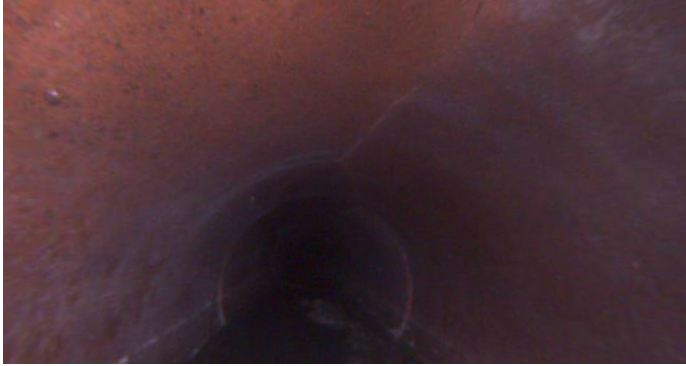
Code: **FM**  
Description: **Fracture Multiple**

Distance (ft): **61.4**  
Structural Grade: **4**  
O&M Grade: **0**  
Clock Start/From: **7**  
Clock To: **5**  
1st Value:  
2nd Value:  
Value Percent:  
Continuous Index: **S03**  
Within 8" of Joint:  
Remarks:

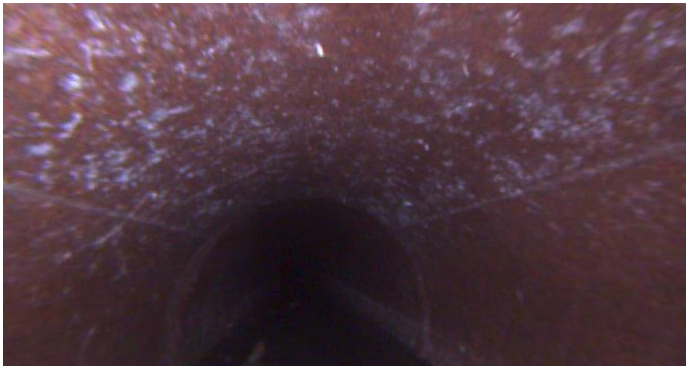
Code: **FM**  
Description: **Fracture Multiple**

Distance (ft): **73.5**  
Structural Grade: **4**  
O&M Grade: **0**  
Clock Start/From: **7**  
Clock To: **5**  
1st Value:  
2nd Value:  
Value Percent:  
Continuous Index: **F03**  
Within 8" of Joint:  
Remarks:

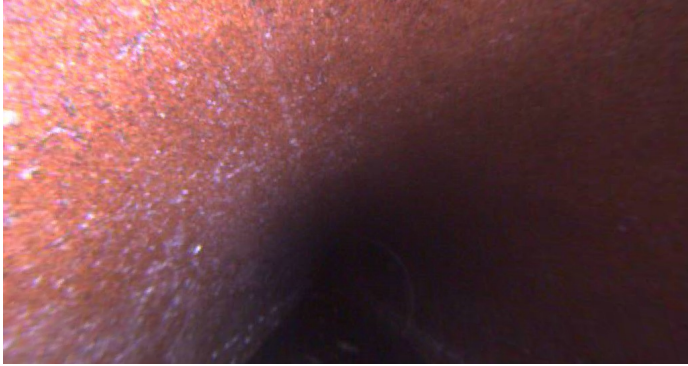
Code:	<b>MSA</b>
Description:	<b>Abandoned Survey</b>
Distance (ft):	<b>75.2</b>
Structural Grade:	<b>0</b>
O&M Grade:	<b>0</b>
Clock Start/From:	
Clock To:	
1st Value:	
2nd Value:	
Value Percent:	
Continuous Index:	
Within 8" of Joint:	<b>NO</b>
Remarks:	<b>Debris under water</b>
