## Profile/Photo Observation Report

Date:	<b>01/13/2025</b>	Weather:		Coding:	<b>PACP 7.0</b>
Pipe Length (ft):	<b>197.0</b>	Owner:	<b>City of Hobart</b>	Pre Clean:	<b>Heavy Cleaning</b>
P.O.#:	<b>YES502259</b>	Surveyor:	<b>S. Bucklin</b>	PSR:	<b>P-804-039-038</b>
Customer:	<b>City of Hobart</b>	Clean Date:	<b>10/30/2024</b>	Shape:	<b>C</b>

Street:	<b>North Liberty Street</b>	Flow Control:	<b>Not Controlled</b>
City:	<b>Hobart, IN</b>	Year Renewed:	
Location:	<b>Yard</b>	Tape/Media #:	
Purpose:	<b>Sewer System Evaluation Survey (SS</b>	Dia/Height:	<b>12"</b>
Use:	<b>Sanitary Sewage Pipe</b>	Material:	<b>VCP</b>
Drain Area:		Lining:	<b>None</b>
Category:	<b>NA</b>		
Comment:			
Location Details:		Direction of Survey:	<b>Downstream</b>
US MH:	<b>M-804-039</b>	DS MH:	<b>M-804-038</b>
		Total Length Surveyed (ft):	<b>198.6</b>

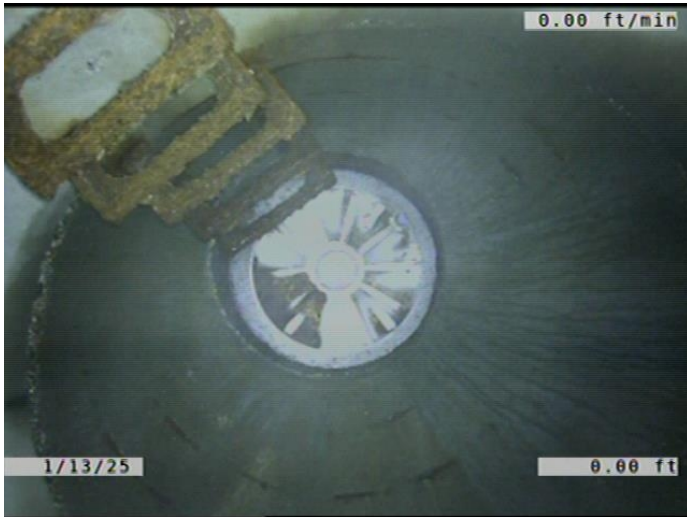
Code: **AMH**  
Description: **Manhole**

Distance (ft): **.0**  
Structural Grade: **0**  
O&M Grade: **0**  
Clock Start/From:  
Clock To:  
1st Value:  
2nd Value:  
Value Percent:  
Continuous Index:  
Within 8" of Joint: **NO**  
Remarks: **M-804-039**

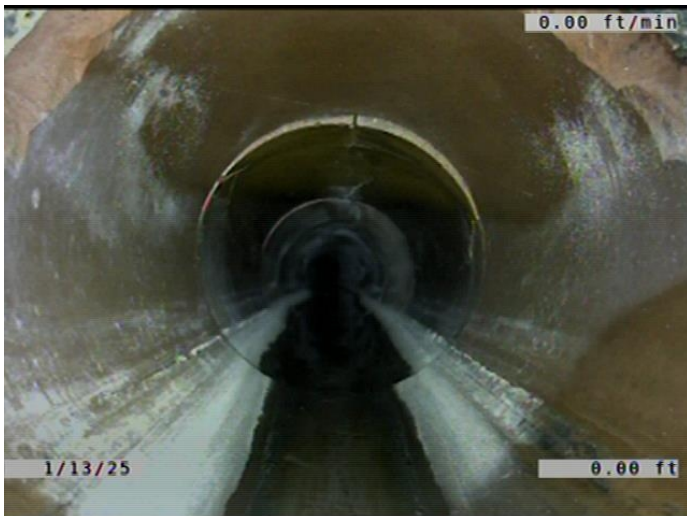
Code: **MWL**  
Description: **Miscellaneous Water Level**

Distance (ft): **.0**  
Structural Grade: **0**  
O&M Grade: **0**  
Clock Start/From:  
Clock To:  
1st Value:  
2nd Value:  
Value Percent: **5.000**  
Continuous Index:  
Within 8" of Joint: **NO**  
Remarks:

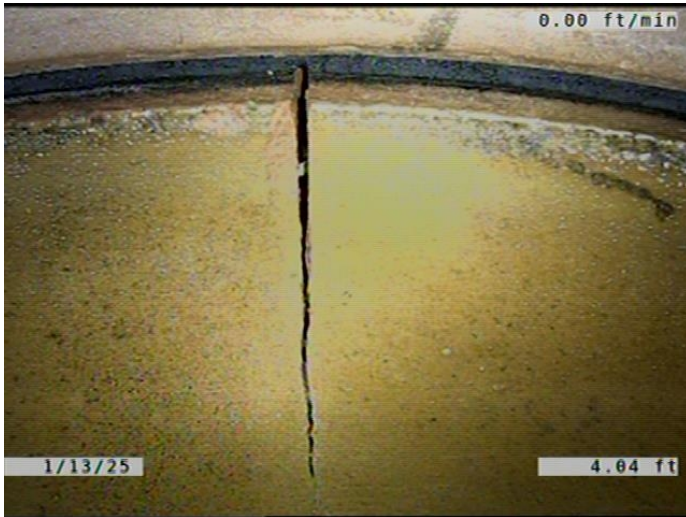
Code: **FM**  
Description: **Fracture Multiple**

Distance (ft): **4.0**  
Structural Grade: **4**  
O&M Grade: **0**  
Clock Start/From: **12**  
Clock To: **12**  
1st Value:  
2nd Value:  
Value Percent:  
Continuous Index: **S02**  
Within 8" of Joint: **YES**  
Remarks:

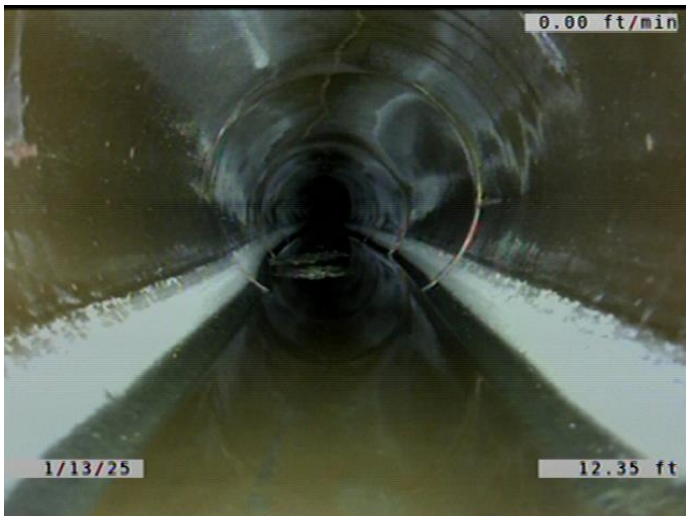
Code: **MWLS**  
Description: **Miscellaneous Water Level Sag**

Distance (ft): **12.4**  
Structural Grade: **2**  
O&M Grade: **0**  
Clock Start/From:  
Clock To:  
1st Value:  
2nd Value:  
Value Percent: **15.000**  
Continuous Index: **S01**  
Within 8" of Joint: **NO**  
Remarks:

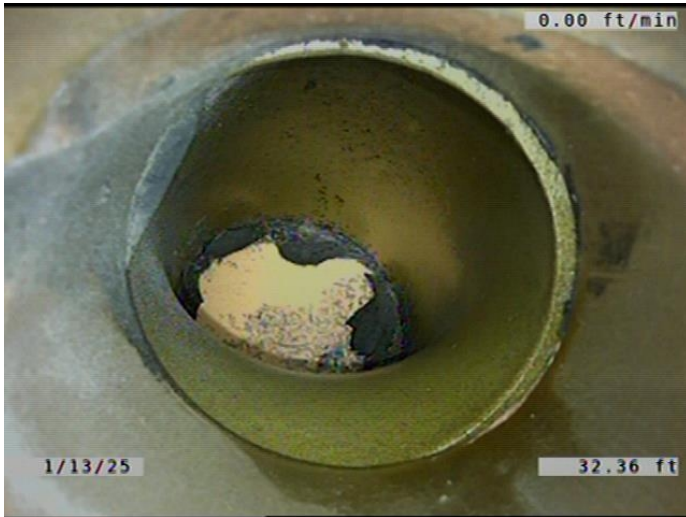
Code: **TFD**  
 Description: **Tap Factory Defective**

Distance (ft): **32.4**  
 Structural Grade: **0**  
 O&M Grade: **3**  
 Clock Start/From: **11**  
 Clock To:  
 1st Value: **6.000**  
 2nd Value:  
 Value Percent:  
 Continuous Index:  
 Within 8" of Joint: **YES**  
 Remarks: **CAPPED. TAP CRACKED.**

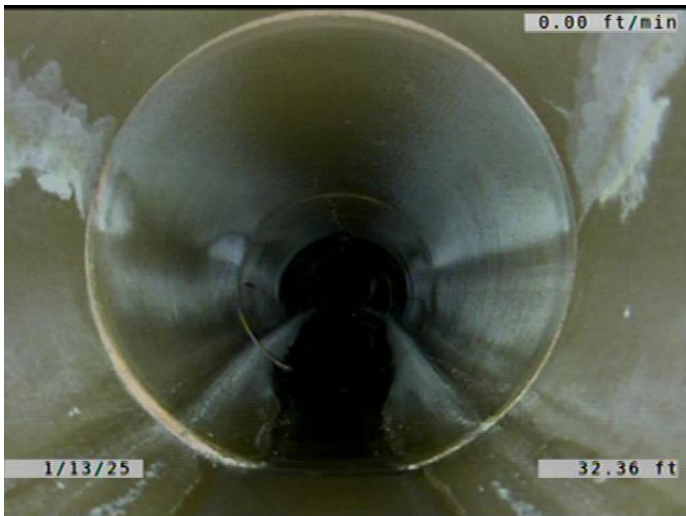
Code: **MWLS**  
 Description: **Miscellaneous Water Level Sag**

Distance (ft): **32.4**  
 Structural Grade: **2**  
 O&M Grade: **0**  
 Clock Start/From:  
 Clock To:  
 1st Value:  
 2nd Value:  
 Value Percent: **15.000**  
 Continuous Index: **F01**  
 Within 8" of Joint: **NO**  
 Remarks:

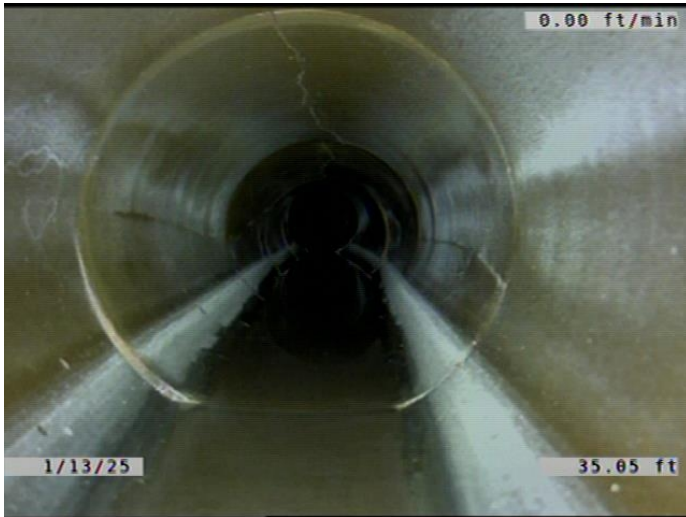
Code: **MWLS**  
Description: **Miscellaneous Water Level Sag**

Distance (ft): **35.0**  
Structural Grade: **2**  
O&M Grade: **0**  
Clock Start/From:  
Clock To:  
1st Value:  
2nd Value:  
Value Percent: **10.000**  
Continuous Index: **S03**  
Within 8" of Joint: **NO**  
Remarks:

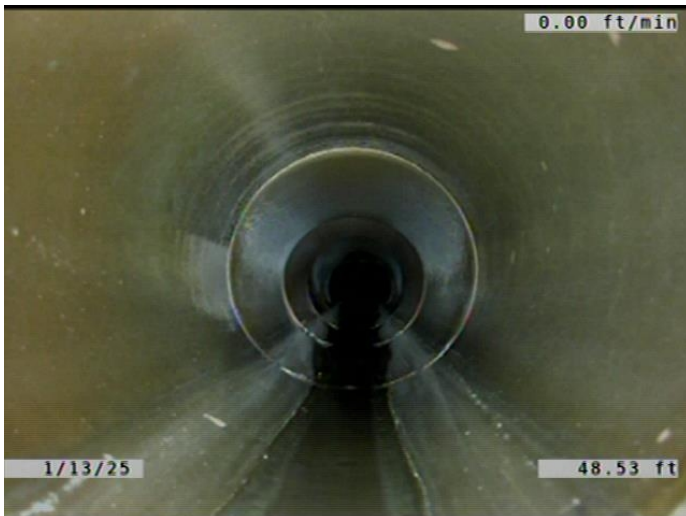
Code: **MWLS**  
Description: **Miscellaneous Water Level Sag**

Distance (ft): **48.5**  
Structural Grade: **2**  
O&M Grade: **0**  
Clock Start/From:  
Clock To:  
1st Value:  
2nd Value:  
Value Percent: **10.000**  
Continuous Index: **F03**  
Within 8" of Joint: **NO**  
Remarks:

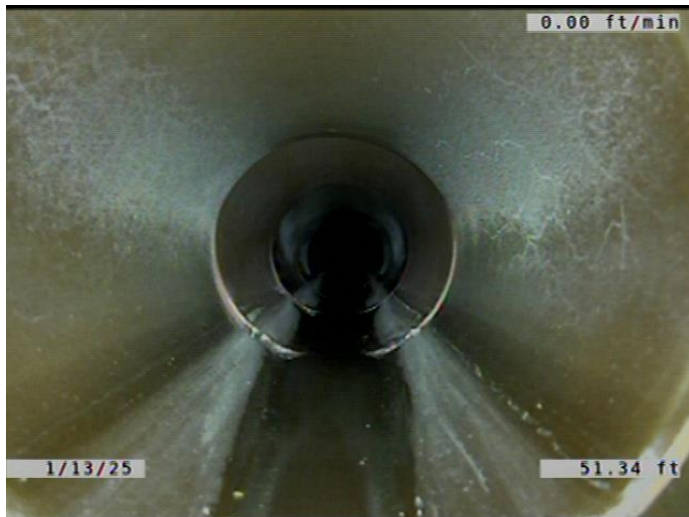
Code: **FM**  
Description: **Fracture Multiple**

Distance (ft): **51.3**  
Structural Grade: **4**  
O&M Grade: **0**  
Clock Start/From: **12**  
Clock To: **12**  
1st Value:  
2nd Value:  
Value Percent:  
Continuous Index: **F02**  
Within 8" of Joint: **YES**  
Remarks:

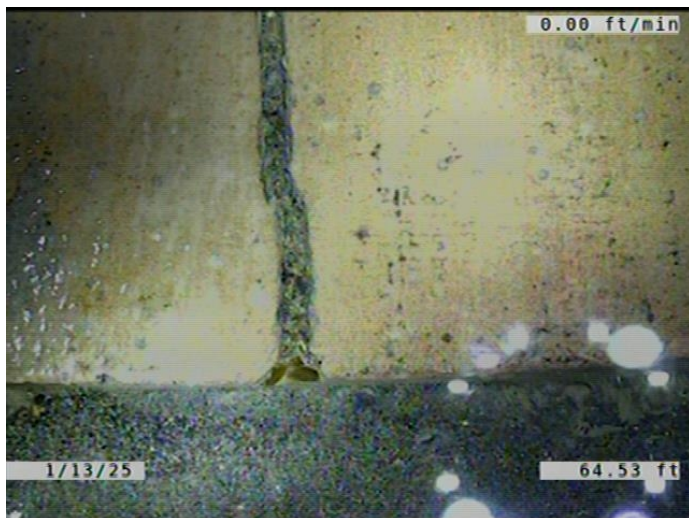
Code: **B**  
Description: **Broken**

Distance (ft): **64.5**  
Structural Grade: **4**  
O&M Grade: **0**  
Clock Start/From: **12**  
Clock To: **12**  
1st Value:  
2nd Value:  
Value Percent:  
Continuous Index: **S04**  
Within 8" of Joint: **YES**  
Remarks:

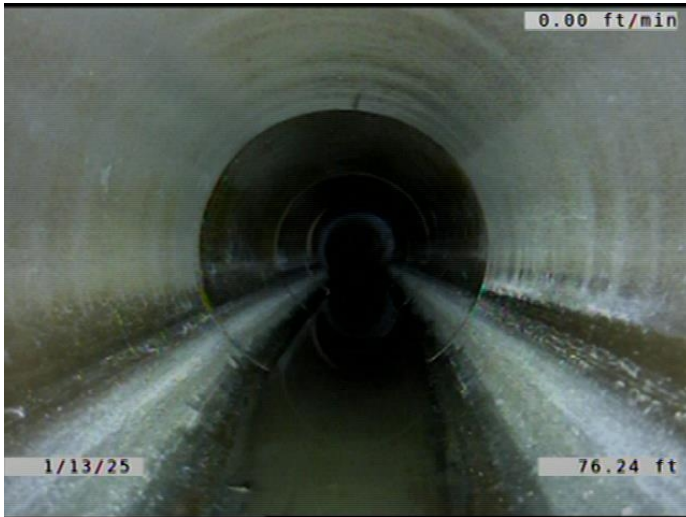
Code: **MWLS**  
Description: **Miscellaneous Water Level Sag**

Distance (ft): **76.2**  
Structural Grade: **2**  
O&M Grade: **0**  
Clock Start/From:  
Clock To:  
1st Value:  
2nd Value:  
Value Percent: **10.000**  
Continuous Index: **S05**  
Within 8" of Joint: **NO**  
Remarks:

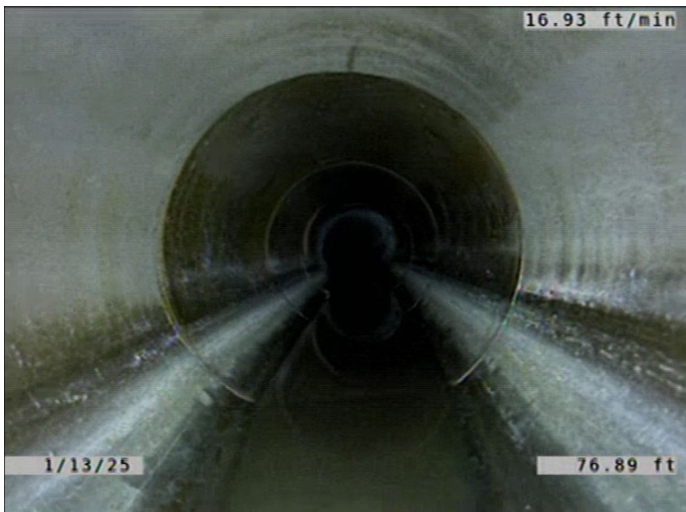
Code: **B**  
Description: **Broken**

Distance (ft): **76.9**  
Structural Grade: **4**  
O&M Grade: **0**  
Clock Start/From: **12**  
Clock To: **12**  
1st Value:  
2nd Value:  
Value Percent:  
Continuous Index: **F04**  
Within 8" of Joint: **YES**  
Remarks:

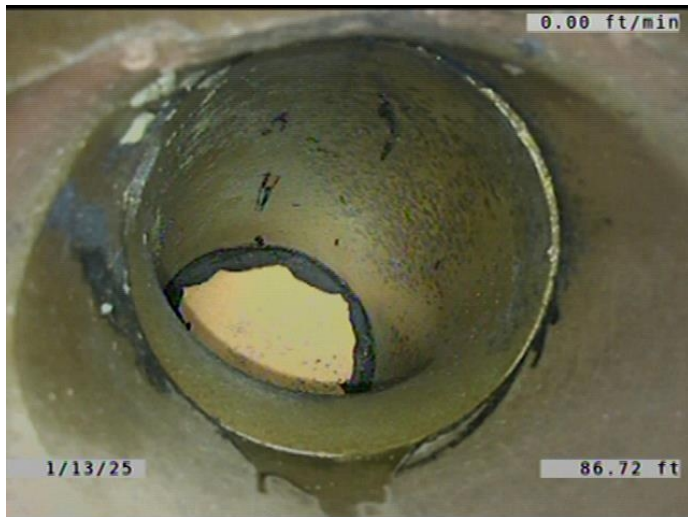
Code: **TFD**  
 Description: **Tap Factory Defective**

Distance (ft): **86.7**  
 Structural Grade: **0**  
 O&M Grade: **3**  
 Clock Start/From: **11**  
 Clock To:  
 1st Value: **6.000**  
 2nd Value:  
 Value Percent:  
 Continuous Index:  
 Within 8" of Joint: **YES**  
 Remarks: **CAPPED. TAP CRACKED.**

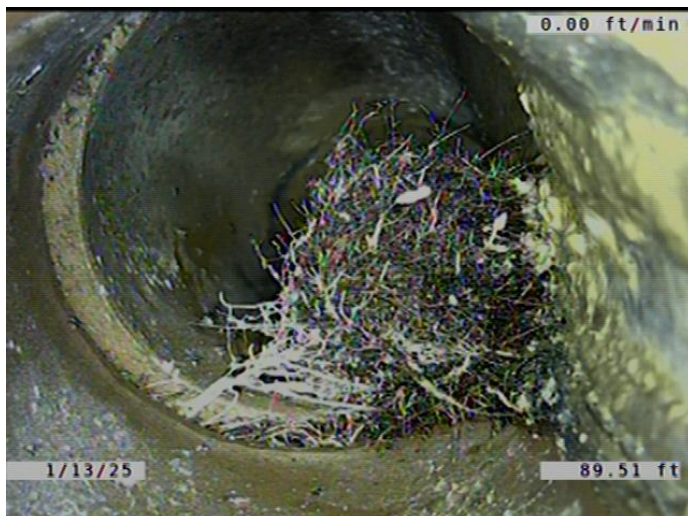
Code: **TFD**  
 Description: **Tap Factory Defective**

Distance (ft): **89.5**  
 Structural Grade: **0**  
 O&M Grade: **3**  
 Clock Start/From: **2**  
 Clock To:  
 1st Value: **6.000**  
 2nd Value:  
 Value Percent:  
 Continuous Index:  
 Within 8" of Joint: **YES**  
 Remarks: **TAP CRACKED. ROOTS GROWING IN A JOINTS.**

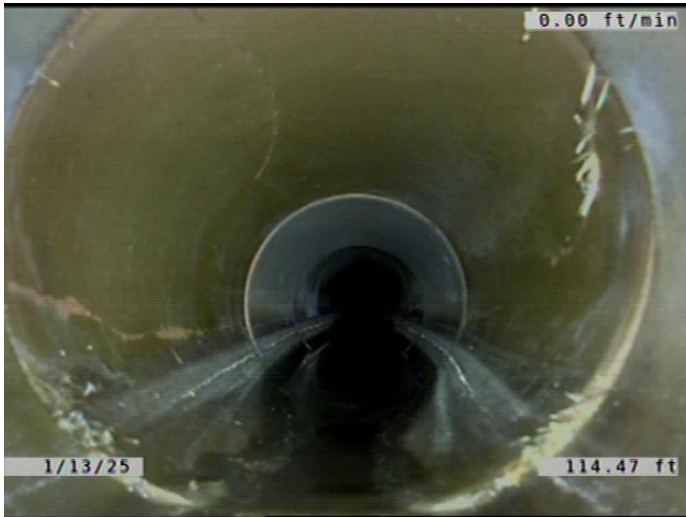
Code: **MWLS**  
Description: **Miscellaneous Water Level Sag**

Distance (ft): **114.5**  
Structural Grade: **2**  
O&M Grade: **0**  
Clock Start/From:  
Clock To:  
1st Value:  
2nd Value:  
Value Percent: **10.000**  
Continuous Index: **F05**  
Within 8" of Joint: **NO**  
Remarks:

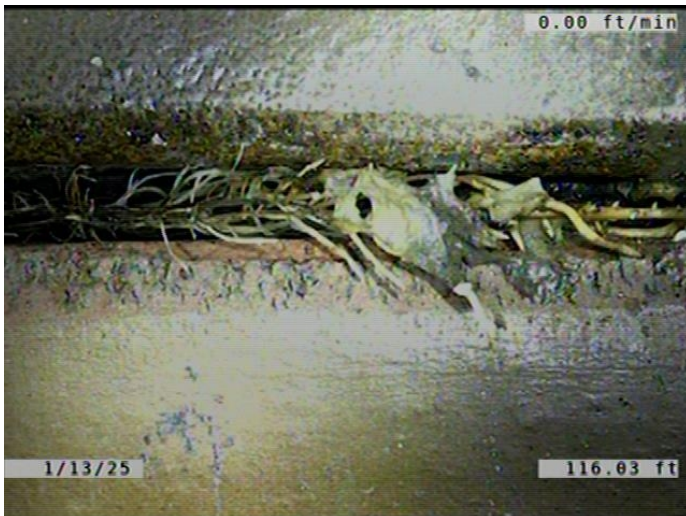
Code: **RFJ**  
Description: **Roots Fine Joint**

Distance (ft): **116.0**  
Structural Grade: **0**  
O&M Grade: **1**  
Clock Start/From: **7**  
Clock To: **5**  
1st Value:  
2nd Value:  
Value Percent:  
Continuous Index: **S08**  
Within 8" of Joint: **YES**  
Remarks:

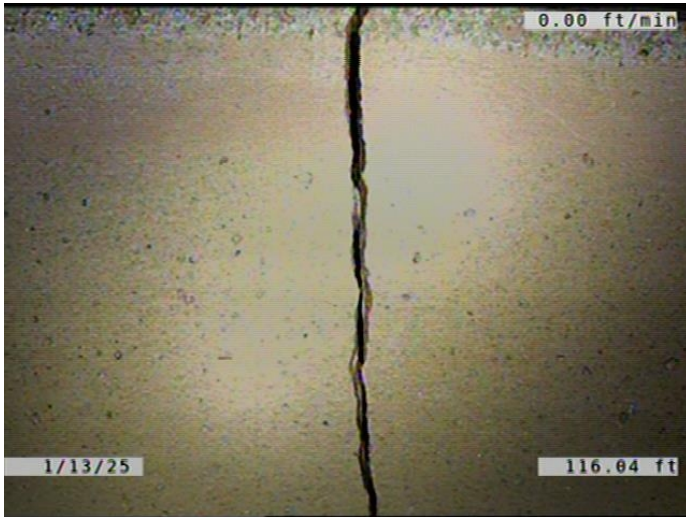
Code: **FM**  
 Description: **Fracture Multiple**

Distance (ft): **116.0**  
 Structural Grade: **4**  
 O&M Grade: **0**  
 Clock Start/From: **8**  
 Clock To: **4**  
 1st Value:  
 2nd Value:  
 Value Percent:  
 Continuous Index:  
 Within 8" of Joint: **YES**  
 Remarks:

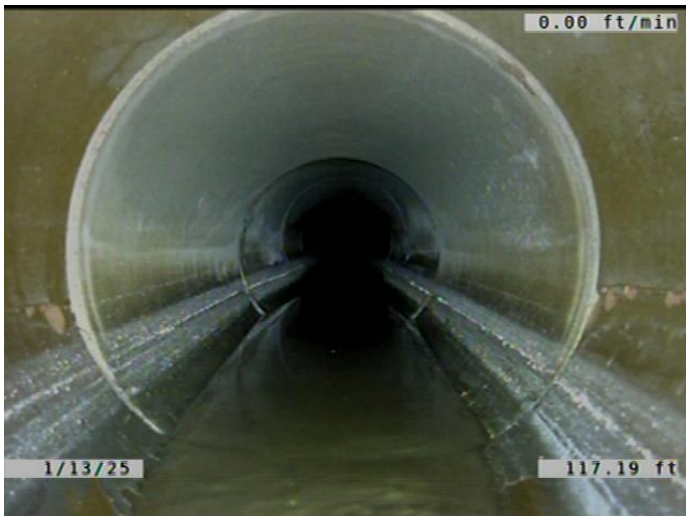
Code: **MWLS**  
 Description: **Miscellaneous Water Level Sag**

Distance (ft): **117.2**  
 Structural Grade: **2**  
 O&M Grade: **0**  
 Clock Start/From:  
 Clock To:  
 1st Value:  
 2nd Value:  
 Value Percent: **15.000**  
 Continuous Index: **S07**  
 Within 8" of Joint: **NO**  
 Remarks:

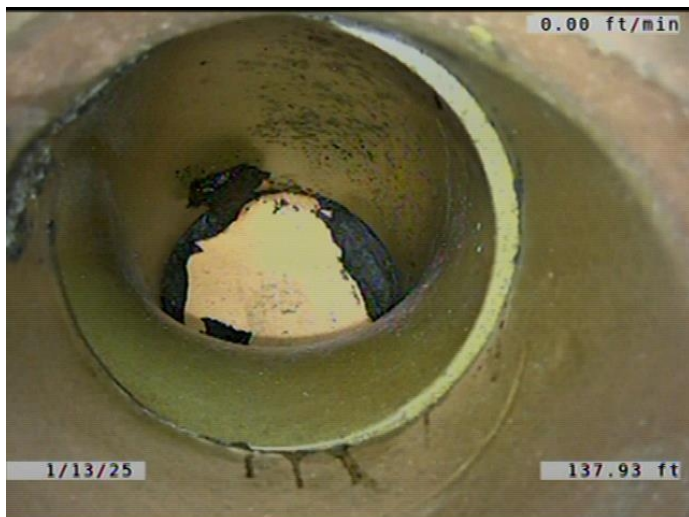
Code: **TFC**  
 Description: **Tap Factory Capped**

Distance (ft): **137.9**  
 Structural Grade: **0**  
 O&M Grade: **0**  
 Clock Start/From: **10**  
 Clock To:  
 1st Value: **6.000**  
 2nd Value:  
 Value Percent:  
 Continuous Index:  
 Within 8" of Joint: **YES**  
 Remarks:

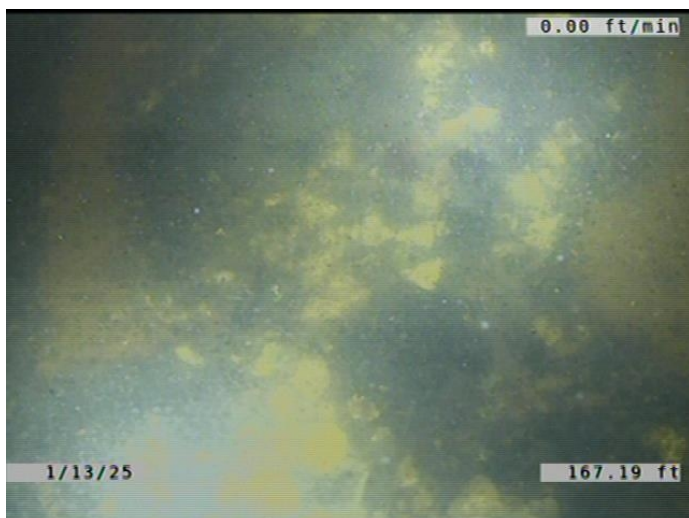
Code: **DSF**  
 Description: **Deposits Settled Fine**

Distance (ft): **167.2**  
 Structural Grade: **0**  
 O&M Grade: **2**  
 Clock Start/From: **5**  
 Clock To: **7**  
 1st Value:  
 2nd Value:  
 Value Percent: **5.000**  
 Continuous Index: **S09**  
 Within 8" of Joint: **YES**  
 Remarks:

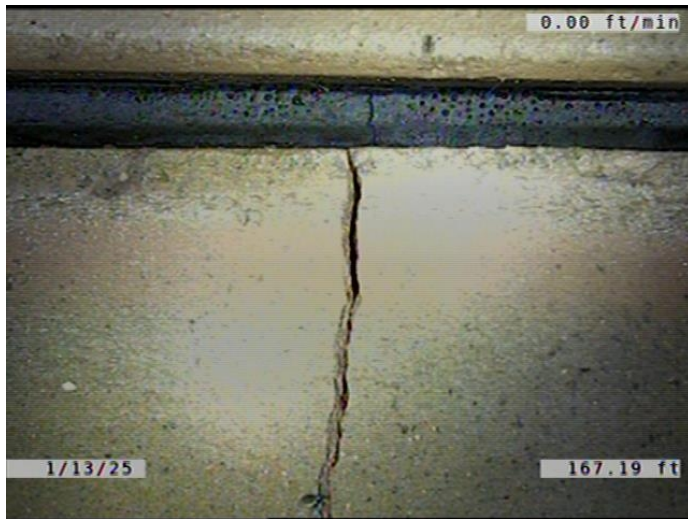
Code: **FM**  
Description: **Fracture Multiple**

Distance (ft): **167.2**  
Structural Grade: **4**  
O&M Grade: **0**  
Clock Start/From: **12**  
Clock To: **12**  
1st Value:  
2nd Value:  
Value Percent:  
Continuous Index: **S10**  
Within 8" of Joint: **YES**  
Remarks:

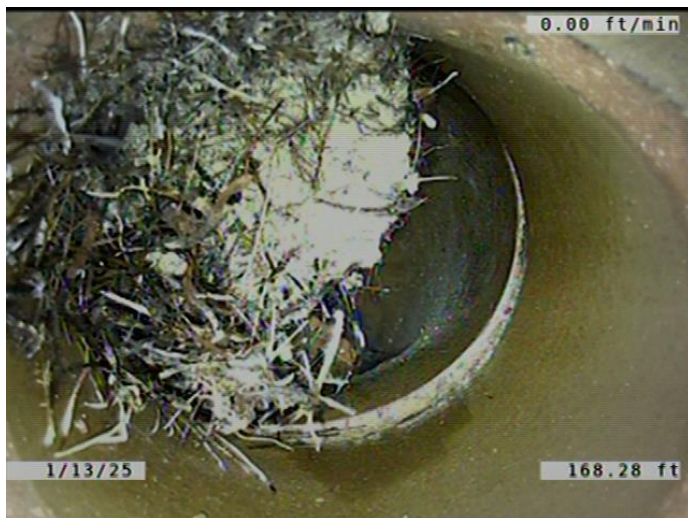
Code: **TFD**  
Description: **Tap Factory Defective**

Distance (ft): **168.3**  
Structural Grade: **0**  
O&M Grade: **3**  
Clock Start/From: **10**  
Clock To:  
1st Value: **6.000**  
2nd Value:  
Value Percent:  
Continuous Index:  
Within 8" of Joint: **YES**  
Remarks: **CAPPED. TAP CRACKED. ROOTS GROWING FROM THE JOINTS INTO T**

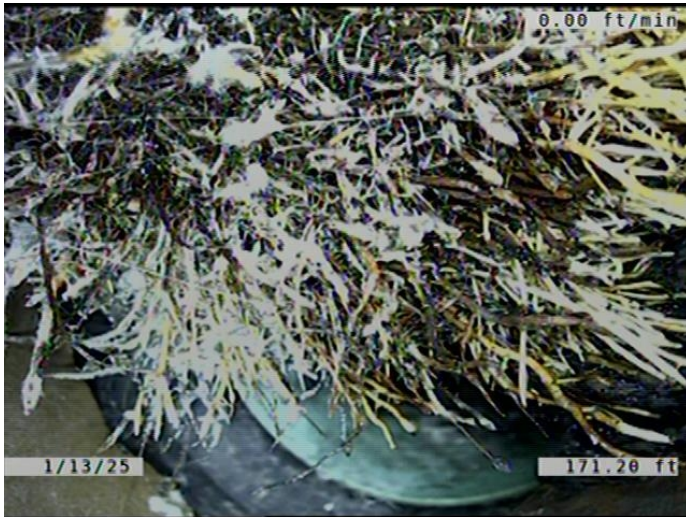
Code:	<b>TFD</b>
Description:	<b>Tap Factory Defective</b>
Distance (ft):	<b>171.2</b>
Structural Grade:	<b>0</b>
O&M Grade:	<b>3</b>
Clock Start/From:	<b>2</b>
Clock To:	
1st Value:	<b>6.000</b>
2nd Value:	
Value Percent:	
Continuous Index:	
Within 8" of Joint:	<b>YES</b>
Remarks:	<b>SERVICE HAS BEEN REPLACED WITH PVC. ROOTS GROWING FROM THE S</b>

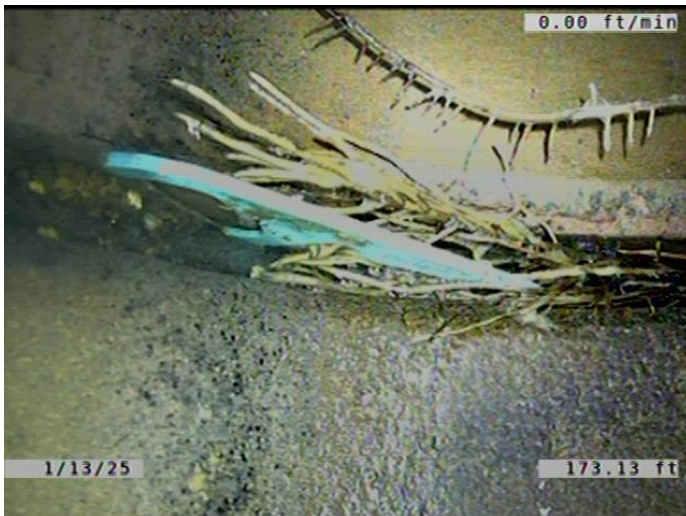
Code:	<b>OBJ</b>
Description:	<b>Obstruction Wedged In The Joint</b>
Distance (ft):	<b>173.1</b>
Structural Grade:	<b>0</b>
O&M Grade:	<b>2</b>
Clock Start/From:	<b>5</b>
Clock To:	
1st Value:	
2nd Value:	
Value Percent:	<b>5.000</b>
Continuous Index:	
Within 8" of Joint:	<b>YES</b>
Remarks:	<b>TOOTHPICK</b>

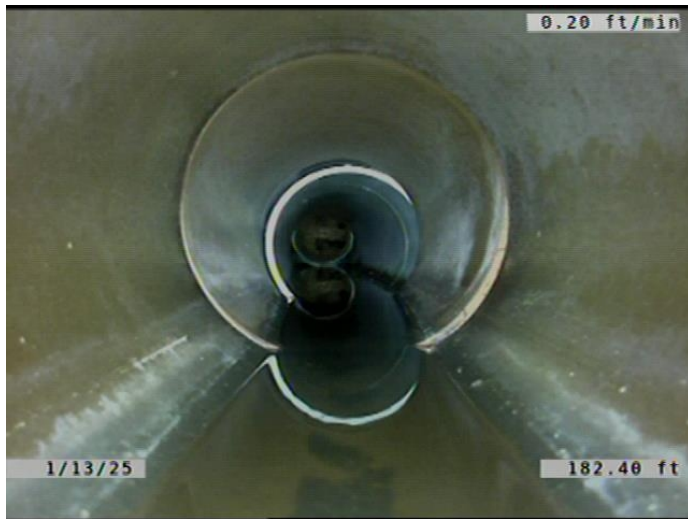
Code: **RFJ**  
Description: **Roots Fine Joint**

Distance (ft): **182.4**  
Structural Grade: **0**  
O&M Grade: **1**  
Clock Start/From: **7**  
Clock To: **5**  
1st Value:  
2nd Value:  
Value Percent:  
Continuous Index: **F08**  
Within 8" of Joint: **YES**  
Remarks:

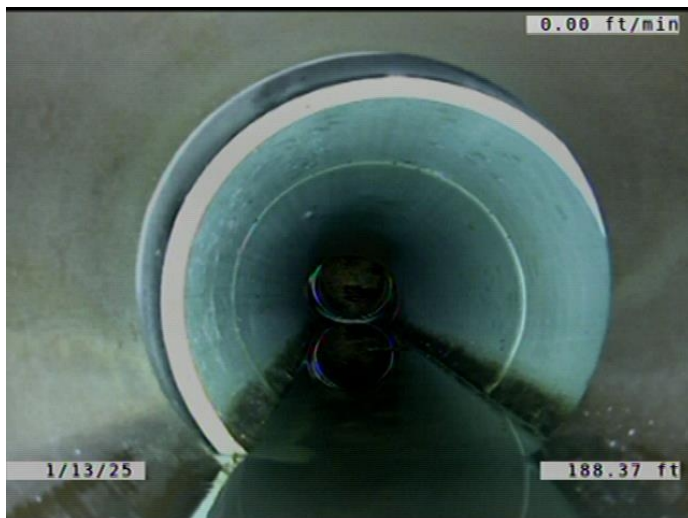
Code: **JOLD**  
Description: **Joint Offset Large Defective**

Distance (ft): **188.4**  
Structural Grade: **4**  
O&M Grade: **0**  
Clock Start/From:  
Clock To:  
1st Value:  
2nd Value:  
Value Percent:  
Continuous Index:  
Within 8" of Joint: **NO**  
Remarks:

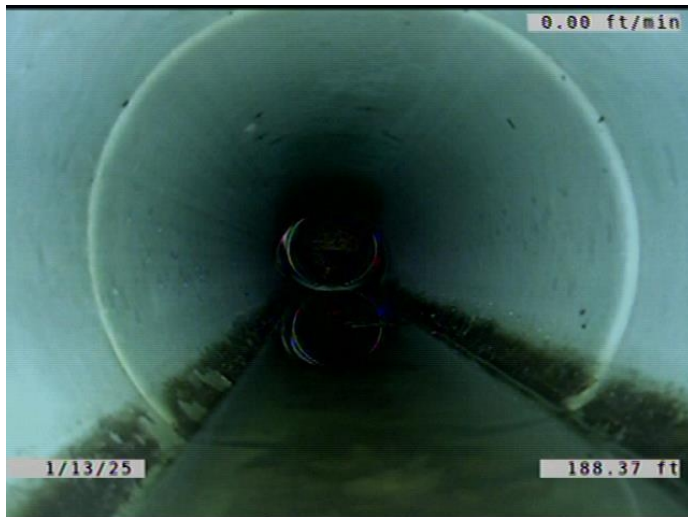
Code: **FM**  
Description: **Fracture Multiple**

Distance (ft): **188.4**  
Structural Grade: **4**  
O&M Grade: **0**  
Clock Start/From: **12**  
Clock To: **12**  
1st Value:  
2nd Value:  
Value Percent:  
Continuous Index: **F10**  
Within 8" of Joint: **YES**  
Remarks:

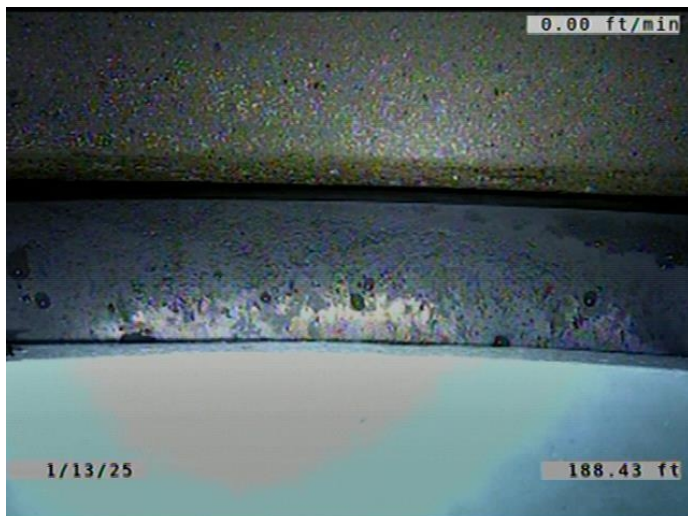
Code: **MMC**  
Description: **Miscellaneous Material Change**

Distance (ft): **188.4**  
Structural Grade: **0**  
O&M Grade: **0**  
Clock Start/From:  
Clock To:  
1st Value:  
2nd Value:  
Value Percent:  
Continuous Index:  
Within 8" of Joint: **NO**  
Remarks: **VCP TO PVC**

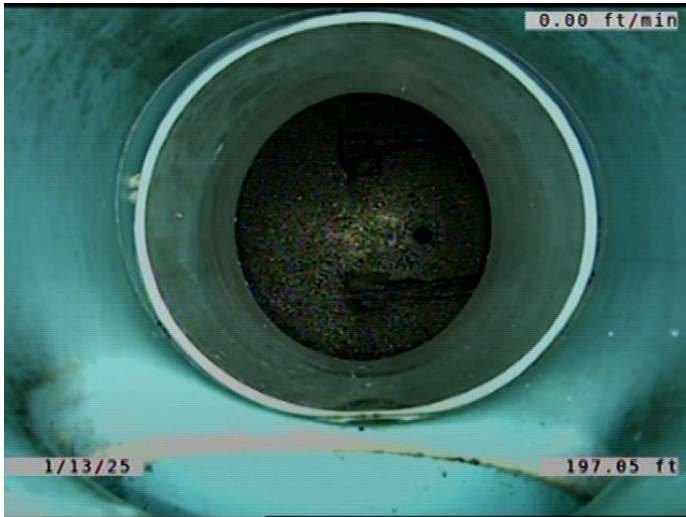
Code: **DSF**  
Description: **Deposits Settled Fine**

Distance (ft): **197.0**  
Structural Grade: **0**  
O&M Grade: **2**  
Clock Start/From: **5**  
Clock To: **7**  
1st Value:  
2nd Value:  
Value Percent: **5.000**  
Continuous Index: **F09**  
Within 8" of Joint: **YES**  
Remarks:

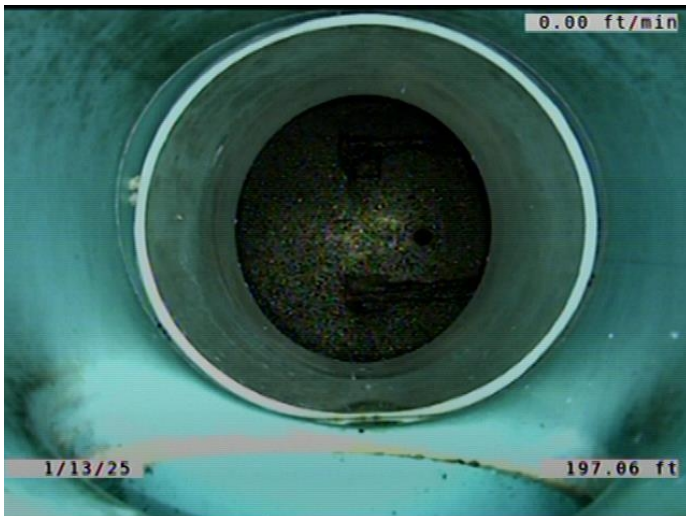
Code: **MWLS**  
Description: **Miscellaneous Water Level Sag**

Distance (ft): **197.0**  
Structural Grade: **2**  
O&M Grade: **0**  
Clock Start/From:  
Clock To:  
1st Value:  
2nd Value:  
Value Percent: **15.000**  
Continuous Index: **F07**  
Within 8" of Joint: **NO**  
Remarks:

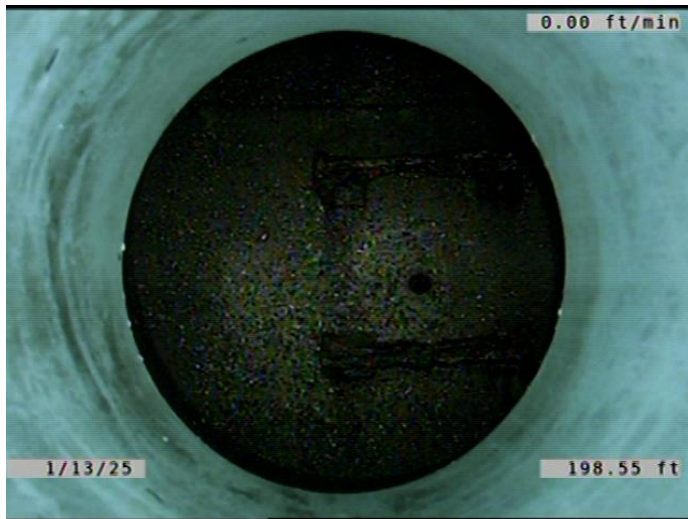
Code:	AMH
Description:	Manhole
Distance (ft):	198.6
Structural Grade:	0
O&M Grade:	0
Clock Start/From:	
Clock To:	
1st Value:	
2nd Value:	
Value Percent:	
Continuous Index:	
Within 8" of Joint:	NO
Remarks:	M-804-038
