Profile/Photo Observation Report

Street:	OFF N LIBERTY ST	Flow Control:	Not Controlled
City:	Hobart, IN	Year Renewed:	
Location:	Other	Tape/Media #:	
Purpose:	Not Known	Dia/Height:	12"
Use:	Sanitary	Material:	VCP
Drain Area:	NA	Lining:	
Category:	NA		
Comment:

Location Details:		Direction of Survey:	Upstream
US MH:	M-804-039	DS MH:	M-804-040
		Total Length Surveyed (ft):	59.2

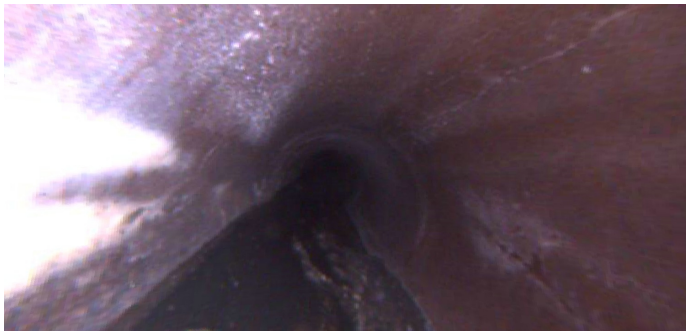
Code: **AMH**
Description: **Manhole**

Distance (ft): **.0**
Structural Grade: **0**
O&M Grade: **0**
Clock Start/From:
Clock To:
1st Value:
2nd Value:
Value Percent:
Continuous Index:
Within 8" of Joint: **NO**
Remarks: **M-804-040**

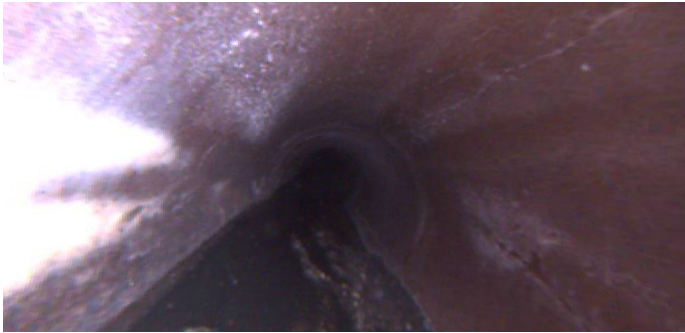
Code:	MWL
Description:	Water Level

Distance (ft):	.0
Structural Grade:	0
O&M Grade:	0
Clock Start/From:	
Clock To:	
1st Value:	
2nd Value:	
Value Percent:	5.000
Continuous Index:	
Within 8" of Joint:	NO
Remarks:

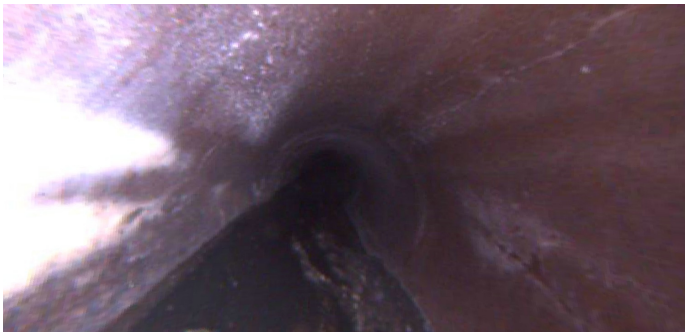
Code:	DSZ
Description:	Deposits Settled Other

Distance (ft):	.0
Structural Grade:	0
O&M Grade:	2
Clock Start/From:	6
Clock To:	
1st Value:	
2nd Value:	
Value Percent:	5.000
Continuous Index:	S02
Within 8" of Joint:	NO
Remarks:	debris

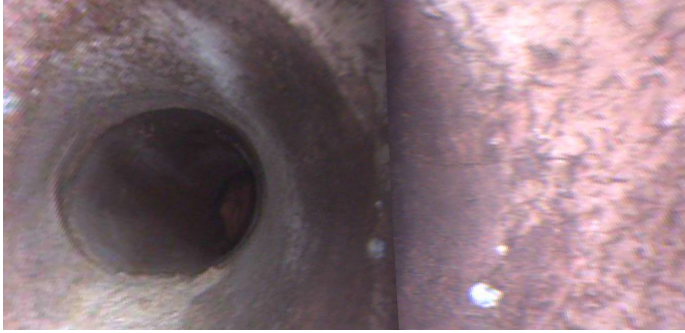
Code: **TF**
Description: **Tap Factory**

Distance (ft): **3.7**
Structural Grade: **0**
O&M Grade: **0**
Clock Start/From: **10**
Clock To:
1st Value: **4.000**
2nd Value:
Value Percent:
Continuous Index:
Within 8" of Joint: **YES**
Remarks:

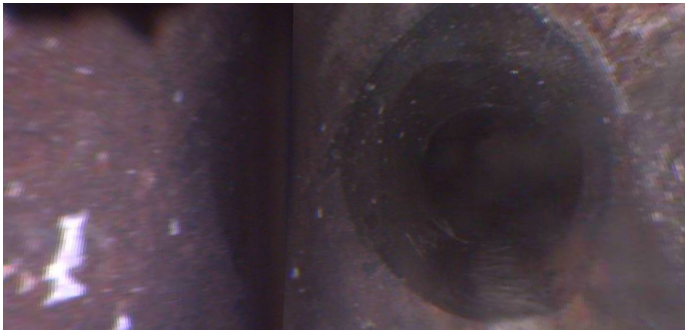
Code: **TF**
Description: **Tap Factory**

Distance (ft): **6.7**
Structural Grade: **0**
O&M Grade: **0**
Clock Start/From: **2**
Clock To:
1st Value: **4.000**
2nd Value:
Value Percent:
Continuous Index:
Within 8" of Joint: **YES**
Remarks:

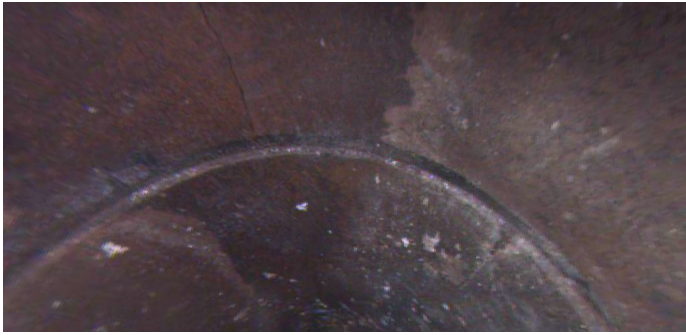
Code: **CM**
Description: **Crack Multiple**

Distance (ft): **9.1**
Structural Grade: **3**
O&M Grade: **0**
Clock Start/From: **10**
Clock To: **2**
1st Value:
2nd Value:
Value Percent:
Continuous Index: **S01**
Within 8" of Joint: **YES**
Remarks: **wandering**

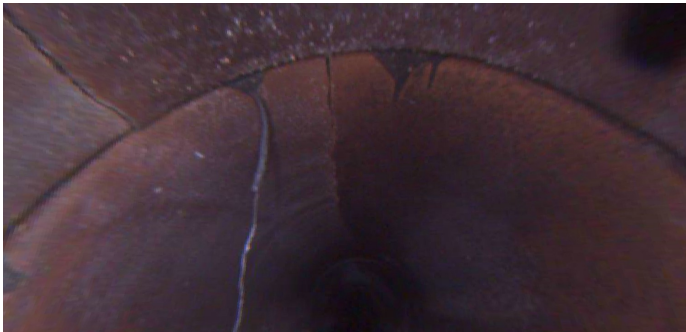
Code: **RFJ**
Description: **Roots Fine Joint**

Distance (ft): **22.8**
Structural Grade: **0**
O&M Grade: **1**
Clock Start/From: **11**
Clock To:
1st Value:
2nd Value:
Value Percent:
Continuous Index:
Within 8" of Joint: **YES**
Remarks:

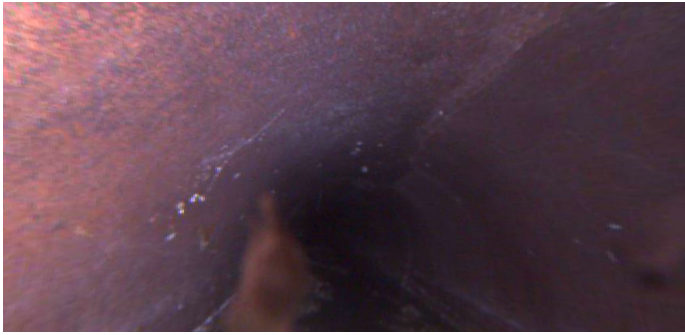
Code: **MSA**
Description: **Abandoned Survey**

Distance (ft): **59.2**
Structural Grade: **0**
O&M Grade: **0**
Clock Start/From:
Clock To:
1st Value:
2nd Value:
Value Percent:
Continuous Index:
Within 8" of Joint: **NO**
Remarks: **debris**

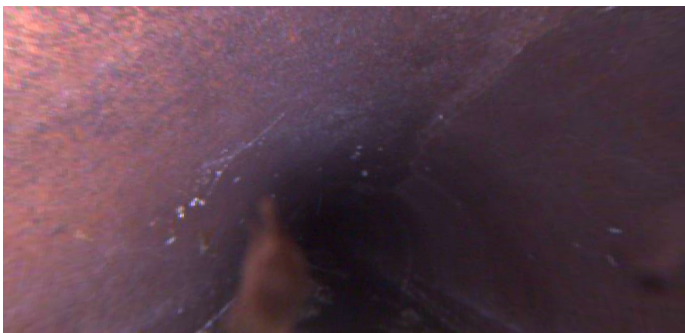
Code: **DSZ**
Description: **Deposits Settled Other**

Distance (ft): **59.2**
Structural Grade: **0**
O&M Grade: **2**
Clock Start/From: **6**
Clock To:
1st Value:
2nd Value:
Value Percent: **5.000**
Continuous Index: **F02**
Within 8" of Joint: **NO**
Remarks: **debris**

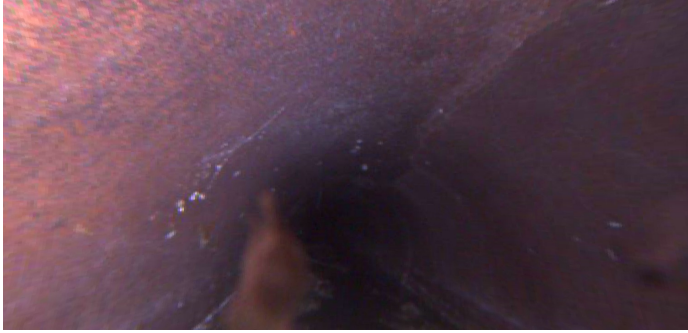
Code:	CM
Description:	Crack Multiple
Distance (ft):	59.2
Structural Grade:	3
O&M Grade:	0
Clock Start/From:	10
Clock To:	2
1st Value:	
2nd Value:	
Value Percent:	
Continuous Index:	F01
Within 8" of Joint:	YES
Remarks:	wandering
