Profile/Photo Observation Report

Date:	04/10/2018	Weather:		Coding:	PACP 6.0
Pipe Length (ft):	197.1	Owner:	NA	Pre Clean:	Not Known
P.O.#:		Surveyor:	Byrd Fitzgerald	PSR:	P-804-040-039
Customer:		Clean Date:	01/01/1900	Shape:	C

Street:	N Liberty St.	Flow Control:	Not Controlled
City:	Hobart, IN	Year Renewed:	
Location:	Other	Tape/Media #:	
Purpose:	Not Known	Dia/Height:	12"
Use:	Sanitary	Material:	VCP
Drain Area:	NA	Lining:	
Category:	NA		
Comment:

Location Details:		Direction of Survey:	Upstream
US MH:	M-804-039	DS MH:	M-804-040
		Total Length Surveyed (ft):	59.2

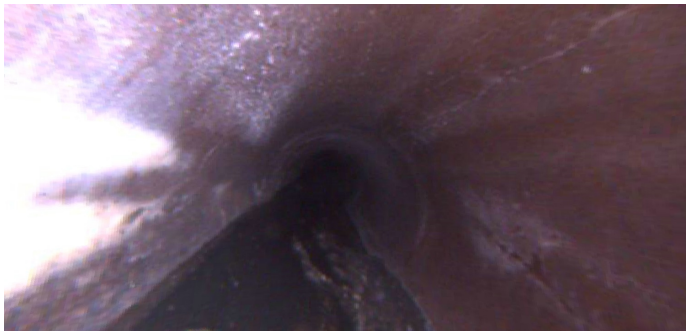
Code: **AMH**
Description: **Manhole**

Distance (ft): **.0**
Structural Grade: **0**
O&M Grade: **0**
Clock Start/From:
Clock To:
1st Value:
2nd Value:
Value Percent:
Continuous Index:
Within 8" of Joint: **NO**
Remarks: **M-804-040**

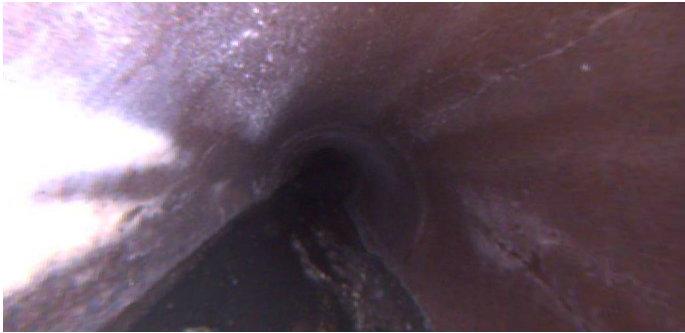
Code:	MWL
Description:	Water Level

Distance (ft):	.0
Structural Grade:	0
O&M Grade:	0
Clock Start/From:	
Clock To:	
1st Value:	
2nd Value:	
Value Percent:	5.000
Continuous Index:	
Within 8" of Joint:	NO
Remarks:

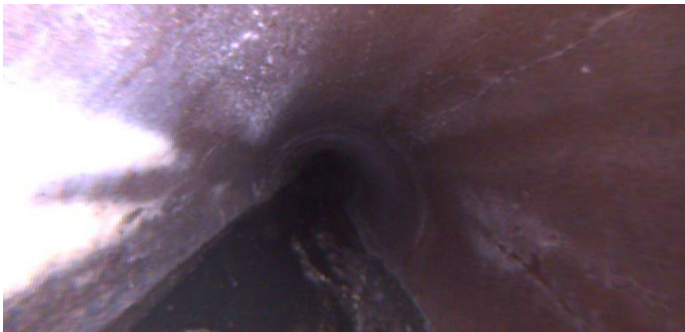
Code:	DSZ
Description:	Deposits Settled Other

Distance (ft):	.0
Structural Grade:	0
O&M Grade:	2
Clock Start/From:	6
Clock To:	
1st Value:	
2nd Value:	
Value Percent:	5.000
Continuous Index:	S02
Within 8" of Joint:	NO
Remarks:	debris

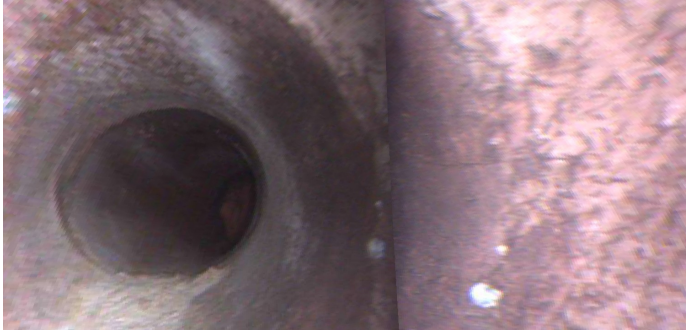
Code: **TF**
Description: **Tap Factory**

Distance (ft): **3.7**
Structural Grade: **0**
O&M Grade: **0**
Clock Start/From: **10**
Clock To:
1st Value: **4.000**
2nd Value:
Value Percent:
Continuous Index:
Within 8" of Joint: **YES**
Remarks:

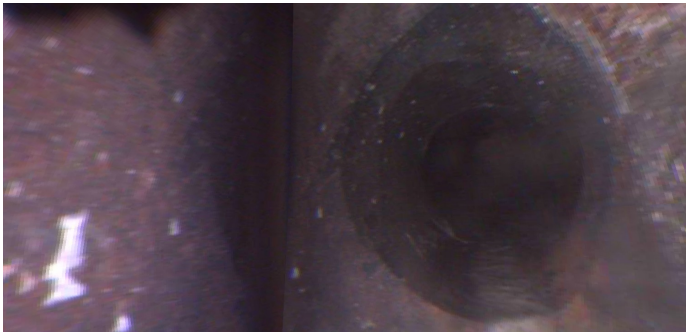
Code: **TF**
Description: **Tap Factory**

Distance (ft): **6.7**
Structural Grade: **0**
O&M Grade: **0**
Clock Start/From: **2**
Clock To:
1st Value: **4.000**
2nd Value:
Value Percent:
Continuous Index:
Within 8" of Joint: **YES**
Remarks:

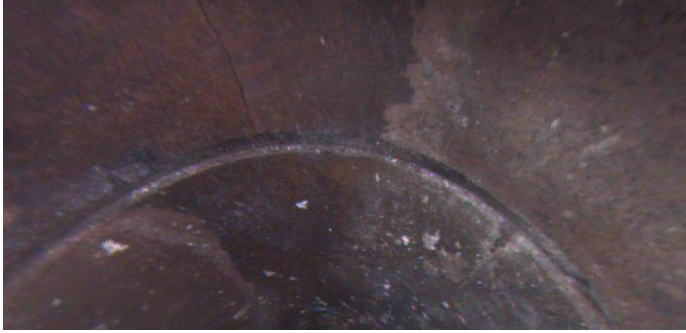
Code: **CM**
Description: **Crack Multiple**

Distance (ft): **9.1**
Structural Grade: **3**
O&M Grade: **0**
Clock Start/From: **10**
Clock To: **2**
1st Value:
2nd Value:
Value Percent:
Continuous Index: **S01**
Within 8" of Joint: **YES**
Remarks: **wandering**

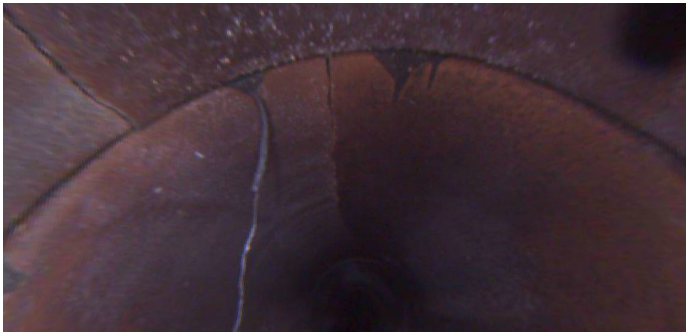
Code: **RFJ**
Description: **Roots Fine Joint**

Distance (ft): **22.8**
Structural Grade: **0**
O&M Grade: **1**
Clock Start/From: **11**
Clock To:
1st Value:
2nd Value:
Value Percent:
Continuous Index:
Within 8" of Joint: **YES**
Remarks:

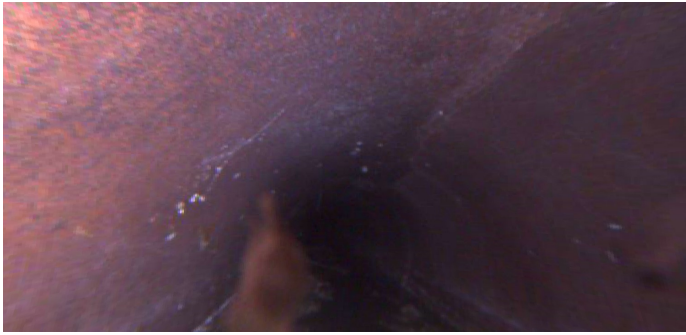
Code: **MSA**
Description: **Abandoned Survey**

Distance (ft): **59.2**
Structural Grade: **0**
O&M Grade: **0**
Clock Start/From:
Clock To:
1st Value:
2nd Value:
Value Percent:
Continuous Index:
Within 8" of Joint: **NO**
Remarks: **debris**

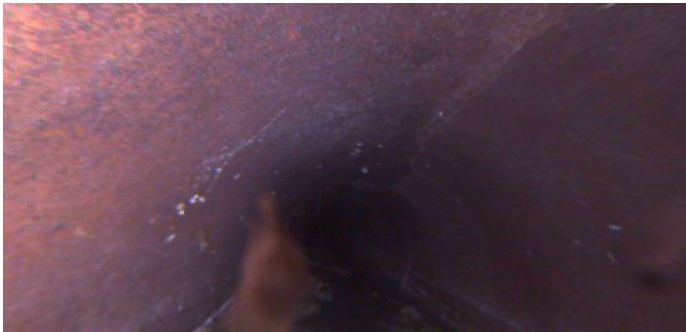
Code: **DSZ**
Description: **Deposits Settled Other**

Distance (ft): **59.2**
Structural Grade: **0**
O&M Grade: **2**
Clock Start/From: **6**
Clock To:
1st Value:
2nd Value:
Value Percent: **5.000**
Continuous Index: **F02**
Within 8" of Joint: **NO**
Remarks: **debris**

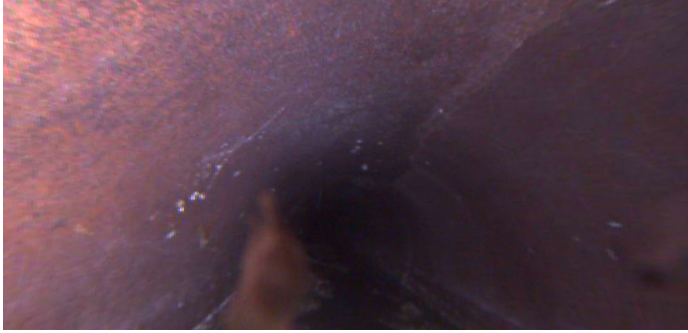
Code:	CM
Description:	Crack Multiple
Distance (ft):	59.2
Structural Grade:	3
O&M Grade:	0
Clock Start/From:	10
Clock To:	2
1st Value:	
2nd Value:	
Value Percent:	
Continuous Index:	F01
Within 8" of Joint:	YES
Remarks:	wandering
