Profile/Photo Observation Report

Date:	04/10/2018	Weather:		Coding:	PACP 6.0
Pipe Length (ft):	197.1	Owner:	NA	Pre Clean:	Not Known
P.O.#:		Surveyor:	Jen Costello	PSR:	P-804-040-039
Customer:		Clean Date:	01/01/1900	Shape:	C

Street:	OFF N LIBERTY ST	Flow Control:	Not Controlled
City:	Hobart, IN	Year Renewed:	
Location:	Other	Tape/Media #:	
Purpose:	Not Known	Dia/Height:	12"
Use:	Sanitary	Material:	VCP
Drain Area:	NA	Lining:	
Category:	NA		
Comment:

Location Details:		Direction of Survey:	Downstream
US MH:	M-804-039	DS MH:	M-804-040
		Total Length Surveyed (ft):	24.3

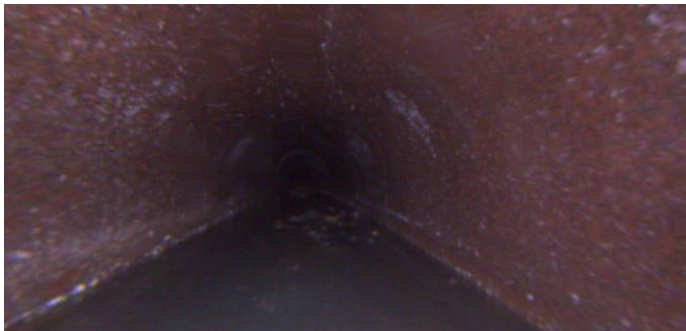
Code: **AMH**
Description: **Manhole**

Distance (ft): **.0**
Structural Grade: **0**
O&M Grade: **0**
Clock Start/From:
Clock To:
1st Value:
2nd Value:
Value Percent:
Continuous Index:
Within 8" of Joint: **NO**
Remarks: **M-804-039**

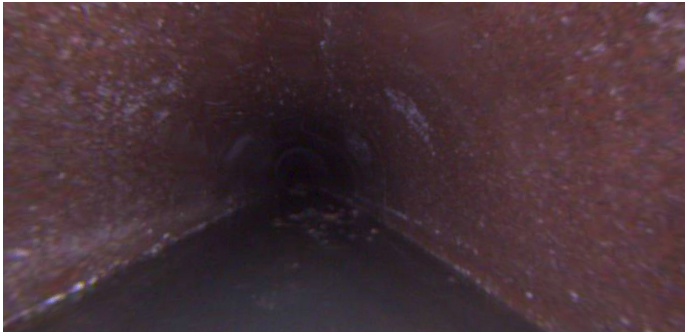
Code:	MWL
Description:	Water Level

Distance (ft):	.0
Structural Grade:	0
O&M Grade:	0
Clock Start/From:	
Clock To:	
1st Value:	
2nd Value:	
Value Percent:	20.000
Continuous Index:	
Within 8" of Joint:	NO
Remarks:

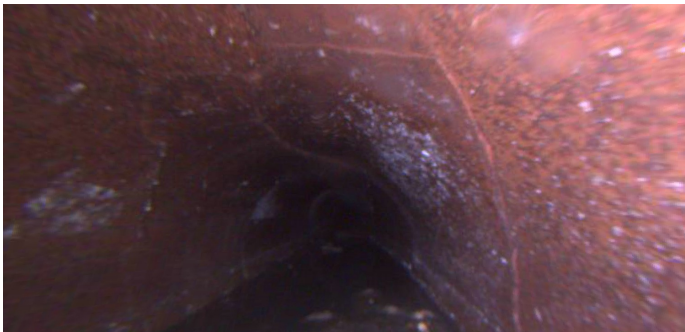
Code:	FM
Description:	Fracture Multiple

Distance (ft):	2.4
Structural Grade:	4
O&M Grade:	0
Clock Start/From:	8
Clock To:	4
1st Value:	
2nd Value:	
Value Percent:	
Continuous Index:	S01
Within 8" of Joint:	YES
Remarks:

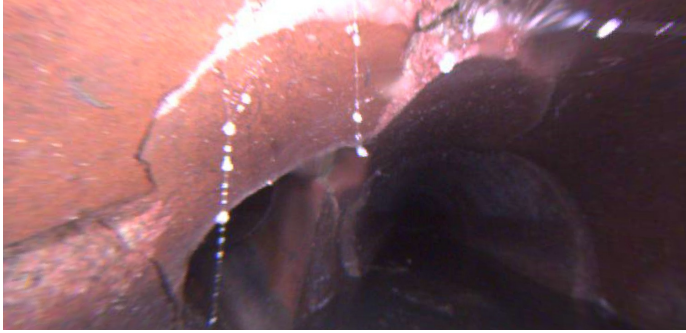
Code: **B**
Description: **Broken**

Distance (ft): **23.0**
Structural Grade: **5**
O&M Grade: **0**
Clock Start/From: **9**
Clock To: **12**
1st Value:
2nd Value:
Value Percent:
Continuous Index:
Within 8" of Joint:
Remarks:

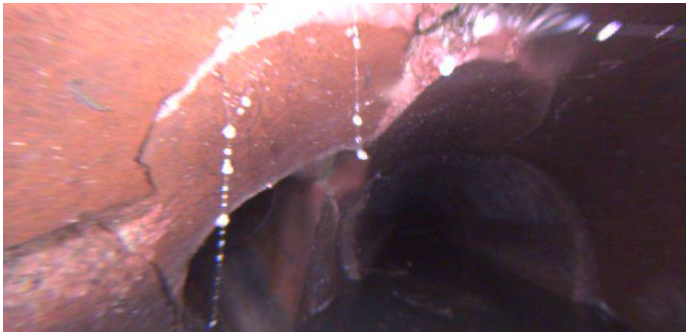
Code: **TFA**
Description: **Tap Factory Active**

Distance (ft): **23.0**
Structural Grade: **0**
O&M Grade: **0**
Clock Start/From: **9**
Clock To:
1st Value: **4.000**
2nd Value:
Value Percent:
Continuous Index:
Within 8" of Joint:
Remarks:

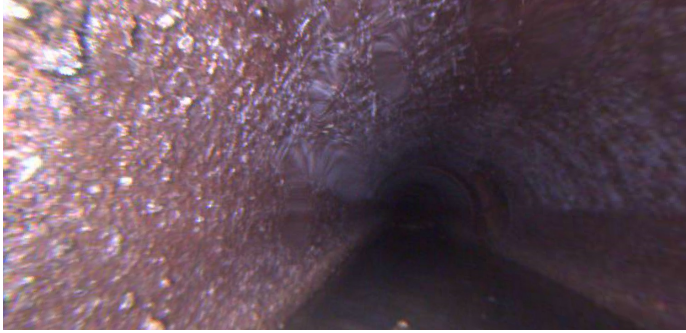
Code: **FM**
Description: **Fracture Multiple**

Distance (ft): **24.3**
Structural Grade: **4**
O&M Grade: **0**
Clock Start/From: **8**
Clock To: **4**
1st Value:
2nd Value:
Value Percent:
Continuous Index: **F01**
Within 8" of Joint: **YES**
Remarks:

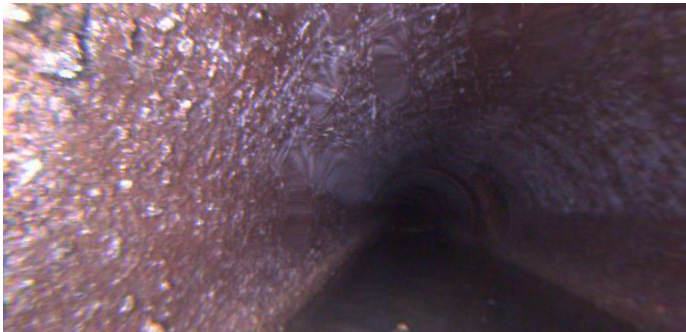
Code: **MSA**
Description: **Abandoned Survey**

Distance (ft): **24.3**
Structural Grade: **0**
O&M Grade: **0**
Clock Start/From:
Clock To:
1st Value:
2nd Value:
Value Percent:
Continuous Index:
Within 8" of Joint: **NO**
Remarks: **debris**
