Profile/Photo Observation Report

Date:	04/10/2018	Weather:		Coding:	PACP 6.0
Pipe Length (ft):	197.1	Owner:	NA	Pre Clean:	Not Known
P.O.#:		Surveyor:	Jen Costello	PSR:	P-804-040-039
Customer:		Clean Date:	01/01/1900	Shape:	C

Street:	N Liberty St.	Flow Control:	Not Controlled
City:	Hobart, IN	Year Renewed:	
Location:	Other	Tape/Media #:	
Purpose:	Not Known	Dia/Height:	12"
Use:	Sanitary	Material:	VCP
Drain Area:	NA	Lining:	
Category:	NA		
Comment:

Location Details:		Direction of Survey:	Downstream
US MH:	M-804-039	DS MH:	M-804-040
		Total Length Surveyed (ft):	24.3

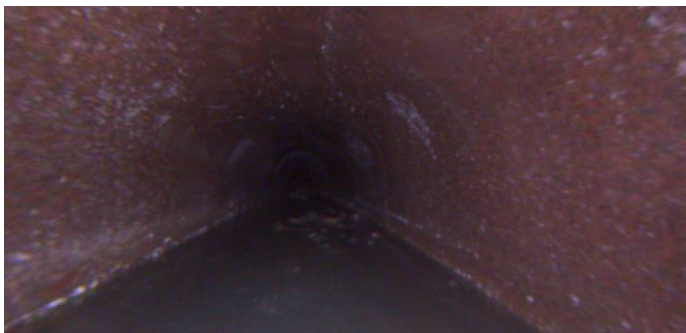
Code: **AMH**
Description: **Manhole**

Distance (ft): **.0**
Structural Grade: **0**
O&M Grade: **0**
Clock Start/From:
Clock To:
1st Value:
2nd Value:
Value Percent:
Continuous Index:
Within 8" of Joint: **NO**
Remarks: **M-804-039**

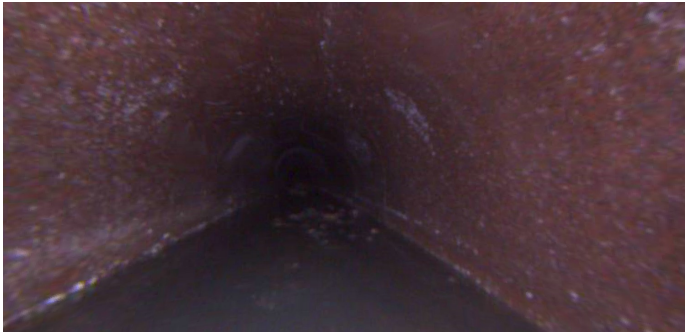
Code:	MWL
Description:	Water Level

Distance (ft):	.0
Structural Grade:	0
O&M Grade:	0
Clock Start/From:	
Clock To:	
1st Value:	
2nd Value:	
Value Percent:	20.000
Continuous Index:	
Within 8" of Joint:	NO
Remarks:

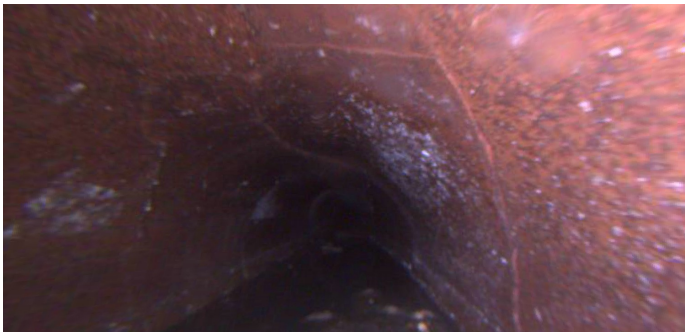
Code:	FM
Description:	Fracture Multiple

Distance (ft):	2.4
Structural Grade:	4
O&M Grade:	0
Clock Start/From:	8
Clock To:	4
1st Value:	
2nd Value:	
Value Percent:	
Continuous Index:	S01
Within 8" of Joint:	YES
Remarks:

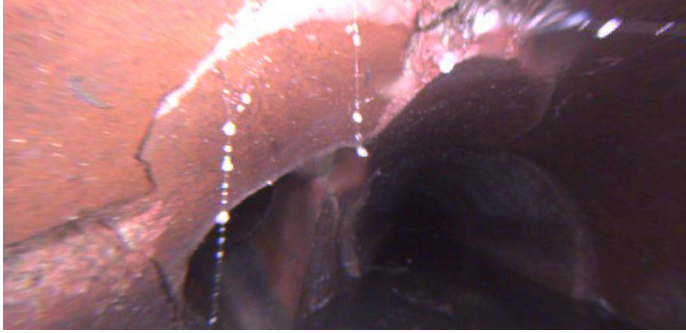
Code: **B**
Description: **Broken**

Distance (ft): **23.0**
Structural Grade: **5**
O&M Grade: **0**
Clock Start/From: **9**
Clock To: **12**
1st Value:
2nd Value:
Value Percent:
Continuous Index:
Within 8" of Joint:
Remarks:

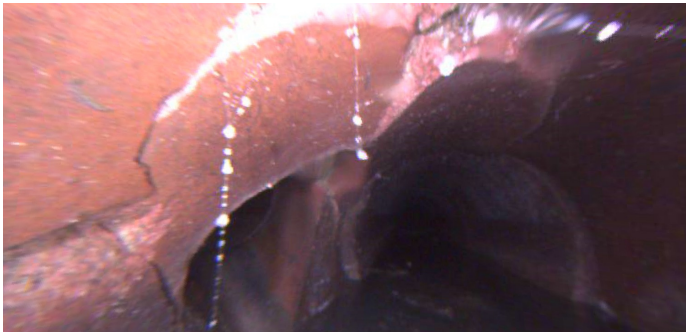
Code: **TFA**
Description: **Tap Factory Active**

Distance (ft): **23.0**
Structural Grade: **0**
O&M Grade: **0**
Clock Start/From: **9**
Clock To:
1st Value: **4.000**
2nd Value:
Value Percent:
Continuous Index:
Within 8" of Joint:
Remarks:

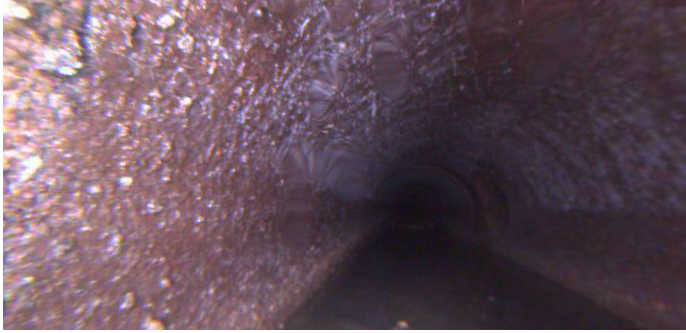
Code: **FM**
Description: **Fracture Multiple**

Distance (ft): **24.3**
Structural Grade: **4**
O&M Grade: **0**
Clock Start/From: **8**
Clock To: **4**
1st Value:
2nd Value:
Value Percent:
Continuous Index: **F01**
Within 8" of Joint: **YES**
Remarks:

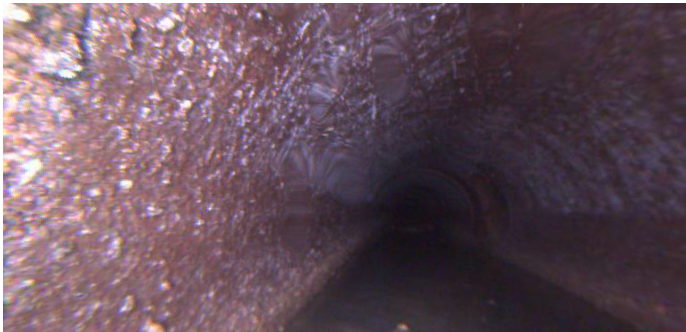
Code: **MSA**
Description: **Abandoned Survey**

Distance (ft): **24.3**
Structural Grade: **0**
O&M Grade: **0**
Clock Start/From:
Clock To:
1st Value:
2nd Value:
Value Percent:
Continuous Index:
Within 8" of Joint: **NO**
Remarks: **debris**
