Profile/Photo Observation Report

Street:	N LIBERTY ST	Flow Control:	Not Controlled
City:	Hobart, IN	Year Renewed:	
Location:	Other	Tape/Media #:	
Purpose:	Not Known	Dia/Height:	12"
Use:	Sanitary	Material:	VCP
Drain Area:	NA	Lining:	
Category:	NA		
Comment:

Location Details:		Direction of Survey:	Downstream
US MH:	M-804-040	DS MH:	M-804-071
		Total Length Surveyed (ft):	45.7

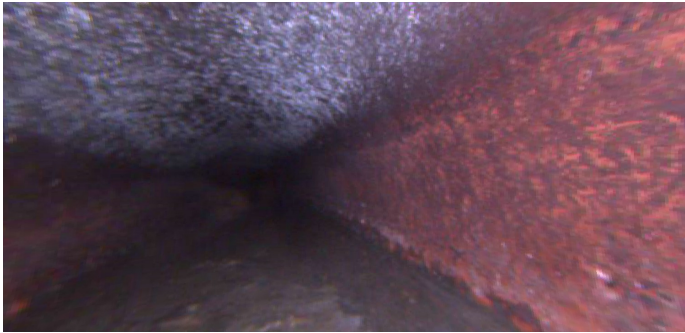
Code:	MWL
Description:	Water Level

Distance (ft):	.0
Structural Grade:	0
O&M Grade:	0
Clock Start/From:	
Clock To:	
1st Value:	
2nd Value:	
Value Percent:	5.000
Continuous Index:	
Within 8" of Joint:	NO
Remarks:

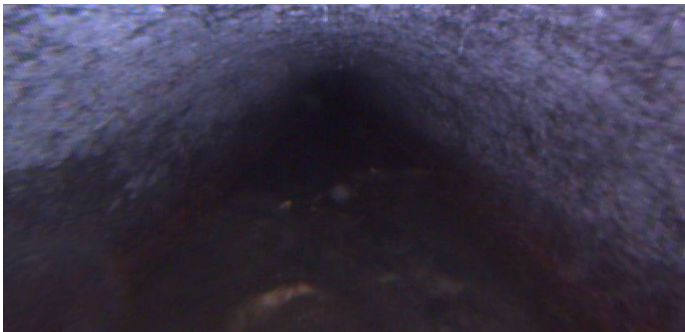
Code:	DSZ
Description:	Deposits Settled Other

Distance (ft):	26.3
Structural Grade:	0
O&M Grade:	2
Clock Start/From:	6
Clock To:	
1st Value:	
2nd Value:	
Value Percent:	5.000
Continuous Index:	S01
Within 8" of Joint:	NO
Remarks:	debris

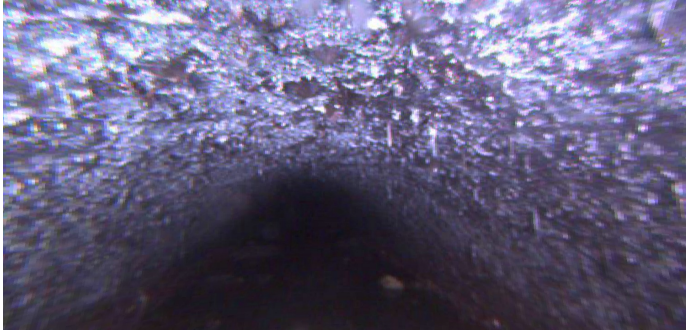
Code: **MSA**
Description: **Abandoned Survey**

Distance (ft): **45.7**
Structural Grade: **0**
O&M Grade: **0**
Clock Start/From:
Clock To:
1st Value:
2nd Value:
Value Percent:
Continuous Index:
Within 8" of Joint: **NO**
Remarks: **DSZ**

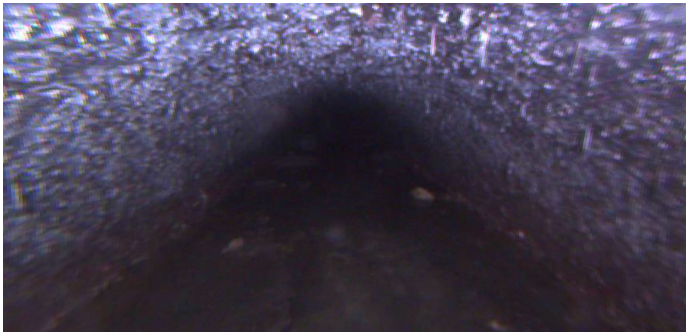
Code: **DSZ**
Description: **Deposits Settled Other**

Distance (ft): **45.7**
Structural Grade: **0**
O&M Grade: **2**
Clock Start/From: **6**
Clock To:
1st Value:
2nd Value:
Value Percent: **5.000**
Continuous Index: **F01**
Within 8" of Joint: **NO**
Remarks: **debris**
