## Profile/Photo Observation Report

Street:	<b>N Liberty St.</b>	Flow Control:	<b>Not Controlled</b>
City:	<b>Hobart, IN</b>	Year Renewed:	
Location:	<b>Other</b>	Tape/Media #:	
Purpose:	<b>Not Known</b>	Dia/Height:	<b>12"</b>
Use:	<b>Sanitary</b>	Material:	<b>VCP</b>
Drain Area:	<b>NA</b>	Lining:	
Category:	<b>NA</b>		
Comment:

Location Details:		Direction of Survey:	<b>Downstream</b>
US MH:	<b>M-804-040</b>	DS MH:	<b>M-804-071</b>
		Total Length Surveyed (ft):	<b>45.7</b>

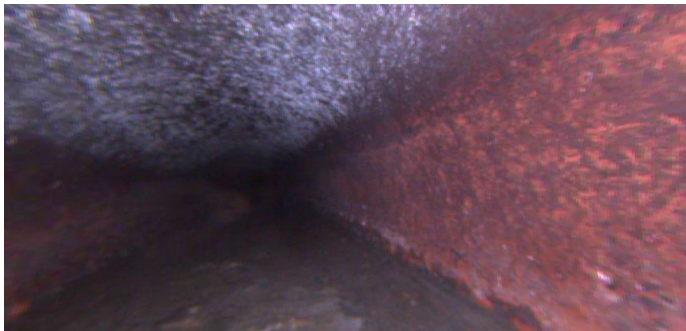
Code: **AMH**  
Description: **Manhole**

Distance (ft): **.0**  
Structural Grade: **0**  
O&M Grade: **0**  
Clock Start/From:  
Clock To:  
1st Value:  
2nd Value:  
Value Percent:  
Continuous Index:  
Within 8" of Joint: **NO**  
Remarks: **M-804-040**

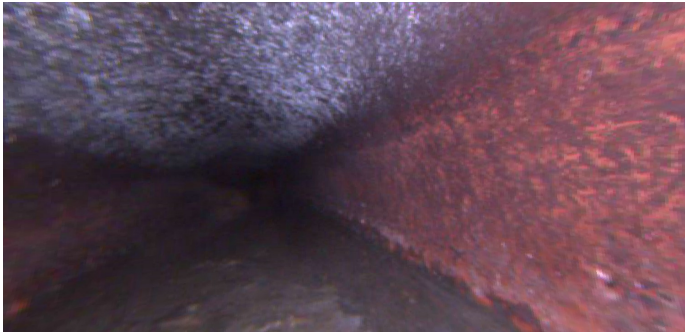
Code:	<b>MWL</b>
Description:	<b>Water Level</b>

Distance (ft):	<b>.0</b>
Structural Grade:	<b>0</b>
O&M Grade:	<b>0</b>
Clock Start/From:	
Clock To:	
1st Value:	
2nd Value:	
Value Percent:	<b>5.000</b>
Continuous Index:	
Within 8" of Joint:	<b>NO</b>
Remarks:

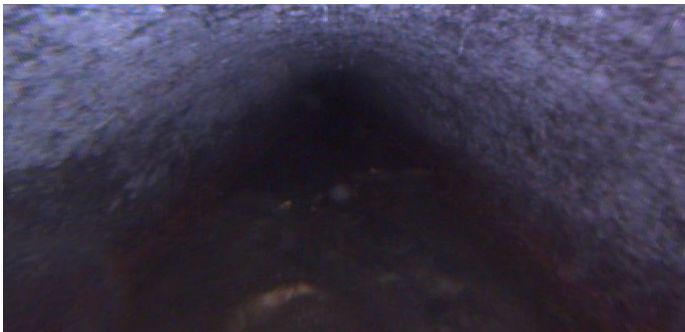
Code:	<b>DSZ</b>
Description:	<b>Deposits Settled Other</b>

Distance (ft):	<b>26.3</b>
Structural Grade:	<b>0</b>
O&M Grade:	<b>2</b>
Clock Start/From:	<b>6</b>
Clock To:	
1st Value:	
2nd Value:	
Value Percent:	<b>5.000</b>
Continuous Index:	<b>S01</b>
Within 8" of Joint:	<b>NO</b>
Remarks:	<b>debris</b>

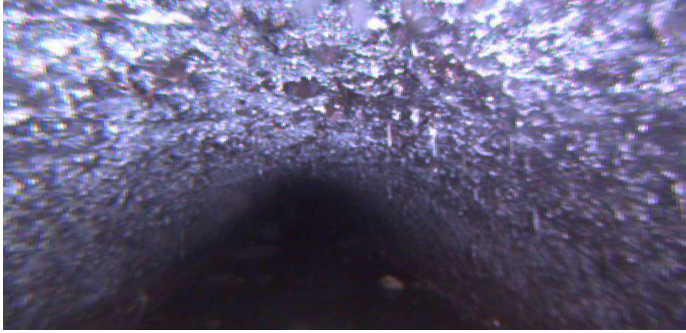
Code: **MSA**  
Description: **Abandoned Survey**

Distance (ft): **45.7**  
Structural Grade: **0**  
O&M Grade: **0**  
Clock Start/From:  
Clock To:  
1st Value:  
2nd Value:  
Value Percent:  
Continuous Index:  
Within 8" of Joint: **NO**  
Remarks: **DSZ**

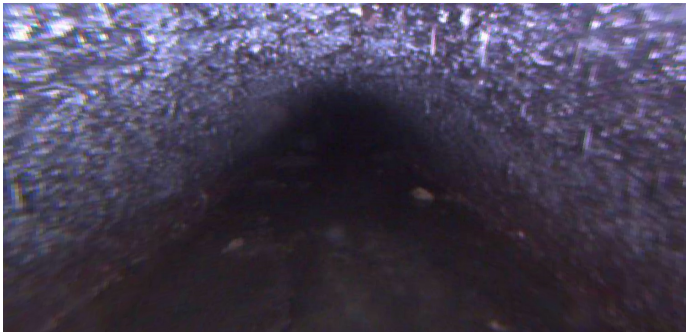
Code: **DSZ**  
Description: **Deposits Settled Other**

Distance (ft): **45.7**  
Structural Grade: **0**  
O&M Grade: **2**  
Clock Start/From: **6**  
Clock To:  
1st Value:  
2nd Value:  
Value Percent: **5.000**  
Continuous Index: **F01**  
Within 8" of Joint: **NO**  
Remarks: **debris**
