Profile/Photo Observation Report

Date:	01/29/2025	Weather:		Coding:	PACP 7.0
Pipe Length (ft):	382.4	Owner:	City of Hobart	Pre Clean:	Heavy Cleaning
P.O.#:	YES502259	Surveyor:	S. Bucklin	PSR:	P-804-042-041
Customer:	City of Hobart	Clean Date:	10/25/2024	Shape:	C

Street:	High Street	Flow Control:	Not Controlled
City:	Hobart, IN	Year Renewed:	
Location:	Easement/Right of Way	Tape/Media #:	
Purpose:	Sewer System Evaluation Survey (SS)	Dia/Height:	10"
Use:	Sanitary Sewage Pipe	Material:	VCP
Drain Area:		Lining:	None
Category:	NA		
Comment:			
Location Details:		Direction of Survey:	Downstream
US MH:	M-804-042	DS MH:	M-804-041
		Total Length Surveyed (ft):	373.9

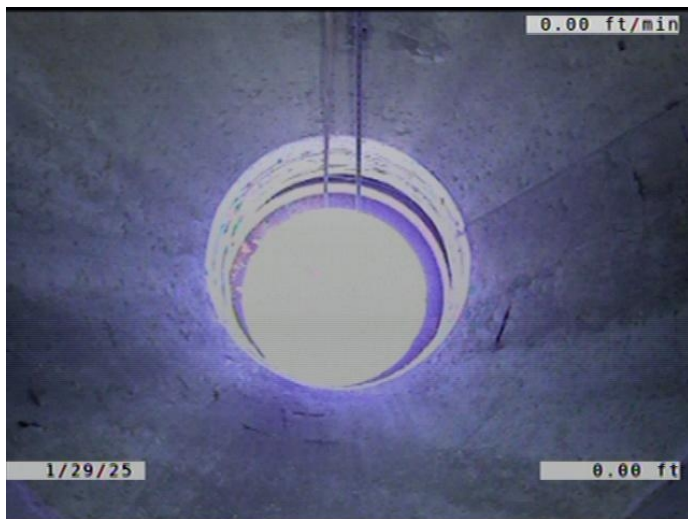
Code: **AMH**
Description: **Manhole**

Distance (ft): **.0**
Structural Grade: **0**
O&M Grade: **0**
Clock Start/From:
Clock To:
1st Value:
2nd Value:
Value Percent:
Continuous Index:
Within 8" of Joint: **NO**
Remarks: **M-804-042**

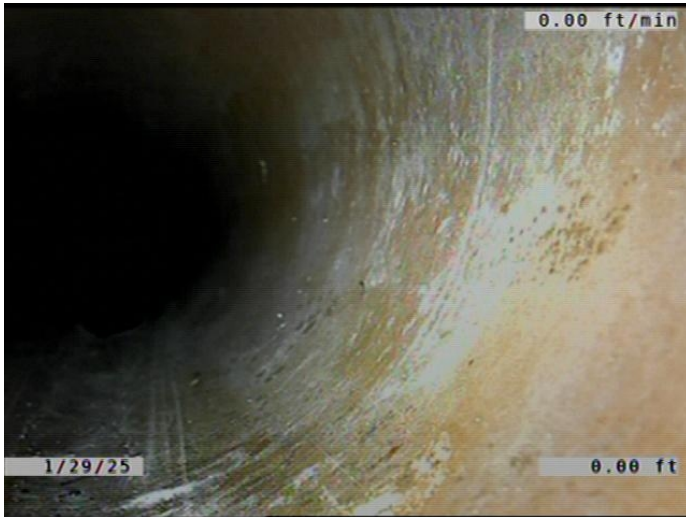
Code: **MWL**
Description: **Miscellaneous Water Level**

Distance (ft): **.0**
Structural Grade: **0**
O&M Grade: **0**
Clock Start/From:
Clock To:
1st Value:
2nd Value:
Value Percent: **0.000**
Continuous Index:
Within 8" of Joint: **NO**
Remarks:

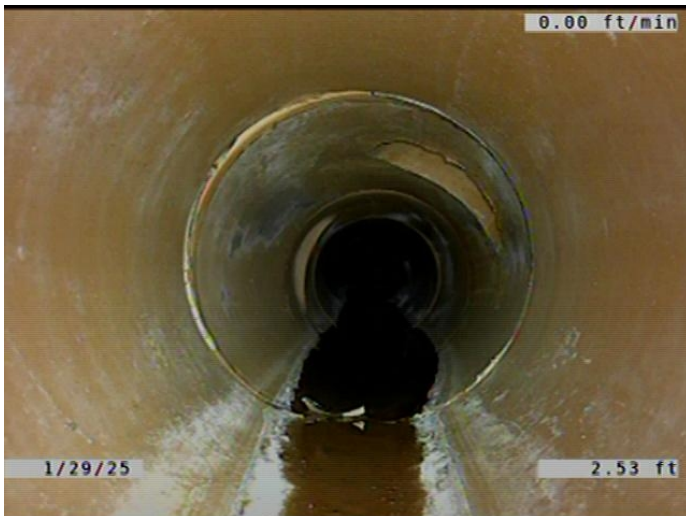
Code: **MWL**
Description: **Miscellaneous Water Level**

Distance (ft): **2.5**
Structural Grade: **0**
O&M Grade: **0**
Clock Start/From:
Clock To:
1st Value:
2nd Value:
Value Percent: **5.000**
Continuous Index:
Within 8" of Joint: **NO**
Remarks:

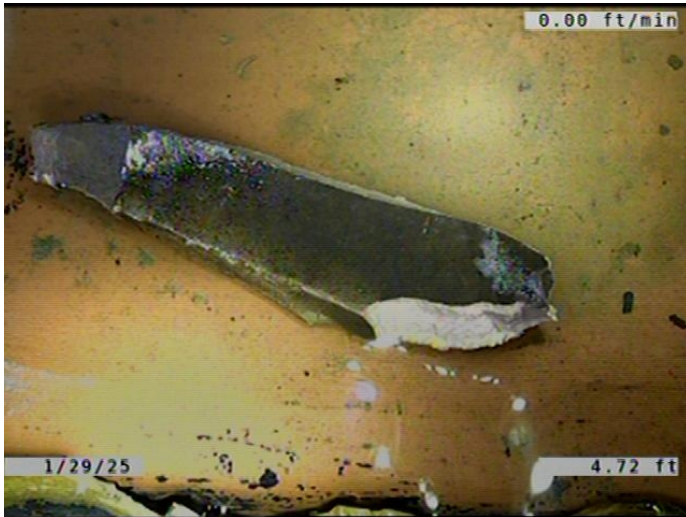
Code: **ISSR**
Description: **Intruding Sealing Material Sealing Ring**

Distance (ft): **4.7**
Structural Grade: **0**
O&M Grade: **2**
Clock Start/From: **6**
Clock To: **7**
1st Value:
2nd Value:
Value Percent: **5.000**
Continuous Index:
Within 8" of Joint: **NO**
Remarks:

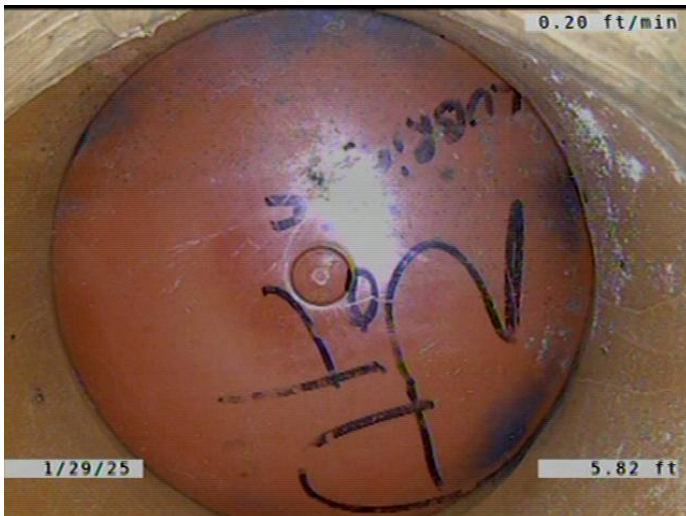
Code: **TFC**
Description: **Tap Factory Capped**

Distance (ft): **5.8**
Structural Grade: **0**
O&M Grade: **0**
Clock Start/From: **1**
Clock To:
1st Value: **6.000**
2nd Value:
Value Percent:
Continuous Index:
Within 8" of Joint: **YES**
Remarks:

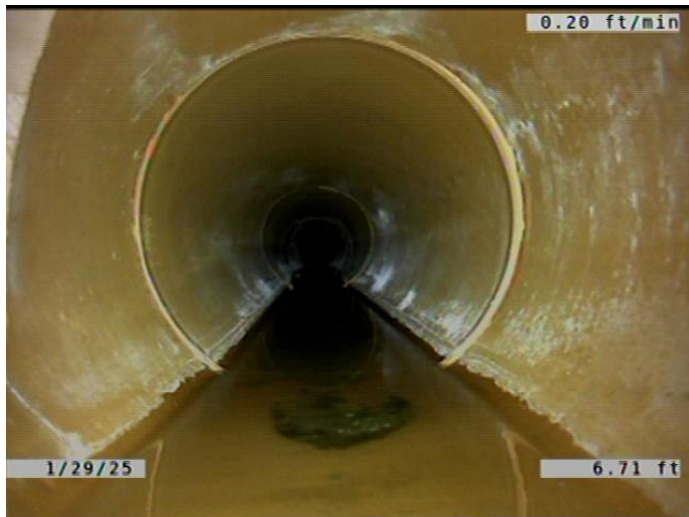
Code: **MWLS**
Description: **Miscellaneous Water Level Sag**

Distance (ft): **6.7**
Structural Grade: **2**
O&M Grade: **0**
Clock Start/From:
Clock To:
1st Value:
2nd Value:
Value Percent: **10.000**
Continuous Index: **S01**
Within 8" of Joint: **NO**
Remarks:

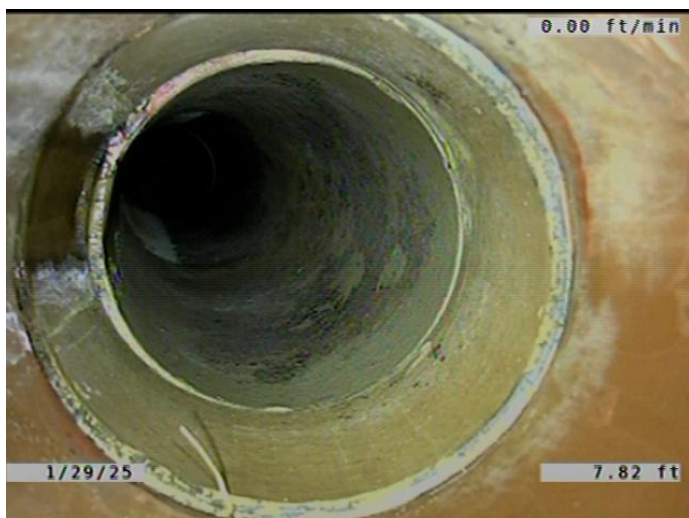
Code: **TF**
Description: **Tap Factory**

Distance (ft): **7.8**
Structural Grade: **0**
O&M Grade: **0**
Clock Start/From: **10**
Clock To:
1st Value: **6.000**
2nd Value:
Value Percent:
Continuous Index:
Within 8" of Joint: **YES**
Remarks: **ROOT GROWING IN THE SERVICE TO MAIN CONNECTION.**

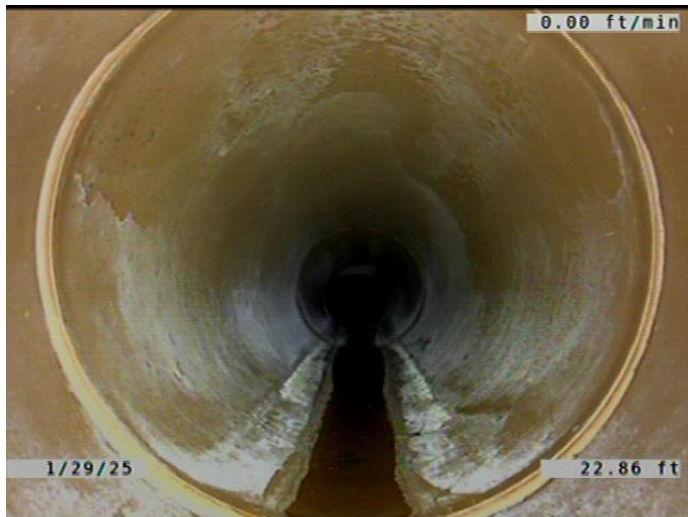
Code: **MWLS**
Description: **Miscellaneous Water Level Sag**

Distance (ft): **22.8**
Structural Grade: **2**
O&M Grade: **0**
Clock Start/From:
Clock To:
1st Value:
2nd Value:
Value Percent: **10.000**
Continuous Index: **F01**
Within 8" of Joint: **NO**
Remarks:

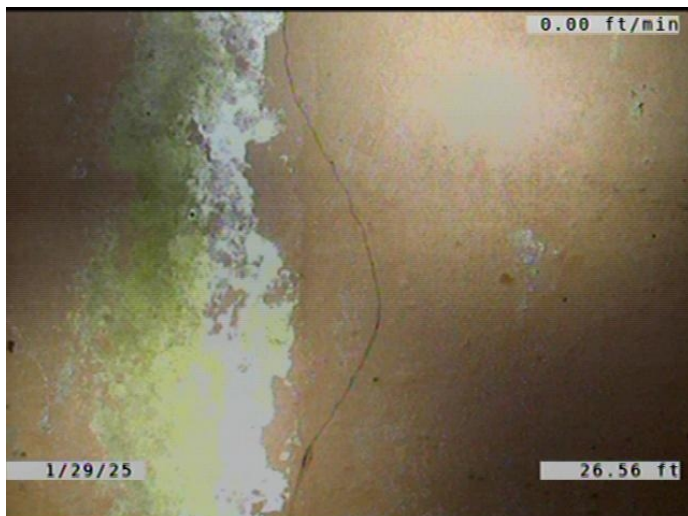
Code: **FM**
Description: **Fracture Multiple**

Distance (ft): **26.6**
Structural Grade: **4**
O&M Grade: **0**
Clock Start/From: **3**
Clock To: **5**
1st Value:
2nd Value:
Value Percent:
Continuous Index: **S02**
Within 8" of Joint: **YES**
Remarks:

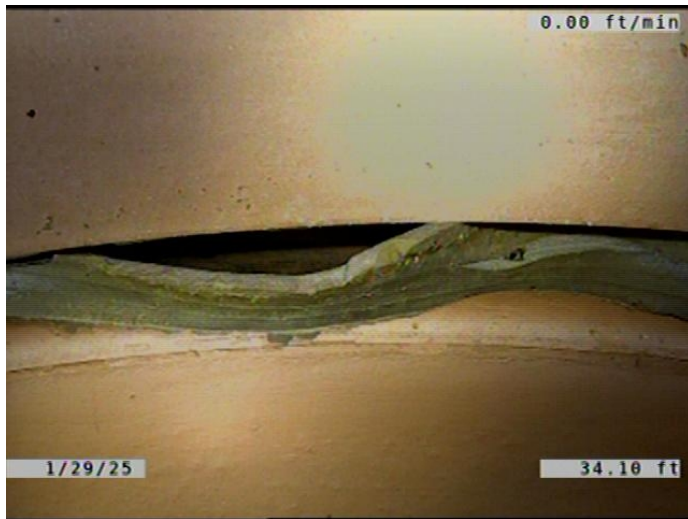
Code:	ISSRB
Description:	Intruding Sealing Material Sealing Ring Broken
Distance (ft):	34.1
Structural Grade:	0
O&M Grade:	2
Clock Start/From:	9
Clock To:	11
1st Value:	
2nd Value:	
Value Percent:	5.000
Continuous Index:	
Within 8" of Joint:	NO
Remarks:

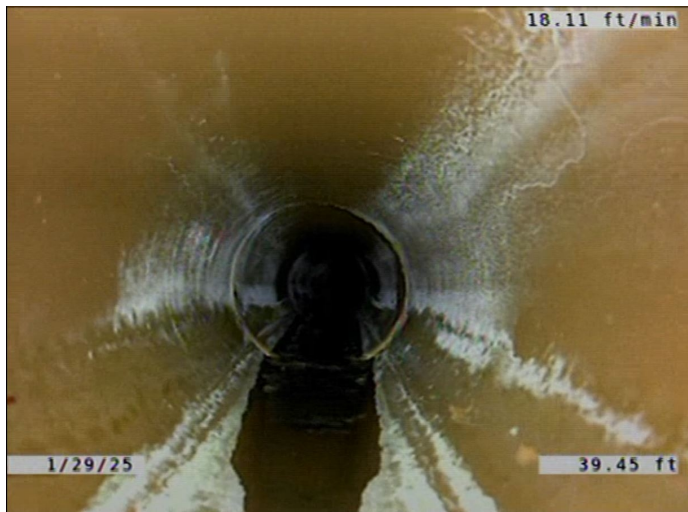
Code:	FM
Description:	Fracture Multiple
Distance (ft):	39.5
Structural Grade:	4
O&M Grade:	0
Clock Start/From:	3
Clock To:	5
1st Value:	
2nd Value:	
Value Percent:	
Continuous Index:	F02
Within 8" of Joint:	YES
Remarks:

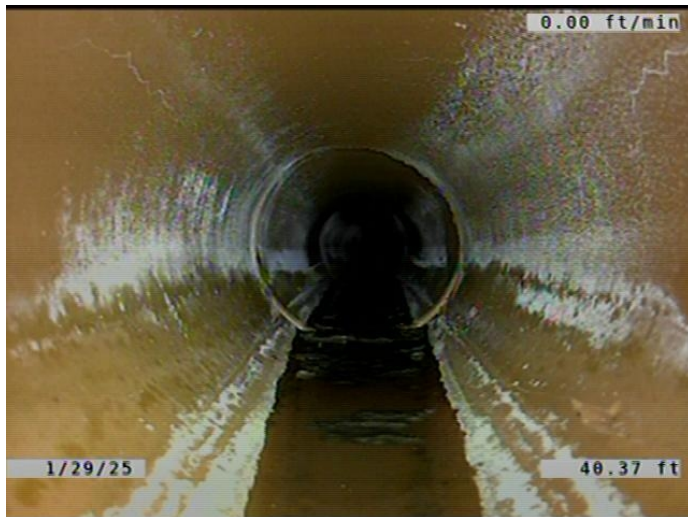
Code: **MWLS**
Description: **Miscellaneous Water Level Sag**

Distance (ft): **40.4**
Structural Grade: **2**
O&M Grade: **0**
Clock Start/From:
Clock To:
1st Value:
2nd Value:
Value Percent: **15.000**
Continuous Index: **S03**
Within 8" of Joint: **NO**
Remarks:

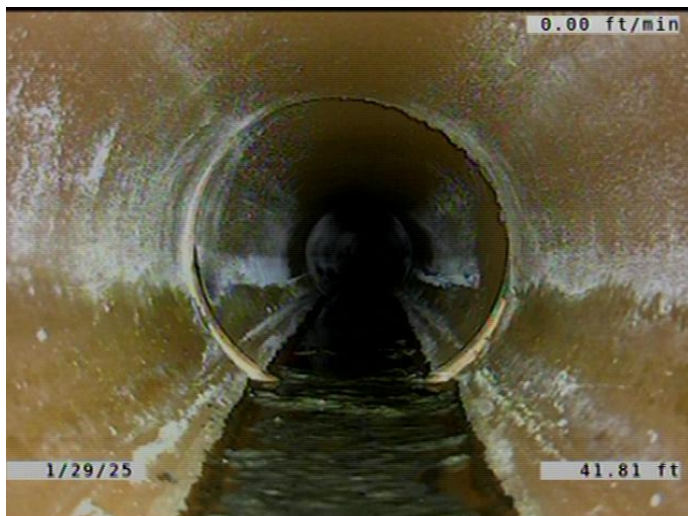
Code: **DSF**
Description: **Deposits Settled Fine**

Distance (ft): **41.8**
Structural Grade: **0**
O&M Grade: **2**
Clock Start/From: **5**
Clock To: **7**
1st Value:
2nd Value:
Value Percent: **5.000**
Continuous Index: **S04**
Within 8" of Joint: **YES**
Remarks:

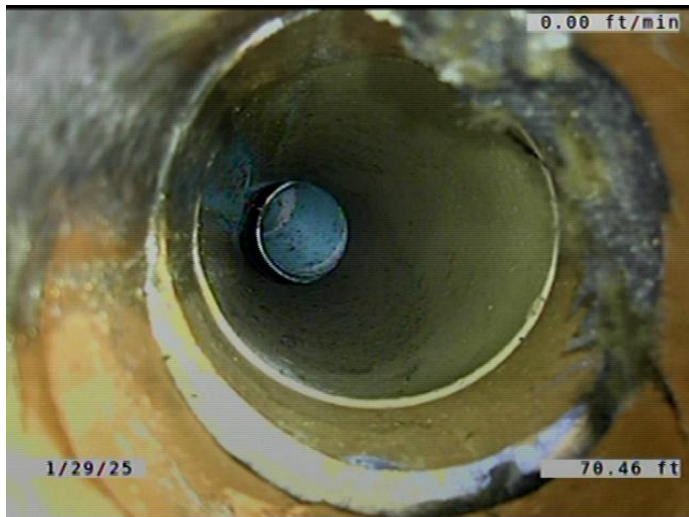
Code:	TFD
Description:	Tap Factory Defective
Distance (ft):	70.5
Structural Grade:	0
O&M Grade:	3
Clock Start/From:	10
Clock To:	
1st Value:	6.000
2nd Value:	
Value Percent:	
Continuous Index:	
Within 8" of Joint:	YES
Remarks:	SERVICE IS PVC. TAP BROKEN. ROOTS GROWING THROUGH THE BR

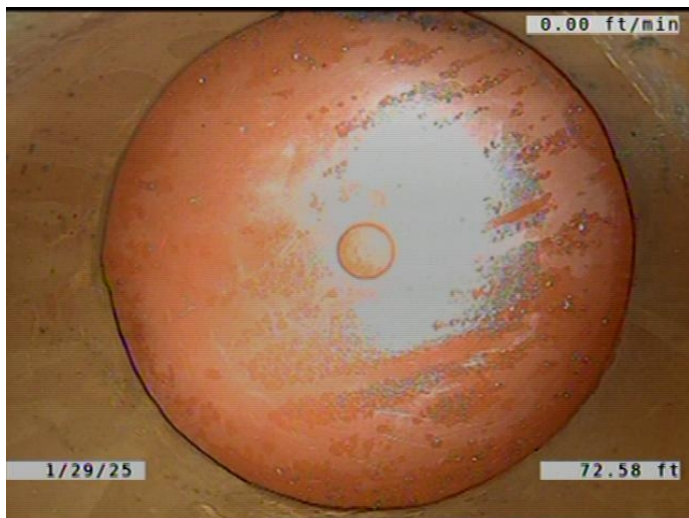
Code:	TFC
Description:	Tap Factory Capped
Distance (ft):	72.6
Structural Grade:	0
O&M Grade:	0
Clock Start/From:	2
Clock To:	
1st Value:	6.000
2nd Value:	
Value Percent:	
Continuous Index:	
Within 8" of Joint:	YES
Remarks:

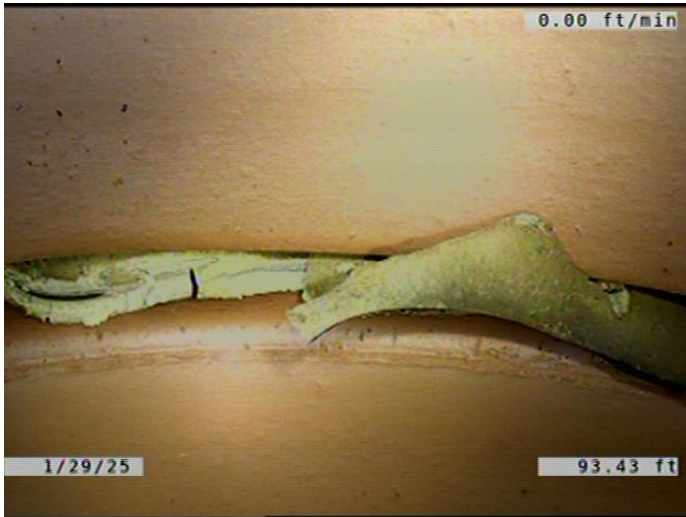
Code: **ISSRB**
Description: **Intruding Sealing Material Sealing Ring Broken**

Distance (ft): **93.4**
Structural Grade: **0**
O&M Grade: **2**
Clock Start/From: **12**
Clock To: **1**
1st Value:
2nd Value:
Value Percent: **5.000**
Continuous Index:
Within 8" of Joint: **NO**
Remarks:

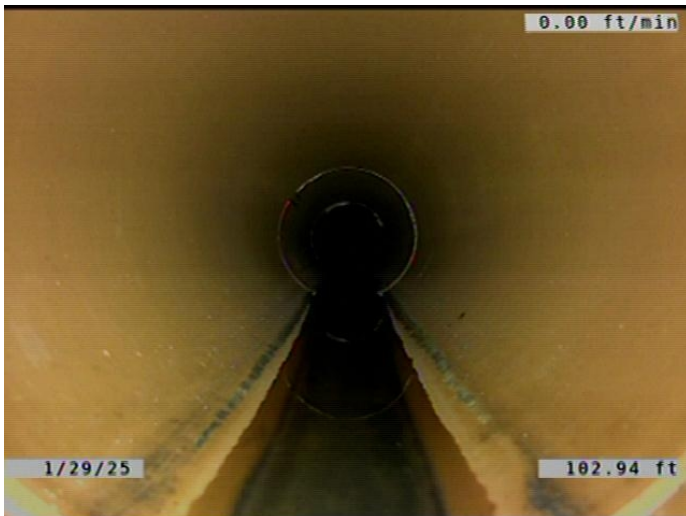
Code: **MWLS**
Description: **Miscellaneous Water Level Sag**

Distance (ft): **102.9**
Structural Grade: **2**
O&M Grade: **0**
Clock Start/From:
Clock To:
1st Value:
2nd Value:
Value Percent: **15.000**
Continuous Index: **F03**
Within 8" of Joint: **NO**
Remarks:

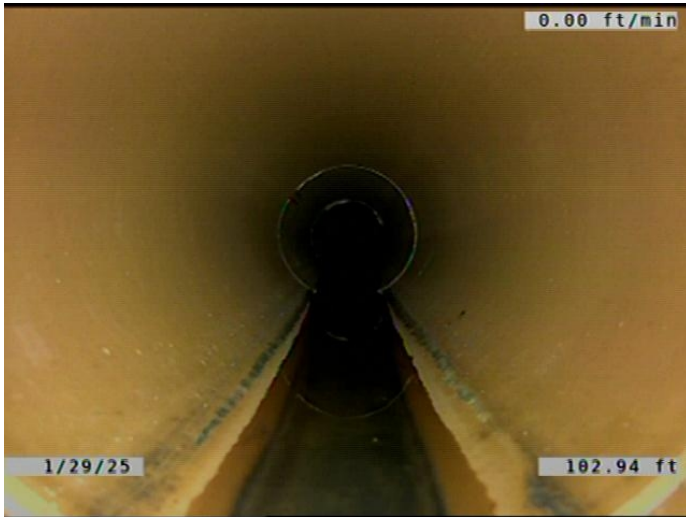
Code: **DSF**
Description: **Deposits Settled Fine**

Distance (ft): **102.9**
Structural Grade: **0**
O&M Grade: **2**
Clock Start/From: **5**
Clock To: **7**
1st Value:
2nd Value:
Value Percent: **5.000**
Continuous Index: **F04**
Within 8" of Joint: **YES**
Remarks:

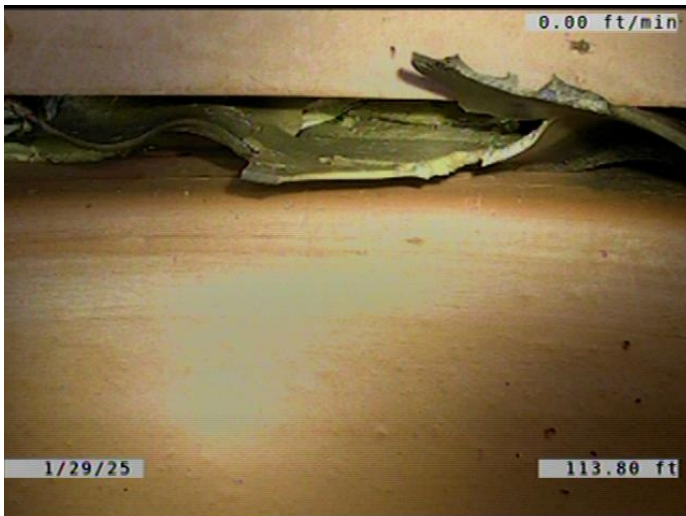
Code: **ISSRB**
Description: **Intruding Sealing Material Sealing Ring Broken**

Distance (ft): **113.8**
Structural Grade: **0**
O&M Grade: **2**
Clock Start/From: **11**
Clock To: **2**
1st Value:
2nd Value:
Value Percent: **5.000**
Continuous Index:
Within 8" of Joint: **NO**
Remarks:

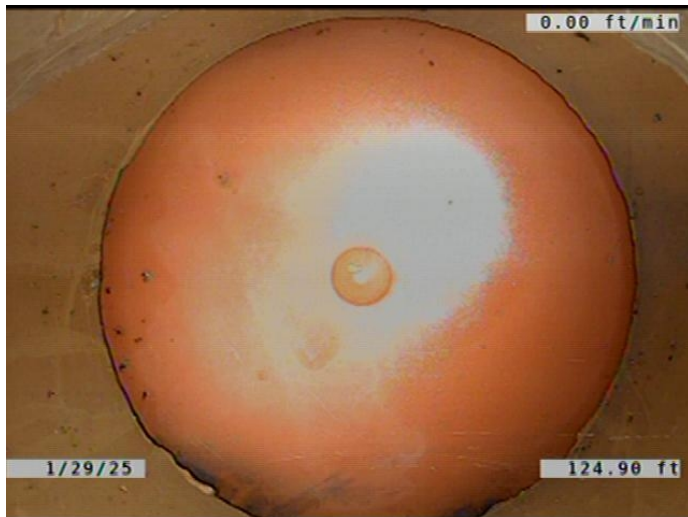
Code: **TFC**
Description: **Tap Factory Capped**

Distance (ft): **124.9**
Structural Grade: **0**
O&M Grade: **0**
Clock Start/From: **2**
Clock To:
1st Value: **5.000**
2nd Value:
Value Percent:
Continuous Index:
Within 8" of Joint: **YES**
Remarks:

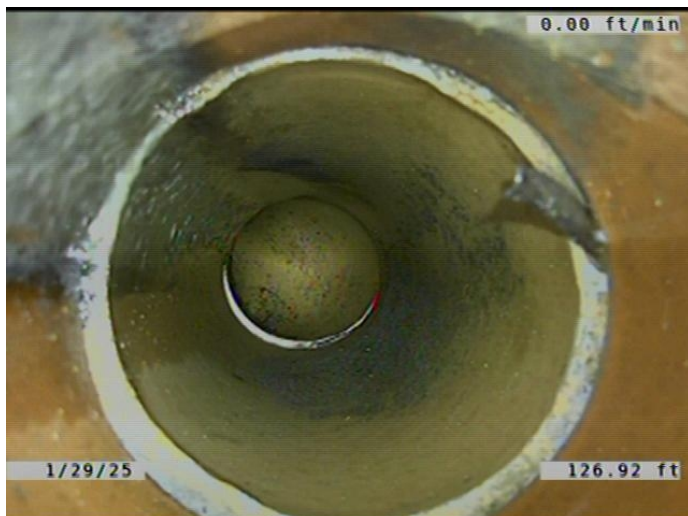
Code: **TF**
Description: **Tap Factory**

Distance (ft): **126.9**
Structural Grade: **0**
O&M Grade: **0**
Clock Start/From: **11**
Clock To:
1st Value: **6.000**
2nd Value:
Value Percent:
Continuous Index:
Within 8" of Joint: **YES**
Remarks: **CONSTANTLY RUNNING WATER.**

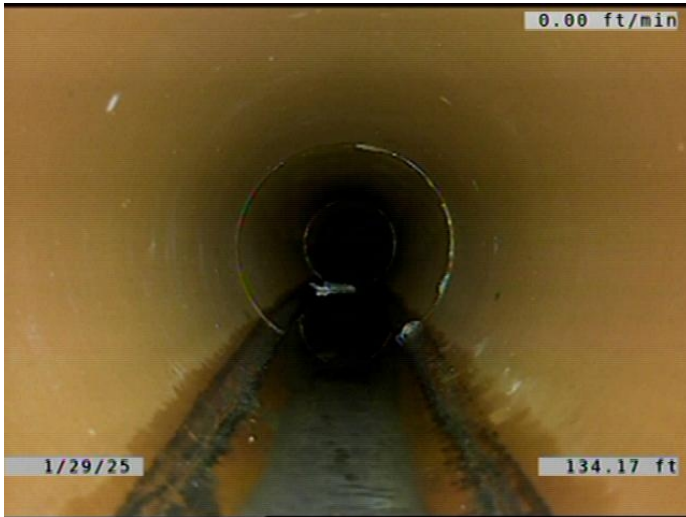
Code: **MWLS**
 Description: **Miscellaneous Water Level Sag**

Distance (ft): **134.2**
 Structural Grade: **2**
 O&M Grade: **0**
 Clock Start/From:
 Clock To:
 1st Value:
 2nd Value:
 Value Percent: **10.000**
 Continuous Index: **S05**
 Within 8" of Joint: **NO**
 Remarks:

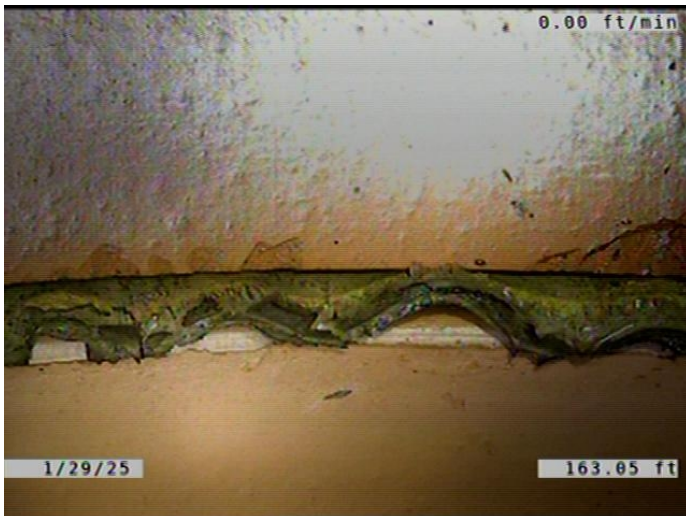
Code: **ISSRH**
 Description: **Intruding Sealing Material Sealing Ring Hanging**

Distance (ft): **163.0**
 Structural Grade: **0**
 O&M Grade: **2**
 Clock Start/From: **9**
 Clock To: **2**
 1st Value:
 2nd Value:
 Value Percent: **5.000**
 Continuous Index:
 Within 8" of Joint: **NO**
 Remarks:

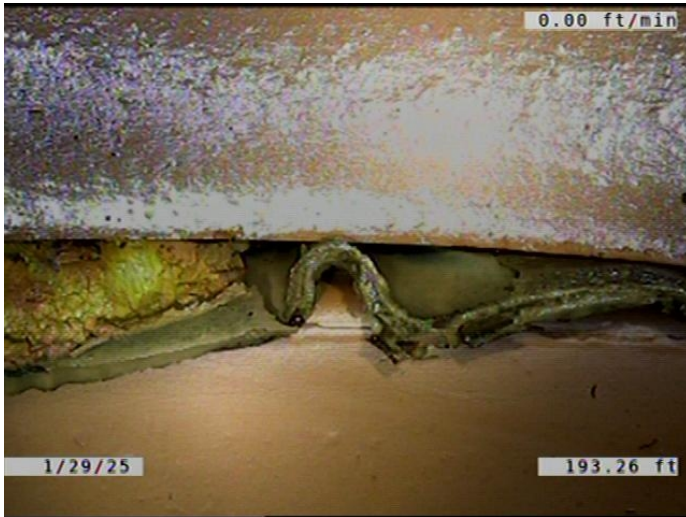
Code: **ISSRH**
Description: **Intruding Sealing Material Sealing Ring Hanging**

Distance (ft): **193.3**
Structural Grade: **0**
O&M Grade: **2**
Clock Start/From: **9**
Clock To: **3**
1st Value:
2nd Value:
Value Percent: **5.000**
Continuous Index:
Within 8" of Joint: **NO**
Remarks:

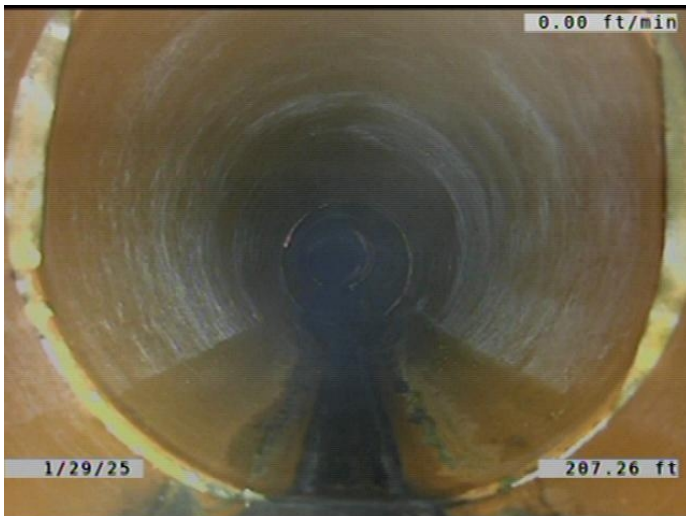
Code: **MWLS**
Description: **Miscellaneous Water Level Sag**

Distance (ft): **207.2**
Structural Grade: **2**
O&M Grade: **0**
Clock Start/From:
Clock To:
1st Value:
2nd Value:
Value Percent: **10.000**
Continuous Index: **F05**
Within 8" of Joint: **NO**
Remarks:

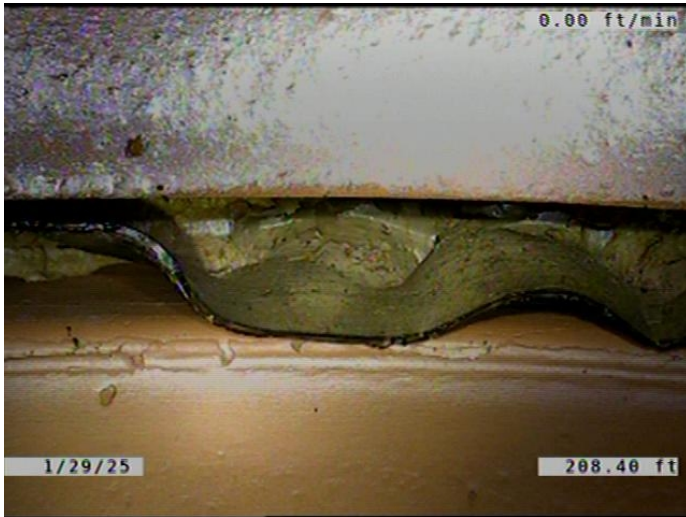
Code: **ISSRH**
Description: **Intruding Sealing Material Sealing Ring Hanging**

Distance (ft): **208.4**
Structural Grade: **0**
O&M Grade: **2**
Clock Start/From: **7**
Clock To: **5**
1st Value:
2nd Value:
Value Percent: **5.000**
Continuous Index:
Within 8" of Joint: **NO**
Remarks:

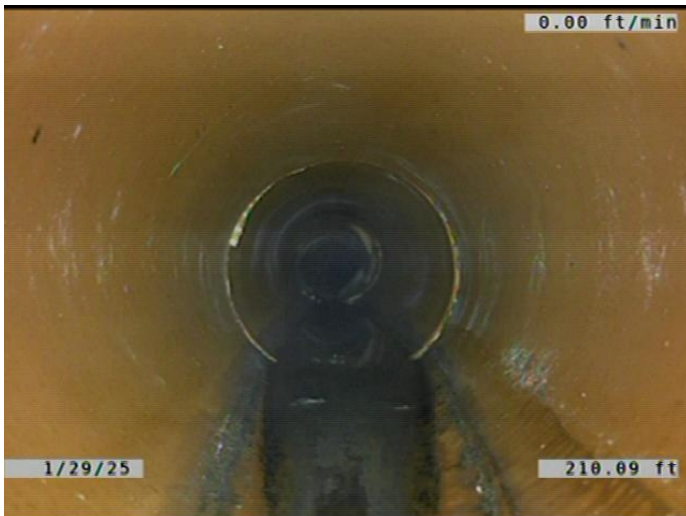
Code: **MWLS**
Description: **Miscellaneous Water Level Sag**

Distance (ft): **210.1**
Structural Grade: **2**
O&M Grade: **0**
Clock Start/From:
Clock To:
1st Value:
2nd Value:
Value Percent: **10.000**
Continuous Index: **S06**
Within 8" of Joint: **NO**
Remarks:

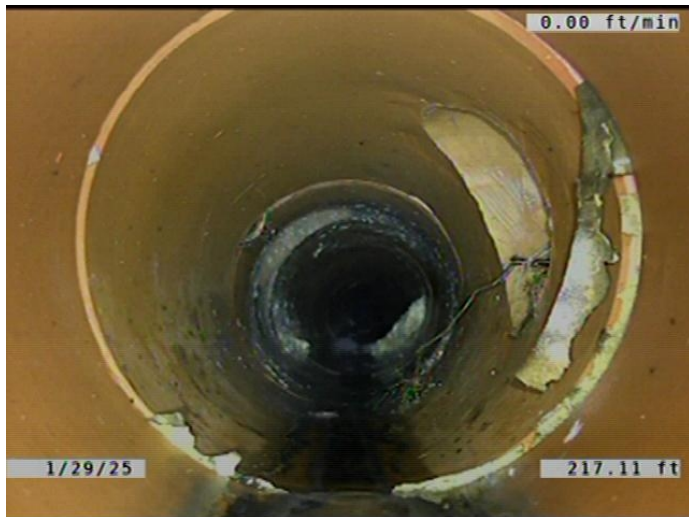
Code: **MWLS**
 Description: **Miscellaneous Water Level Sag**

Distance (ft): **217.1**
 Structural Grade: **2**
 O&M Grade: **0**
 Clock Start/From:
 Clock To:
 1st Value:
 2nd Value:
 Value Percent: **10.000**
 Continuous Index: **F06**
 Within 8" of Joint: **NO**
 Remarks:

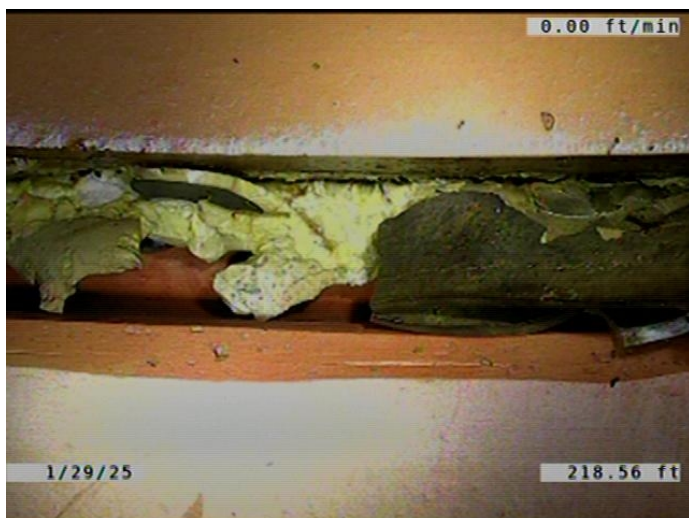
Code: **ISSRB**
 Description: **Intruding Sealing Material Sealing Ring Broken**

Distance (ft): **218.6**
 Structural Grade: **0**
 O&M Grade: **2**
 Clock Start/From: **11**
 Clock To: **2**
 1st Value:
 2nd Value:
 Value Percent: **5.000**
 Continuous Index:
 Within 8" of Joint: **NO**
 Remarks:

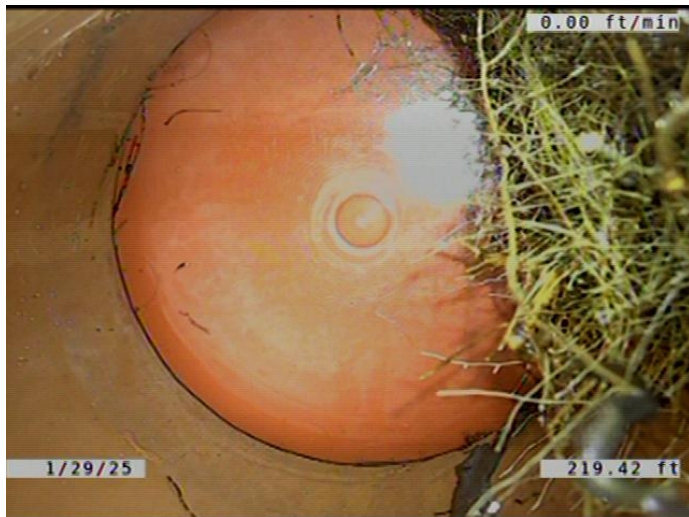
Code:	TFD
Description:	Tap Factory Defective
Distance (ft):	219.4
Structural Grade:	0
O&M Grade:	3
Clock Start/From:	2
Clock To:	
1st Value:	6.000
2nd Value:	
Value Percent:	
Continuous Index:	
Within 8" of Joint:	YES
Remarks:	CAPPED. ROOTS GROWING AROUND THE CAP INTO THE MAIN.

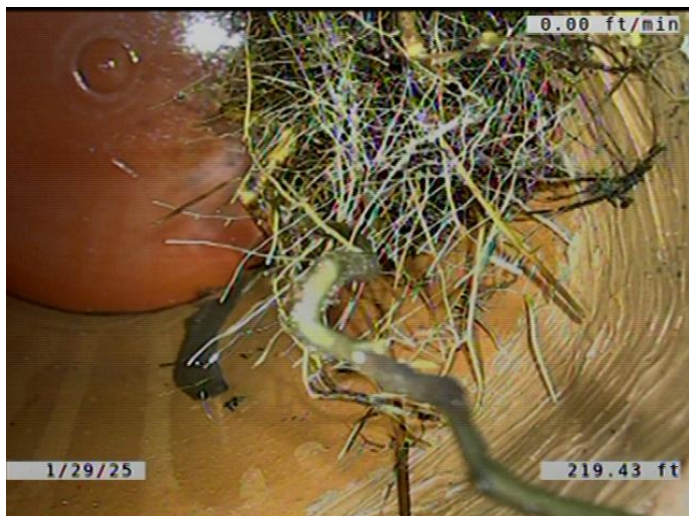
Code:	RFB
Description:	Roots Fine Barrel
Distance (ft):	219.4
Structural Grade:	0
O&M Grade:	2
Clock Start/From:	2
Clock To:	3
1st Value:	
2nd Value:	
Value Percent:	
Continuous Index:	
Within 8" of Joint:	NO
Remarks:

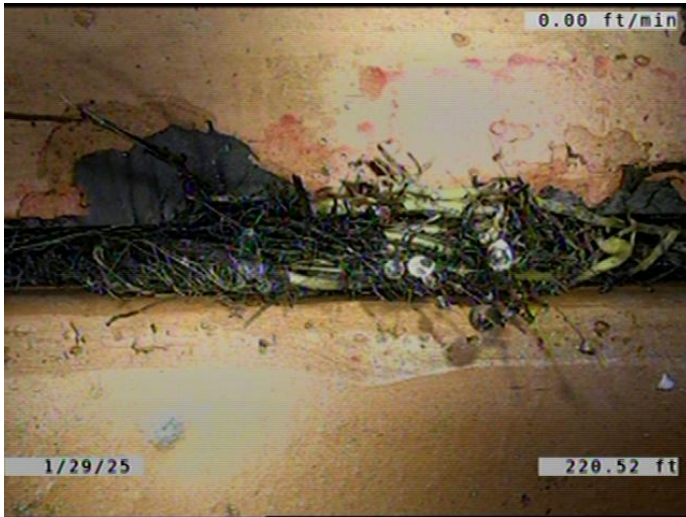
Code: **RFJ**
Description: **Roots Fine Joint**

Distance (ft): **220.5**
Structural Grade: **0**
O&M Grade: **1**
Clock Start/From: **8**
Clock To: **2**
1st Value:
2nd Value:
Value Percent:
Continuous Index:
Within 8" of Joint: **YES**
Remarks:

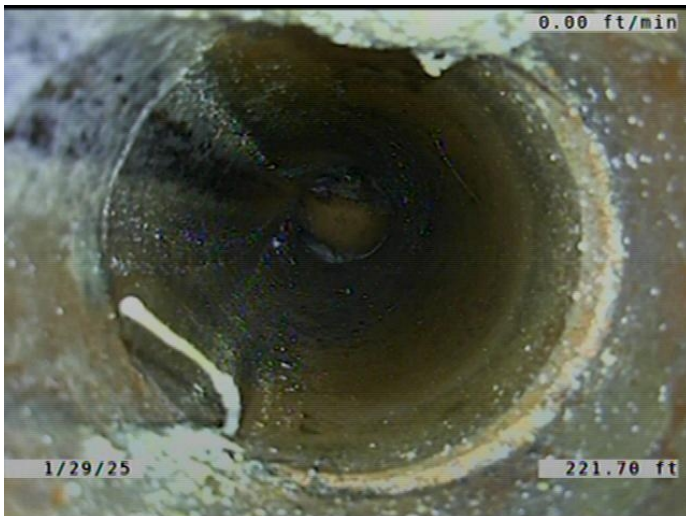
Code: **TFD**
Description: **Tap Factory Defective**

Distance (ft): **221.7**
Structural Grade: **0**
O&M Grade: **3**
Clock Start/From: **11**
Clock To:
1st Value: **6.000**
2nd Value:
Value Percent:
Continuous Index:
Within 8" of Joint: **YES**
Remarks: **ROOTS GROWING IN THE JOINTS OF THE SERVICE.**

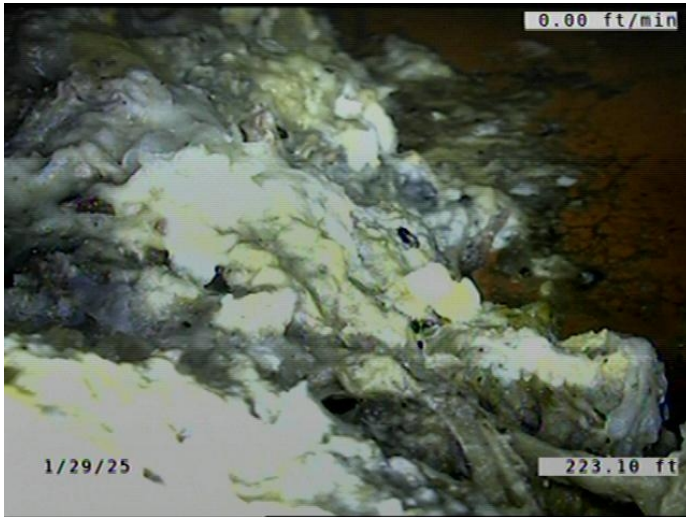
Code: **DAR**
Description: **Deposits Attached Ragging**

Distance (ft): **223.1**
Structural Grade: **0**
O&M Grade: **2**
Clock Start/From: **3**
Clock To: **5**
1st Value:
2nd Value:
Value Percent: **5.000**
Continuous Index:
Within 8" of Joint: **YES**
Remarks:

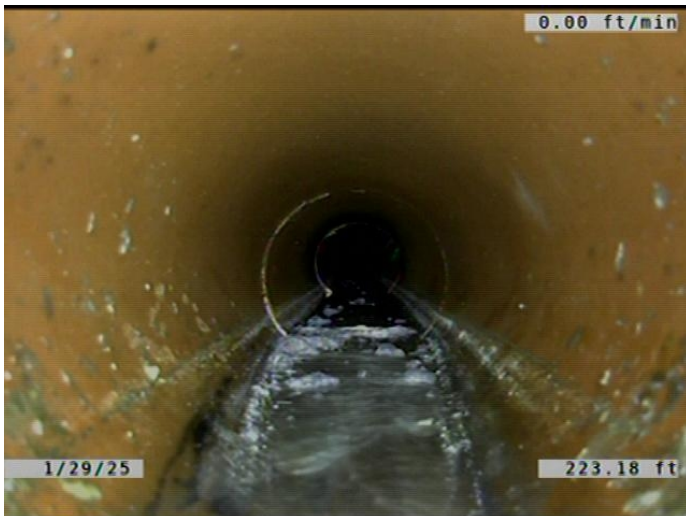
Code: **MWLS**
Description: **Miscellaneous Water Level Sag**

Distance (ft): **223.2**
Structural Grade: **4**
O&M Grade: **0**
Clock Start/From:
Clock To:
1st Value:
2nd Value:
Value Percent: **55.000**
Continuous Index: **S07**
Within 8" of Joint: **NO**
Remarks:

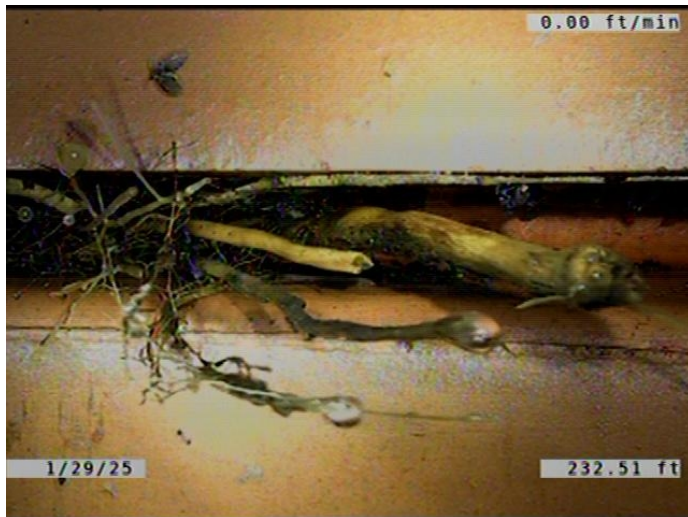
Code: **RFJ**
Description: **Roots Fine Joint**

Distance (ft): **232.5**
Structural Grade: **0**
O&M Grade: **1**
Clock Start/From: **9**
Clock To: **3**
1st Value:
2nd Value:
Value Percent:
Continuous Index:
Within 8" of Joint: **YES**
Remarks:

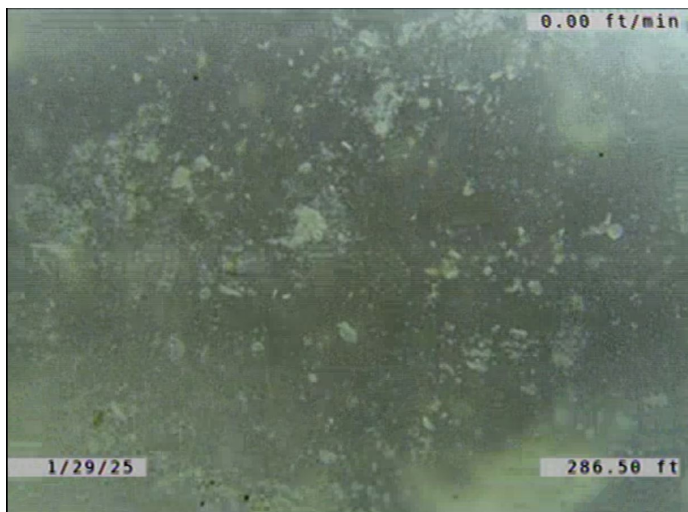
Code: **MCU**
Description: **Miscellaneous Camera Underwater**

Distance (ft): **286.5**
Structural Grade: **0**
O&M Grade: **4**
Clock Start/From:
Clock To:
1st Value:
2nd Value:
Value Percent:
Continuous Index: **S08**
Within 8" of Joint: **NO**
Remarks:

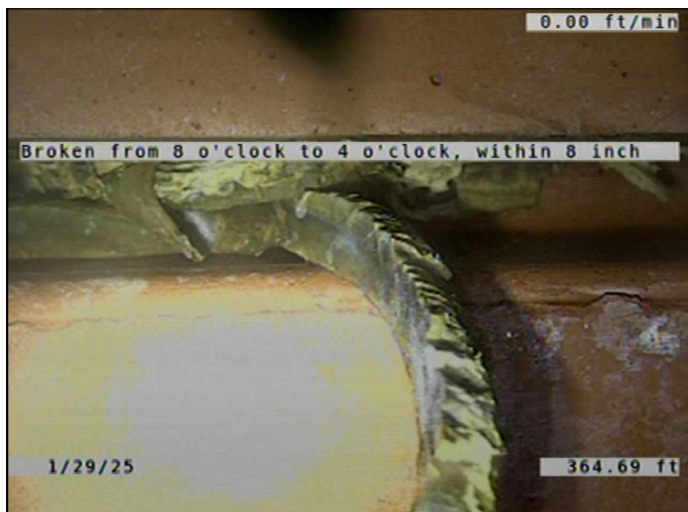
Code: **ISSRB**
Description: **Intruding Sealing Material Sealing Ring Broken**

Distance (ft): **364.7**
Structural Grade: **0**
O&M Grade: **2**
Clock Start/From: **8**
Clock To: **4**
1st Value:
2nd Value:
Value Percent: **5.000**
Continuous Index:
Within 8" of Joint: **NO**
Remarks:

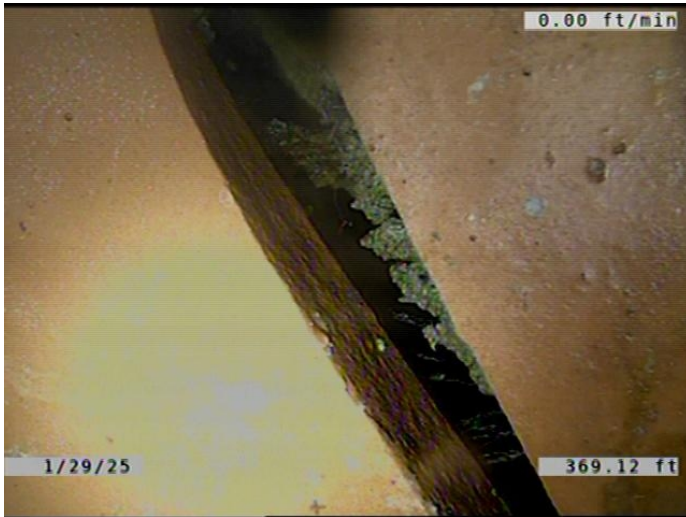
Code: **BVV**
Description: **Broken Void Visible**

Distance (ft): **369.1**
Structural Grade: **5**
O&M Grade: **0**
Clock Start/From: **9**
Clock To: **3**
1st Value:
2nd Value:
Value Percent:
Continuous Index:
Within 8" of Joint: **YES**
Remarks: **SOIL VISIBLE ALSO.**

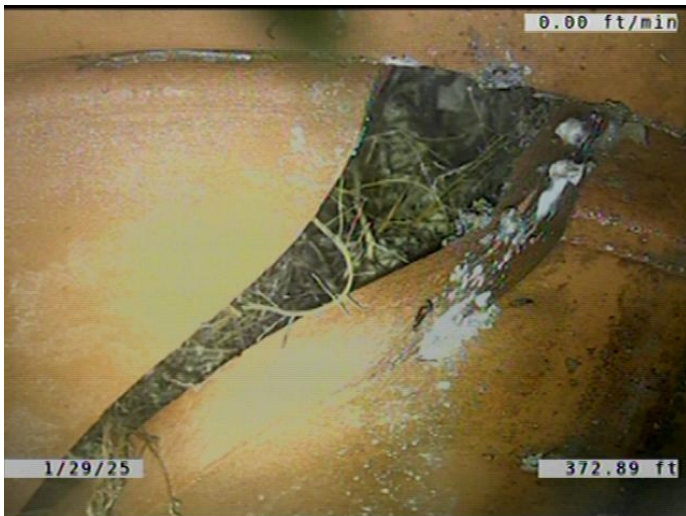
Code: **BVV**
Description: **Broken Void Visible**

Distance (ft): **372.9**
Structural Grade: **5**
O&M Grade: **0**
Clock Start/From: **10**
Clock To: **2**
1st Value:
2nd Value:
Value Percent:
Continuous Index:
Within 8" of Joint: **YES**
Remarks: **SOIL VISIBLE ALSO.**

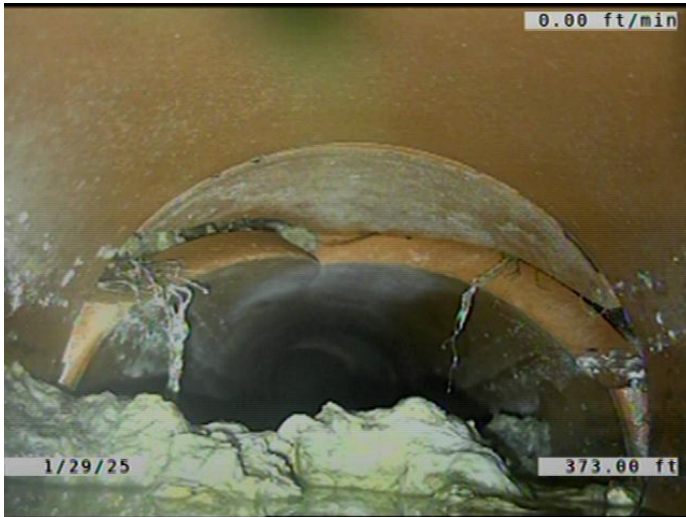
Code: **RFB**
Description: **Roots Fine Barrel**

Distance (ft): **373.0**
Structural Grade: **0**
O&M Grade: **2**
Clock Start/From: **10**
Clock To: **2**
1st Value:
2nd Value:
Value Percent:
Continuous Index:
Within 8" of Joint: **NO**
Remarks:

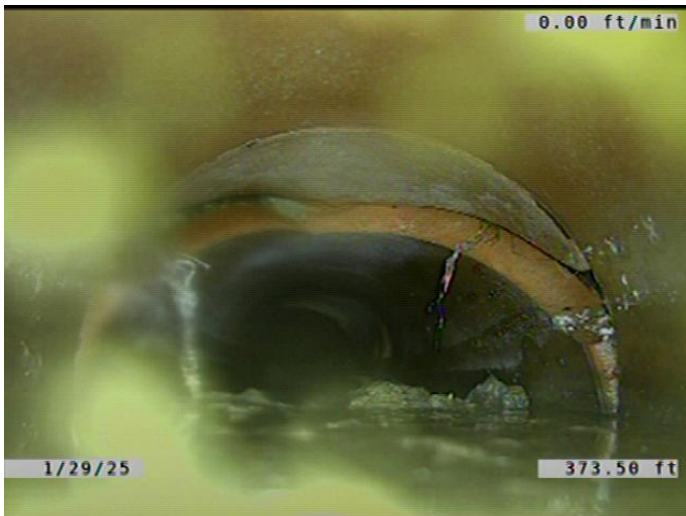
Code: **MWLS**
Description: **Miscellaneous Water Level Sag**

Distance (ft): **373.5**
Structural Grade: **4**
O&M Grade: **0**
Clock Start/From:
Clock To:
1st Value:
2nd Value:
Value Percent: **55.000**
Continuous Index: **F07**
Within 8" of Joint: **NO**
Remarks:

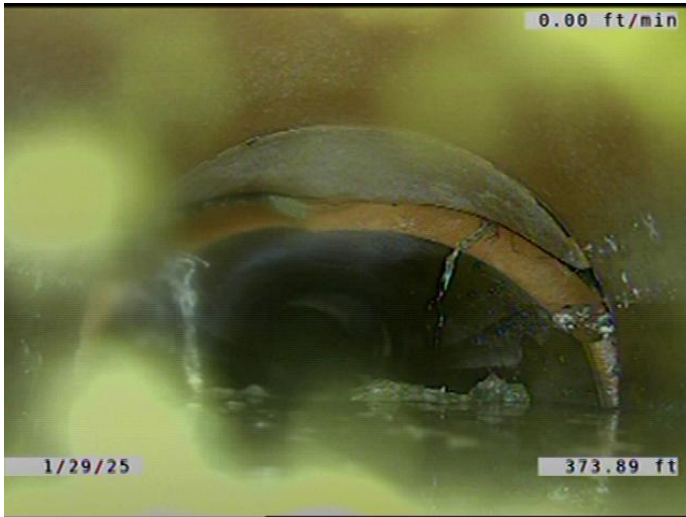
Code:	MSA
Description:	Miscellaneous Survey Abandoned
Distance (ft):	373.9
Structural Grade:	0
O&M Grade:	0
Clock Start/From:	
Clock To:	
1st Value:	
2nd Value:	
Value Percent:	
Continuous Index:	
Within 8" of Joint:	NO
Remarks:	CAMERA CANT MAKE IT PAST BROKEN AND DROPPED PIPE.
