## Profile/Photo Observation Report

Date:	<b>04/07/2018</b>	Weather:		Coding:	<b>PACP 6.0</b>
Pipe Length (ft):	<b>276.5</b>	Owner:	<b>NA</b>	Pre Clean:	<b>Not Known</b>
P.O.#:		Surveyor:	<b>Mark Ruby</b>	PSR:	<b>P-804-048-047</b>
Customer:		Clean Date:	<b>01/01/1900</b>	Shape:	<b>C</b>

Street:	<b>N OHIO ST</b>	Flow Control:	<b>Not Controlled</b>
City:	<b>Hobart, IN</b>	Year Renewed:	
Location:	<b>Other</b>	Tape/Media #:	
Purpose:	<b>Not Known</b>	Dia/Height:	<b>10"</b>
Use:	<b>Sanitary</b>	Material:	<b>VCP</b>
Drain Area:	<b>NA</b>	Lining:	
Category:	<b>NA</b>		
Comment:			
Location Details:		Direction of Survey:	<b>Upstream</b>
US MH:	<b>M-804-047</b>	DS MH:	<b>M-804-048</b>
		Total Length Surveyed (ft):	<b>254.8</b>

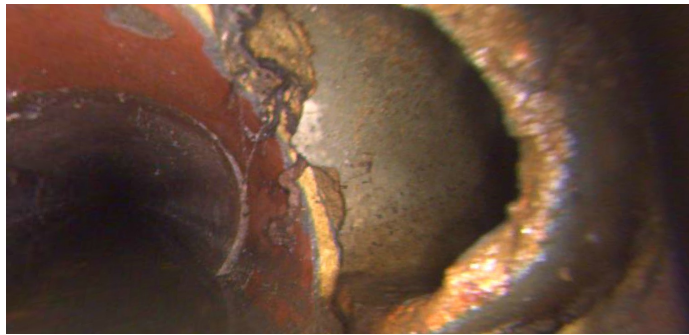
Code: **TBI**  
Description: **Tap Break-in Intruding**

Distance (ft): **.6**  
Structural Grade: **0**  
O&M Grade: **2**  
Clock Start/From: **3**  
Clock To:  
1st Value: **4.000**  
2nd Value: **1.000**  
Value Percent:  
Continuous Index:  
Within 8" of Joint:  
Remarks:

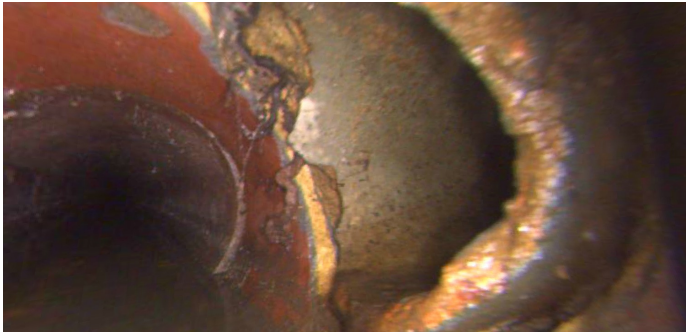
Code: **RFC**  
Description: **Roots Fine Connection**

Distance (ft): **.6**  
Structural Grade: **0**  
O&M Grade: **1**  
Clock Start/From: **2**  
Clock To:  
1st Value:  
2nd Value:  
Value Percent:  
Continuous Index:  
Within 8" of Joint: **NO**  
Remarks:

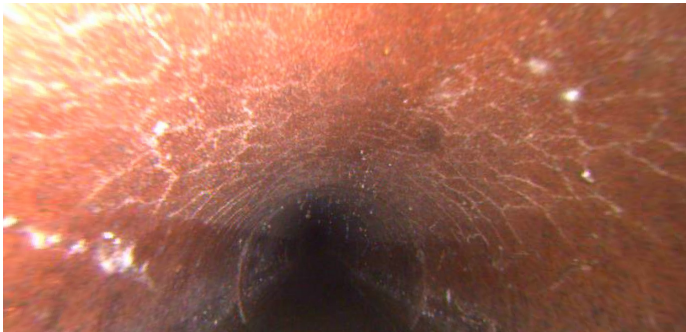
Code: **CM**  
Description: **Crack Multiple**

Distance (ft): **3.3**  
Structural Grade: **3**  
O&M Grade: **0**  
Clock Start/From: **10**  
Clock To: **2**  
1st Value:  
2nd Value:  
Value Percent:  
Continuous Index:  
Within 8" of Joint:  
Remarks:

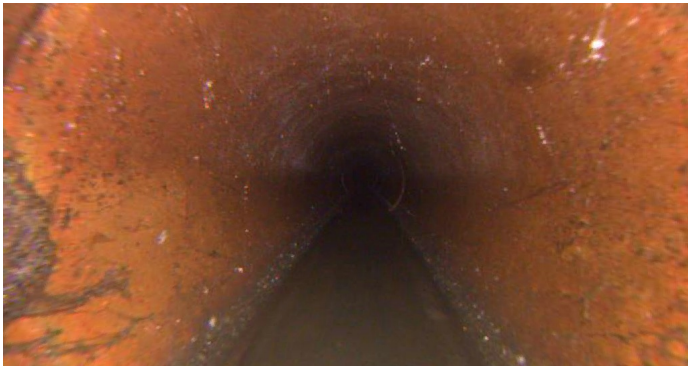
Code: **RFJ**  
Description: **Roots Fine Joint**

Distance (ft): **29.7**  
Structural Grade: **0**  
O&M Grade: **1**  
Clock Start/From: **8**  
Clock To:  
1st Value:  
2nd Value:  
Value Percent:  
Continuous Index:  
Within 8" of Joint: **YES**  
Remarks:

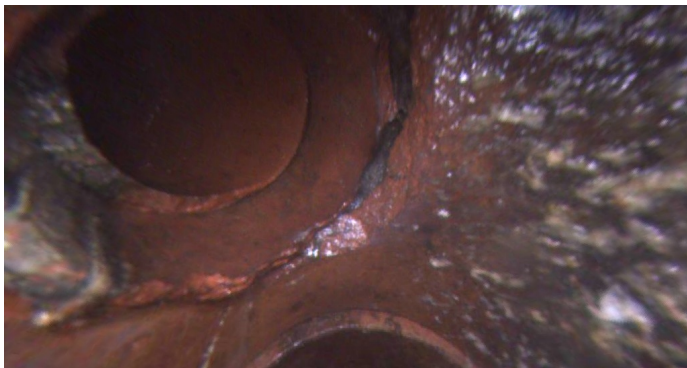
Code: **TBI**  
Description: **Tap Break-in Intruding**

Distance (ft): **139.0**  
Structural Grade: **0**  
O&M Grade: **2**  
Clock Start/From: **1**  
Clock To:  
1st Value: **4.000**  
2nd Value: **1.000**  
Value Percent:  
Continuous Index:  
Within 8" of Joint:  
Remarks: **Photo taken from rear camera.**

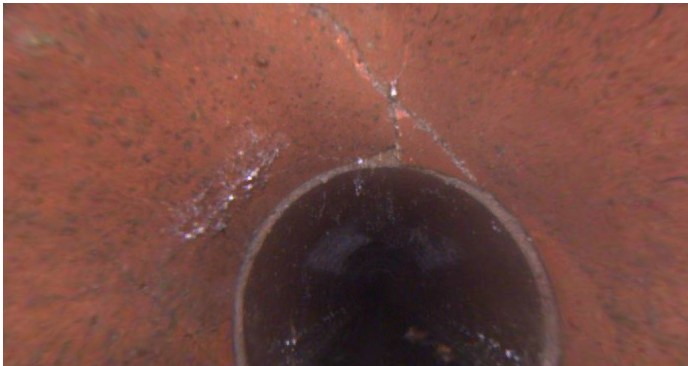
Code: **FM**  
Description: **Fracture Multiple**

Distance (ft): **182.2**  
Structural Grade: **4**  
O&M Grade: **0**  
Clock Start/From: **4**  
Clock To: **10**  
1st Value:  
2nd Value:  
Value Percent:  
Continuous Index:  
Within 8" of Joint:  
Remarks: **Photo taken from rear camera.**

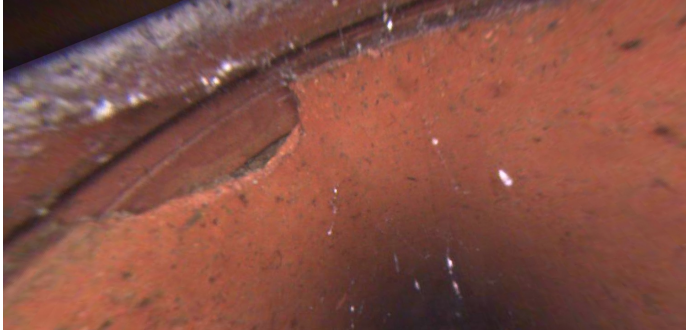
Code: **SSS**  
Description: **Surface Spalling**

Distance (ft): **221.7**  
Structural Grade: **2**  
O&M Grade: **0**  
Clock Start/From: **1**  
Clock To: **2**  
1st Value:  
2nd Value:  
Value Percent:  
Continuous Index:  
Within 8" of Joint: **YES**  
Remarks:

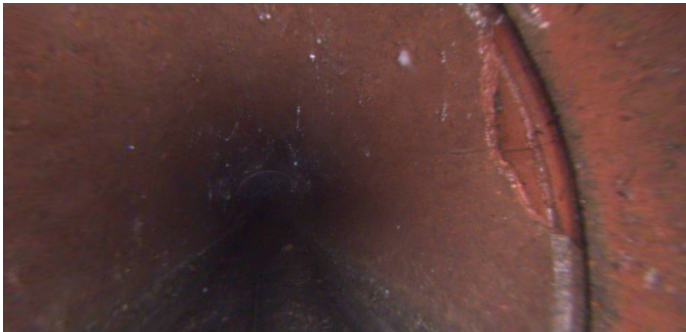
Code: **SSS**  
Description: **Surface Spalling**

Distance (ft): **228.0**  
Structural Grade: **2**  
O&M Grade: **0**  
Clock Start/From: **9**  
Clock To: **10**  
1st Value:  
2nd Value:  
Value Percent:  
Continuous Index:  
Within 8" of Joint: **YES**  
Remarks:

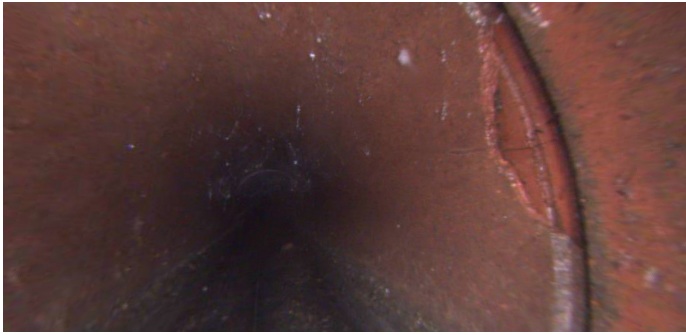
Code: **FL**  
Description: **Fracture Longitudinal**

Distance (ft): **228.0**  
Structural Grade: **3**  
O&M Grade: **0**  
Clock Start/From: **9**  
Clock To:  
1st Value:  
2nd Value:  
Value Percent:  
Continuous Index:  
Within 8" of Joint: **YES**  
Remarks:

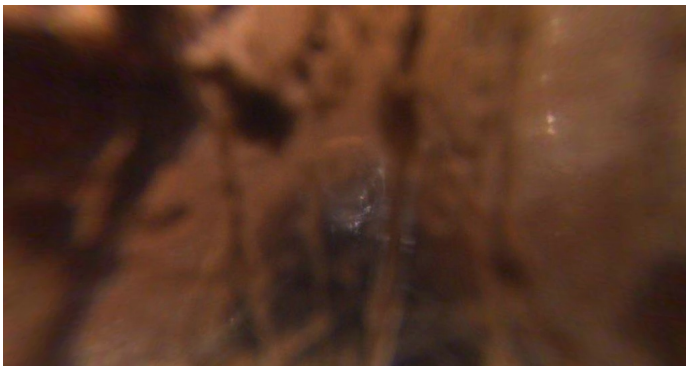
Code: **MSA**  
Description: **Abandoned Survey**

Distance (ft): **254.8**  
Structural Grade: **0**  
O&M Grade: **0**  
Clock Start/From:  
Clock To:  
1st Value:  
2nd Value:  
Value Percent:  
Continuous Index:  
Within 8" of Joint: **NO**  
Remarks: **Debris**
