## Profile/Photo Observation Report

| Street: | <b>N Ohio St.</b> | Flow Control: | <b>Not Controlled</b> |
| City: | <b>Hobart, IN</b> | Year Renewed: | |

| US MH: | <b>M-804-047</b> | DS MH: | <b>M-804-048</b> |

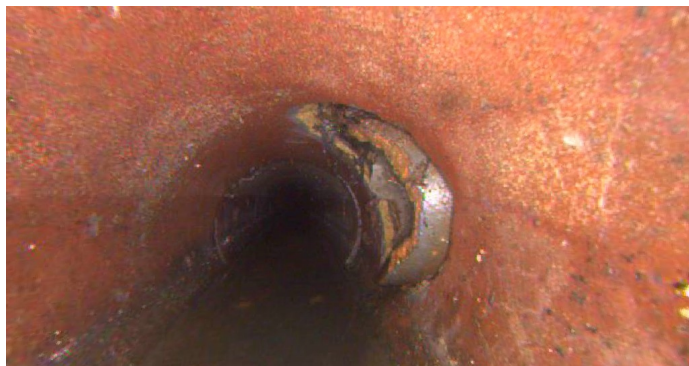
Code: **AMH**  
 Description: **Manhole**

Distance (ft): **.0**  
 Structural Grade: **0**  
 O&M Grade: **0**  
 Clock Start/From:  
 Clock To:  
 1st Value:  
 2nd Value:  
 Value Percent:  
 Continuous Index:  
 Within 8" of Joint: **NO**  
 Remarks: **M-804-048**

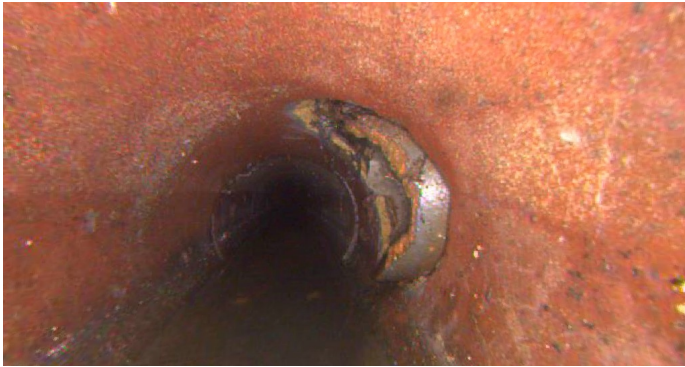
Code: **MWL**  
Description: **Water Level**

Distance (ft): **.0**  
Structural Grade: **0**  
O&M Grade: **0**  
Clock Start/From:  
Clock To:  
1st Value:  
2nd Value:  
Value Percent: **10.000**  
Continuous Index:  
Within 8" of Joint: **NO**  
Remarks:

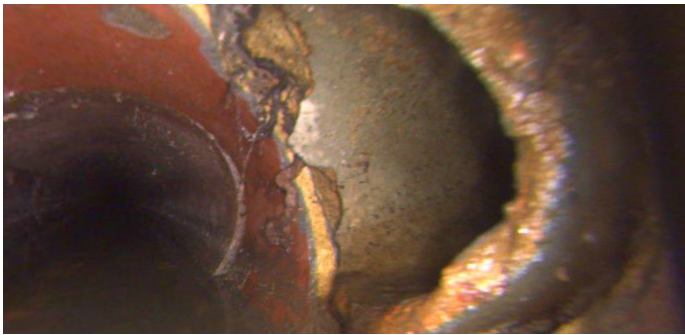
Code: **TBI**  
Description: **Tap Break-in Intruding**

Distance (ft): **.6**  
Structural Grade: **0**  
O&M Grade: **2**  
Clock Start/From: **3**  
Clock To:  
1st Value: **4.000**  
2nd Value: **1.000**  
Value Percent:  
Continuous Index:  
Within 8" of Joint:  
Remarks:

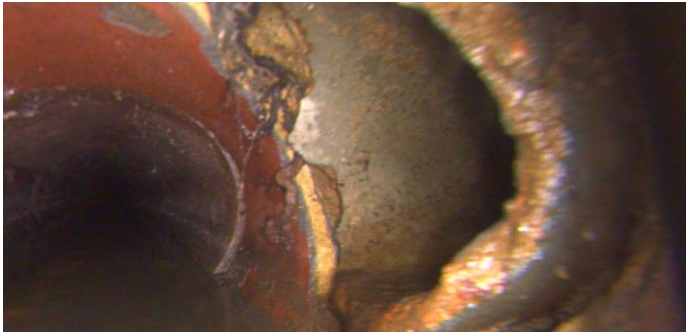
Code: **RFC**  
Description: **Roots Fine Connection**

Distance (ft): **.6**  
Structural Grade: **0**  
O&M Grade: **1**  
Clock Start/From: **2**  
Clock To:  
1st Value:  
2nd Value:  
Value Percent:  
Continuous Index:  
Within 8" of Joint: **NO**  
Remarks:

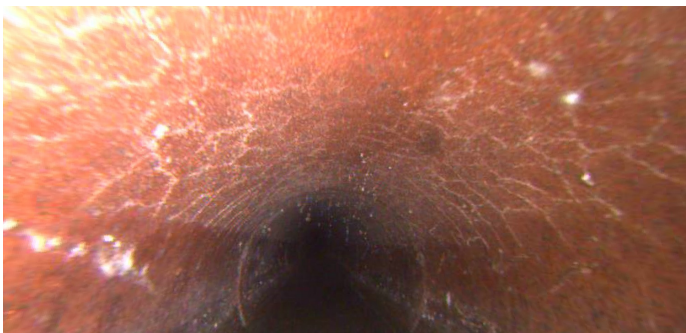
Code: **CM**  
Description: **Crack Multiple**

Distance (ft): **3.3**  
Structural Grade: **3**  
O&M Grade: **0**  
Clock Start/From: **10**  
Clock To: **2**  
1st Value:  
2nd Value:  
Value Percent:  
Continuous Index:  
Within 8" of Joint:  
Remarks:

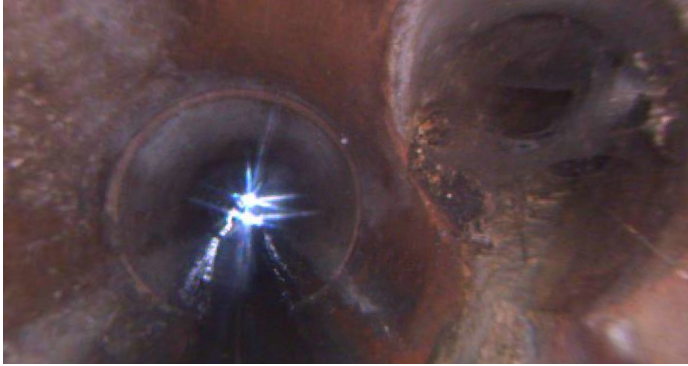
Code: **TF**  
Description: **Tap Factory**

Distance (ft): **12.9**  
Structural Grade: **0**  
O&M Grade: **0**  
Clock Start/From: **9**  
Clock To:  
1st Value: **4.000**  
2nd Value:  
Value Percent:  
Continuous Index:  
Within 8" of Joint:  
Remarks:

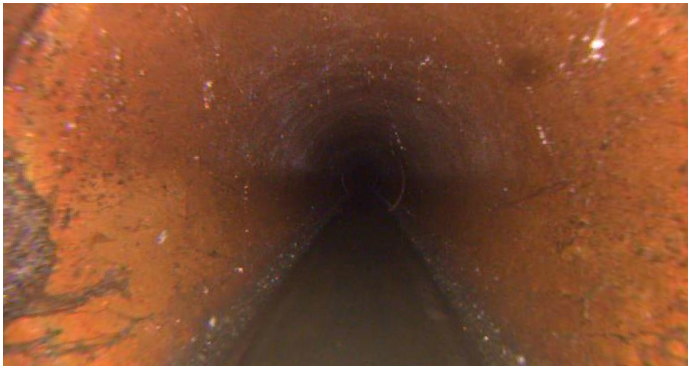
Code: **RFJ**  
Description: **Roots Fine Joint**

Distance (ft): **29.7**  
Structural Grade: **0**  
O&M Grade: **1**  
Clock Start/From: **8**  
Clock To:  
1st Value:  
2nd Value:  
Value Percent:  
Continuous Index:  
Within 8" of Joint: **YES**  
Remarks:

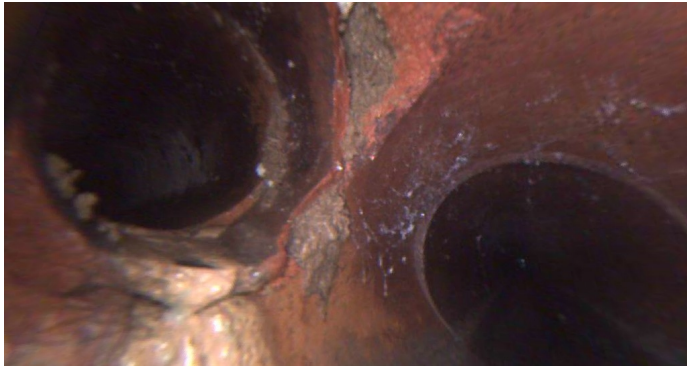
Code: **TB**  
Description: **Tap Break-in**

Distance (ft): **80.5**  
Structural Grade: **0**  
O&M Grade: **0**  
Clock Start/From: **3**  
Clock To:  
1st Value: **4.000**  
2nd Value:  
Value Percent:  
Continuous Index:  
Within 8" of Joint:  
Remarks: **Photo taken from rear camera.**

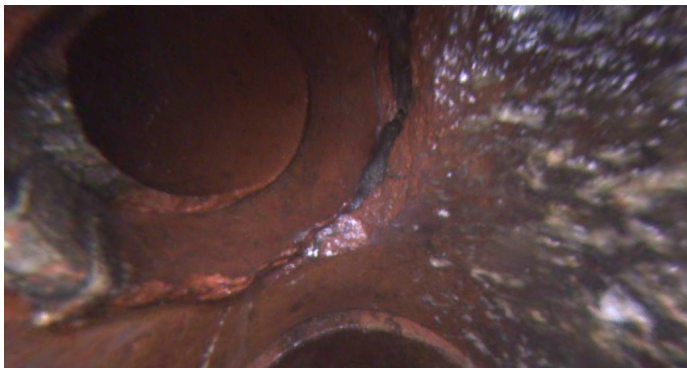
Code: **TBI**  
Description: **Tap Break-in Intruding**

Distance (ft): **139.0**  
Structural Grade: **0**  
O&M Grade: **2**  
Clock Start/From: **1**  
Clock To:  
1st Value: **4.000**  
2nd Value: **1.000**  
Value Percent:  
Continuous Index:  
Within 8" of Joint:  
Remarks: **Photo taken from rear camera.**

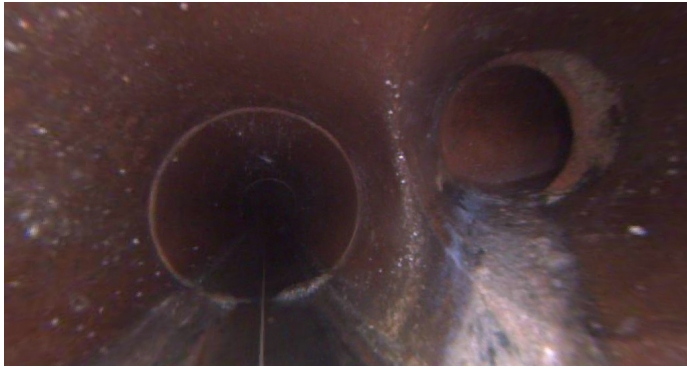
Code: **TF**  
Description: **Tap Factory**

Distance (ft): **164.1**  
Structural Grade: **0**  
O&M Grade: **0**  
Clock Start/From: **9**  
Clock To:  
1st Value: **4.000**  
2nd Value:  
Value Percent:  
Continuous Index:  
Within 8" of Joint:  
Remarks: **Photo taken from rear camera.**

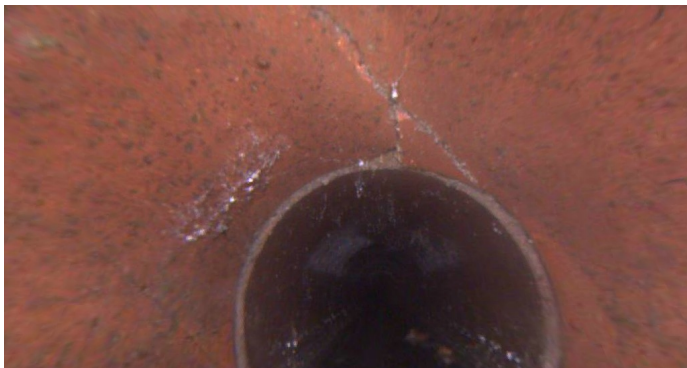
Code: **FM**  
Description: **Fracture Multiple**

Distance (ft): **182.2**  
Structural Grade: **4**  
O&M Grade: **0**  
Clock Start/From: **4**  
Clock To: **10**  
1st Value:  
2nd Value:  
Value Percent:  
Continuous Index:  
Within 8" of Joint:  
Remarks: **Photo taken from rear camera.**

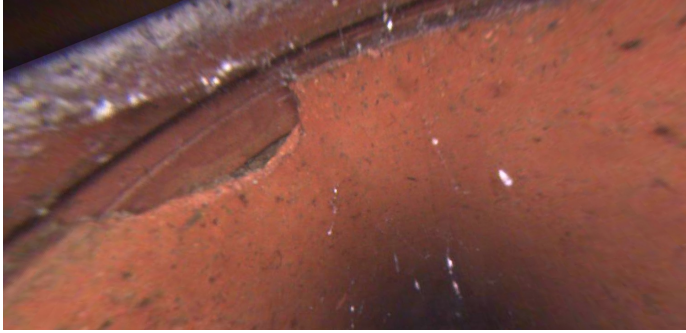
Code: **SSS**  
Description: **Surface Spalling**

Distance (ft): **221.7**  
Structural Grade: **2**  
O&M Grade: **0**  
Clock Start/From: **1**  
Clock To: **2**  
1st Value:  
2nd Value:  
Value Percent:  
Continuous Index:  
Within 8" of Joint: **YES**  
Remarks:

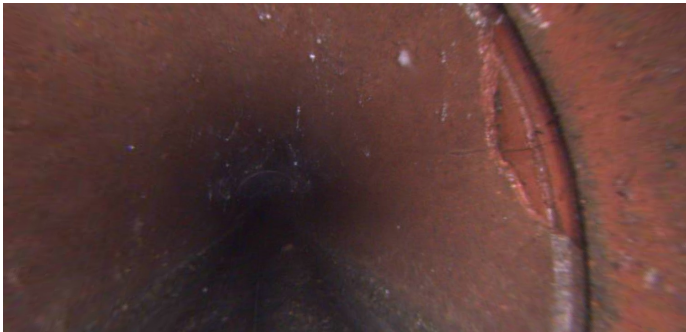
Code: **SSS**  
Description: **Surface Spalling**

Distance (ft): **228.0**  
Structural Grade: **2**  
O&M Grade: **0**  
Clock Start/From: **9**  
Clock To: **10**  
1st Value:  
2nd Value:  
Value Percent:  
Continuous Index:  
Within 8" of Joint: **YES**  
Remarks:

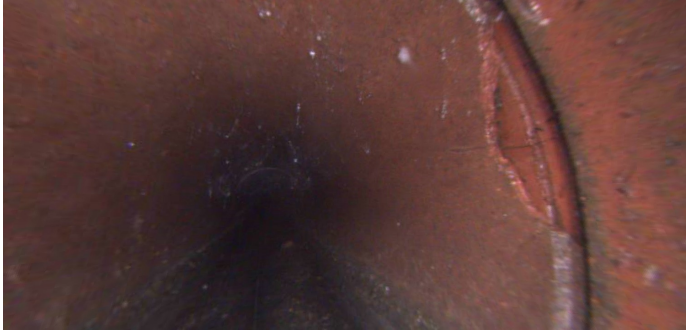
Code: **FL**  
Description: **Fracture Longitudinal**

Distance (ft): **228.0**  
Structural Grade: **3**  
O&M Grade: **0**  
Clock Start/From: **9**  
Clock To:  
1st Value:  
2nd Value:  
Value Percent:  
Continuous Index:  
Within 8" of Joint: **YES**  
Remarks:

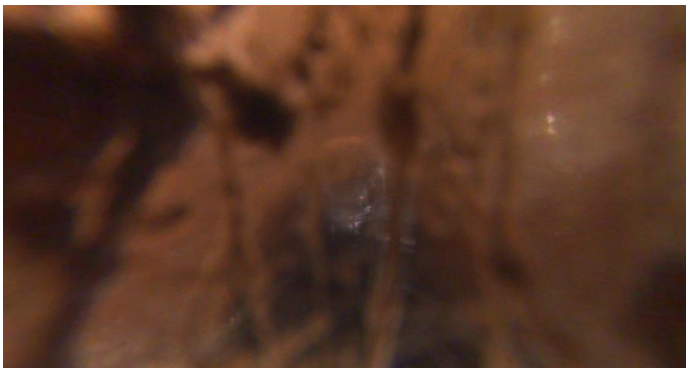
Code: **MSA**  
Description: **Abandoned Survey**

Distance (ft): **254.8**  
Structural Grade: **0**  
O&M Grade: **0**  
Clock Start/From:  
Clock To:  
1st Value:  
2nd Value:  
Value Percent:  
Continuous Index:  
Within 8" of Joint: **NO**  
Remarks: **Debris**
