## Profile/Photo Observation Report

Street:	<b>N OHIO ST</b>	Flow Control:	<b>Not Controlled</b>
City:	<b>Hobart, IN</b>	Year Renewed:	
Location:	<b>Other</b>	Tape/Media #:	
Purpose:	<b>Not Known</b>	Dia/Height:	<b>10"</b>
Use:	<b>Sanitary</b>	Material:	<b>VCP</b>
Drain Area:	<b>NA</b>	Lining:	
Category:	<b>NA</b>		
Comment:

Location Details:		Direction of Survey:	<b>Downstream</b>
US MH:	<b>M-804-047</b>	DS MH:	<b>M-804-048</b>
		Total Length Surveyed (ft):	<b>27.7</b>

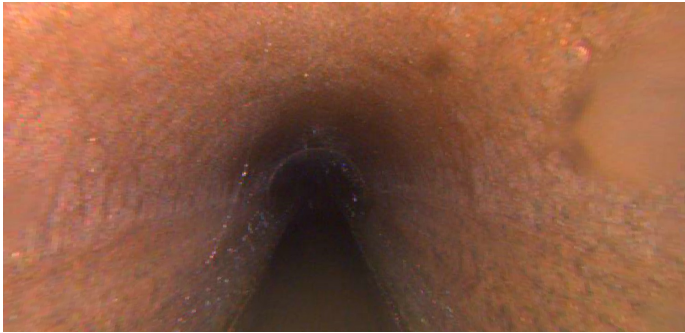
Code:	<b>MWL</b>
Description:	<b>Water Level</b>

Distance (ft):	<b>.0</b>
Structural Grade:	<b>0</b>
O&M Grade:	<b>0</b>
Clock Start/From:	
Clock To:	
1st Value:	
2nd Value:	
Value Percent:	<b>5.000</b>
Continuous Index:	
Within 8" of Joint:	<b>NO</b>
Remarks:
