## Profile/Photo Observation Report

Street:	<b>N Ohio St.</b>	Flow Control:	<b>Not Controlled</b>
City:	<b>Hobart, IN</b>	Year Renewed:	
Location:	<b>Other</b>	Tape/Media #:	
Purpose:	<b>Not Known</b>	Dia/Height:	<b>10"</b>
Use:	<b>Sanitary</b>	Material:	<b>VCP</b>
Drain Area:	<b>NA</b>	Lining:	
Category:	<b>NA</b>		
Comment:

Location Details:		Direction of Survey:	<b>Downstream</b>
US MH:	<b>M-804-047</b>	DS MH:	<b>M-804-048</b>
		Total Length Surveyed (ft):	<b>14.9</b>

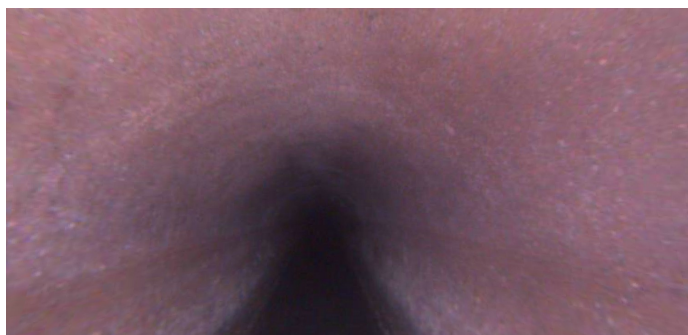
Code: **AMH**  
 Description: **Manhole**  
 Distance (ft): **.0**  
 Structural Grade: **0**  
 O&M Grade: **0**  
 Clock Start/From:  
 Clock To:  
 1st Value:  
 2nd Value:  
 Value Percent:  
 Continuous Index:  
 Within 8" of Joint: **NO**  
 Remarks: **M-804-047**

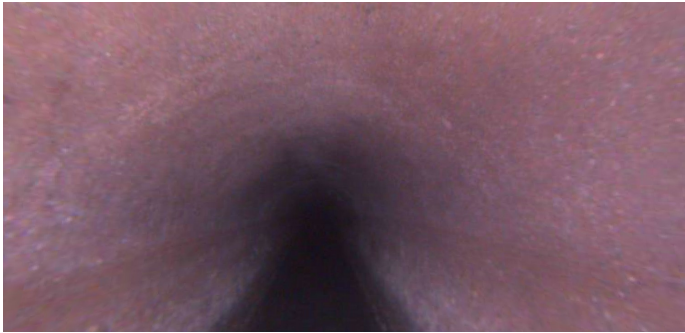
Code:	<b>MWL</b>
Description:	<b>Water Level</b>

Distance (ft):	<b>.0</b>
Structural Grade:	<b>0</b>
O&M Grade:	<b>0</b>
Clock Start/From:	
Clock To:	
1st Value:	
2nd Value:	
Value Percent:	<b>5.000</b>
Continuous Index:	
Within 8" of Joint:	<b>NO</b>
Remarks:

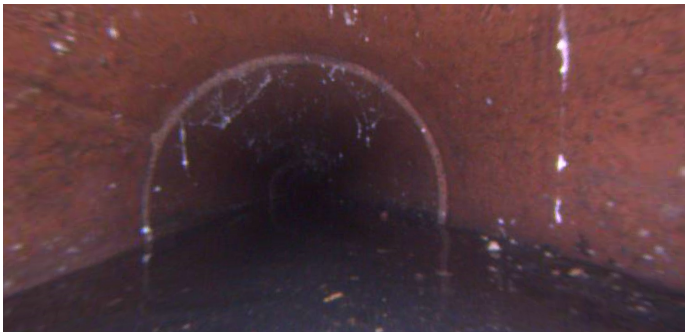
Code:	<b>MSA</b>
Description:	<b>Abandoned Survey</b>

Distance (ft):	<b>14.9</b>
Structural Grade:	<b>0</b>
O&M Grade:	<b>0</b>
Clock Start/From:	
Clock To:	
1st Value:	
2nd Value:	
Value Percent:	
Continuous Index:	
Within 8" of Joint:	<b>NO</b>
Remarks:	<b>DEBRIS UNDER WATER</b>
