Profile/Photo Observation Report

Street:	N OHIO ST	Flow Control:	Not Controlled
City:	Hobart, IN	Year Renewed:	
Location:	Other	Tape/Media #:	
Purpose:	Not Known	Dia/Height:	10"
Use:	Sanitary	Material:	VCP
Drain Area:	NA	Lining:	
Category:	NA		
Comment:

Location Details:		Direction of Survey:	Upstream
US MH:	M-804-048	DS MH:	M-804-049
		Total Length Surveyed (ft):	22.0

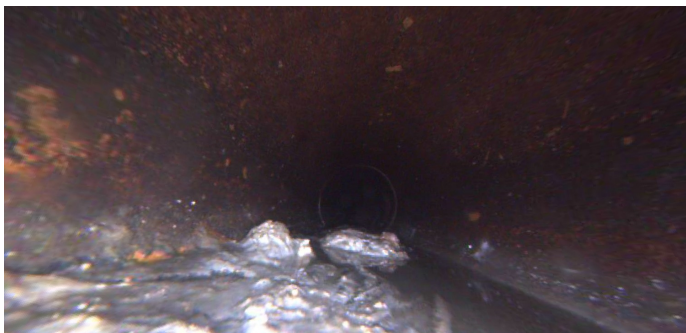
Code: **AMH**
Description: **Manhole**

Distance (ft): **.0**
Structural Grade: **0**
O&M Grade: **0**
Clock Start/From:
Clock To:
1st Value:
2nd Value:
Value Percent:
Continuous Index:
Within 8" of Joint: **NO**
Remarks: **M-804-049**

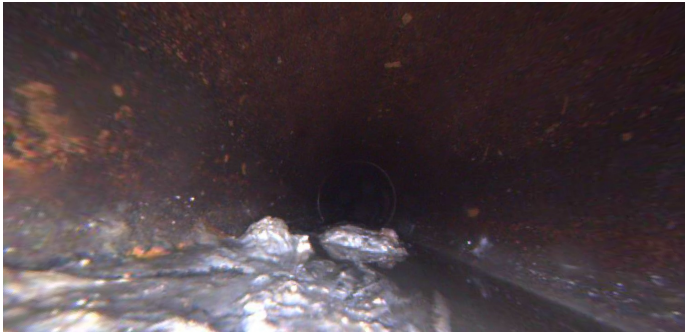
Code:	MWL
Description:	Water Level

Distance (ft):	.0
Structural Grade:	0
O&M Grade:	0
Clock Start/From:	
Clock To:	
1st Value:	
2nd Value:	
Value Percent:	20.000
Continuous Index:	
Within 8" of Joint:	NO
Remarks:

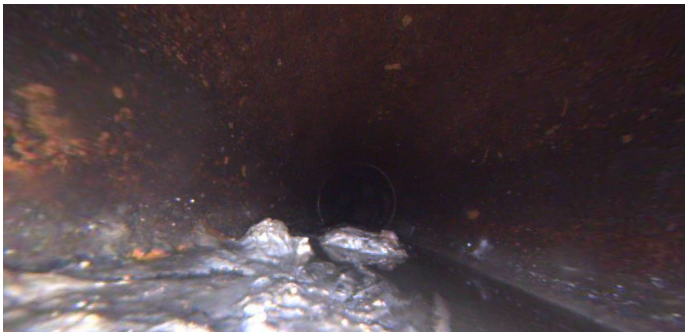
Code:	OBZ
Description:	Obstacle Other

Distance (ft):	.0
Structural Grade:	0
O&M Grade:	2
Clock Start/From:	5
Clock To:	7
1st Value:	
2nd Value:	
Value Percent:	10.000
Continuous Index:	
Within 8" of Joint:	NO
Remarks:	paper products

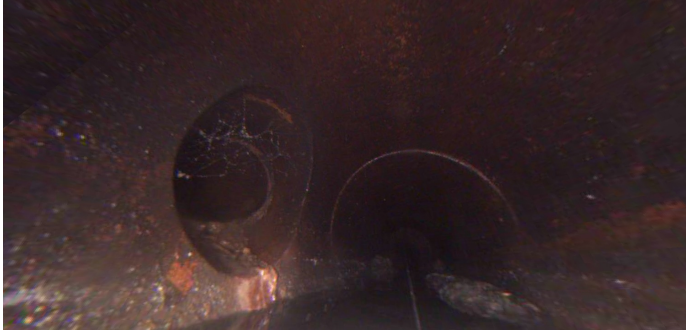
Code: **TF**
Description: **Tap Factory**

Distance (ft): **4.8**
Structural Grade: **0**
O&M Grade: **0**
Clock Start/From: **3**
Clock To:
1st Value: **4.000**
2nd Value:
Value Percent:
Continuous Index:
Within 8" of Joint:
Remarks:

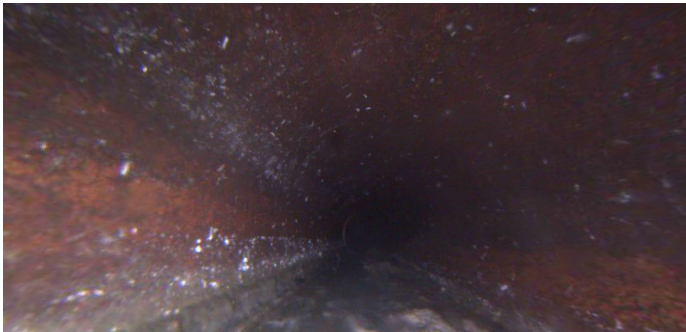
Code: **MSA**
Description: **Abandoned Survey**

Distance (ft): **22.0**
Structural Grade: **0**
O&M Grade: **0**
Clock Start/From:
Clock To:
1st Value:
2nd Value:
Value Percent:
Continuous Index:
Within 8" of Joint: **NO**
Remarks: **debris under water**
