Profile/Photo Observation Report

Street:	N Ohio St.	Flow Control:	Not Controlled
City:	Hobart, IN	Year Renewed:	
Location:	Other	Tape/Media #:	
Purpose:	Not Known	Dia/Height:	10"
Use:	Sanitary	Material:	VCP
Drain Area:	NA	Lining:	
Category:	NA		
Comment:

Location Details:		Direction of Survey:	Upstream
US MH:	M-804-048	DS MH:	M-804-049
		Total Length Surveyed (ft):	22.0

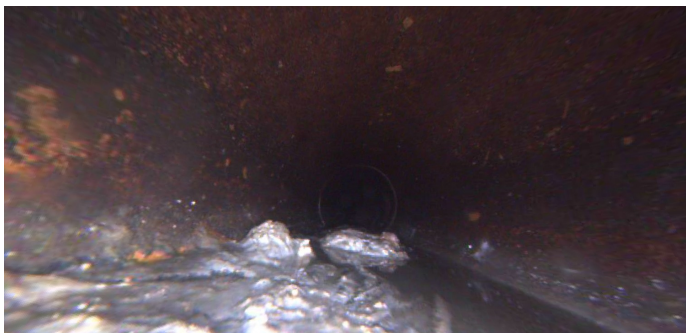
Code: **AMH**
Description: **Manhole**

Distance (ft): **.0**
Structural Grade: **0**
O&M Grade: **0**
Clock Start/From:
Clock To:
1st Value:
2nd Value:
Value Percent:
Continuous Index:
Within 8" of Joint: **NO**
Remarks: **M-804-049**

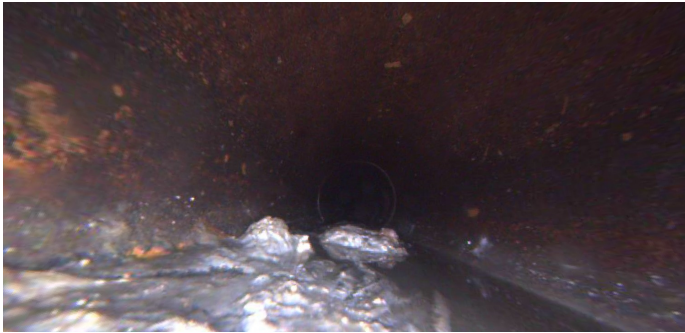
Code:	MWL
Description:	Water Level

Distance (ft):	.0
Structural Grade:	0
O&M Grade:	0
Clock Start/From:	
Clock To:	
1st Value:	
2nd Value:	
Value Percent:	20.000
Continuous Index:	
Within 8" of Joint:	NO
Remarks:

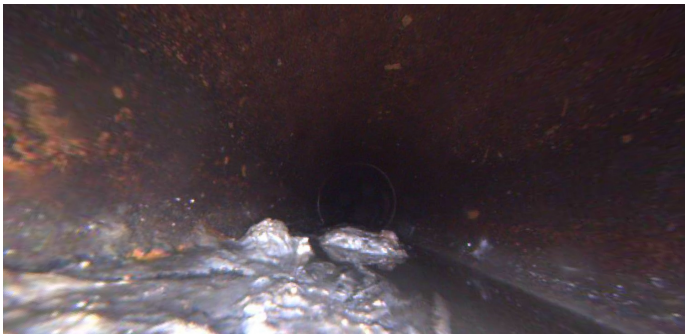
Code:	OBZ
Description:	Obstacle Other

Distance (ft):	.0
Structural Grade:	0
O&M Grade:	2
Clock Start/From:	5
Clock To:	7
1st Value:	
2nd Value:	
Value Percent:	10.000
Continuous Index:	
Within 8" of Joint:	NO
Remarks:	paper products

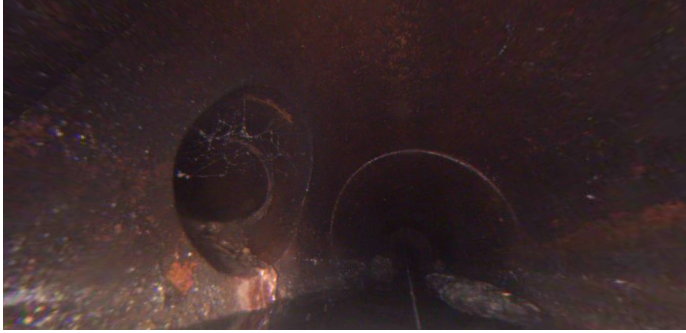
Code: **TF**
Description: **Tap Factory**

Distance (ft): **4.8**
Structural Grade: **0**
O&M Grade: **0**
Clock Start/From: **3**
Clock To:
1st Value: **4.000**
2nd Value:
Value Percent:
Continuous Index:
Within 8" of Joint:
Remarks:

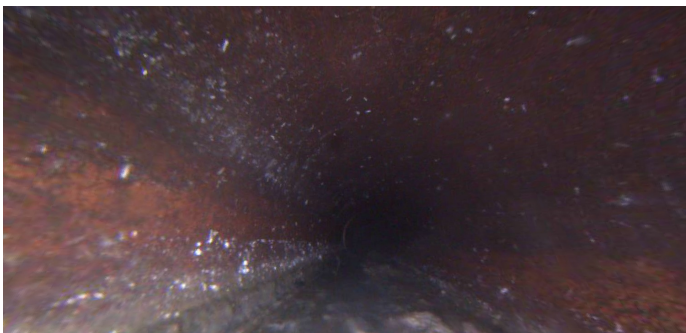
Code: **MSA**
Description: **Abandoned Survey**

Distance (ft): **22.0**
Structural Grade: **0**
O&M Grade: **0**
Clock Start/From:
Clock To:
1st Value:
2nd Value:
Value Percent:
Continuous Index:
Within 8" of Joint: **NO**
Remarks: **debris under water**
