Profile/Photo Observation Report

Street:	N OHIO ST	Flow Control:	Not Controlled
City:	Hobart, IN	Year Renewed:	
Location:	Other	Tape/Media #:	
Purpose:	Not Known	Dia/Height:	10"
Use:	Sanitary	Material:	VCP
Drain Area:	NA	Lining:	
Category:	NA		
Comment:

Location Details:		Direction of Survey:	Downstream
US MH:	M-804-049	DS MH:	M-804-050
		Total Length Surveyed (ft):	5.2

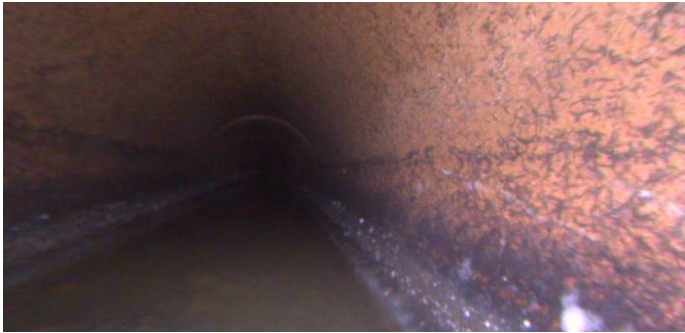
Code:	MWL
Description:	Water Level

Distance (ft):	.0
Structural Grade:	0
O&M Grade:	0
Clock Start/From:	
Clock To:	
1st Value:	
2nd Value:	
Value Percent:	10.000
Continuous Index:	
Within 8" of Joint:	NO
Remarks:

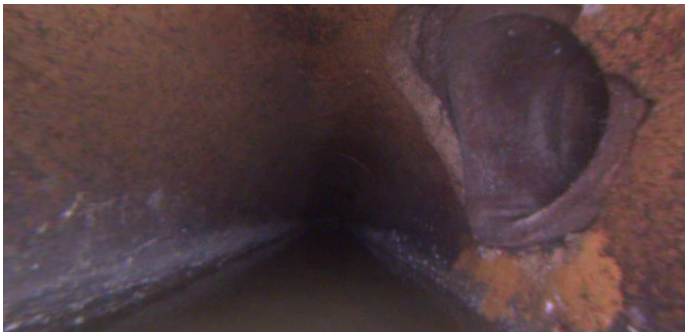
Code:	TBI
Description:	Tap Break-in Intruding

Distance (ft):	5.2
Structural Grade:	0
O&M Grade:	2
Clock Start/From:	3
Clock To:	
1st Value:	4.000
2nd Value:	1.000
Value Percent:	
Continuous Index:	
Within 8" of Joint:	
Remarks:

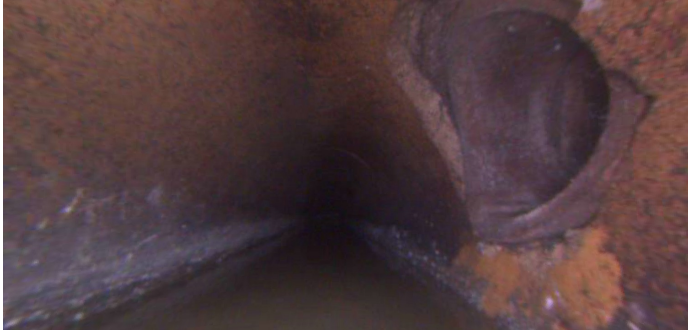
Code:	MSA
Description:	Abandoned Survey
Distance (ft):	5.2
Structural Grade:	0
O&M Grade:	0
Clock Start/From:	
Clock To:	
1st Value:	
2nd Value:	
Value Percent:	
Continuous Index:	
Within 8" of Joint:	NO
Remarks:	unknown
