## Profile/Photo Observation Report

Street:	<b>N OHIO ST</b>	Flow Control:	<b>Not Controlled</b>
City:	<b>Hobart, IN</b>	Year Renewed:	
Location:	<b>Other</b>	Tape/Media #:	
Purpose:	<b>Not Known</b>	Dia/Height:	<b>10"</b>
Use:	<b>Sanitary</b>	Material:	<b>VCP</b>
Drain Area:	<b>NA</b>	Lining:	
Category:	<b>NA</b>		
Comment:

Location Details:		Direction of Survey:	<b>Downstream</b>
US MH:	<b>M-804-050</b>	DS MH:	<b>M-804-051</b>
		Total Length Surveyed (ft):	<b>6.8</b>

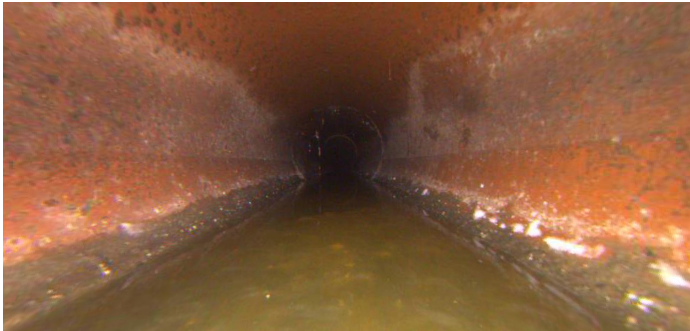
Code: AMH

Description: Manhole

Distance (ft): .0

Remarks: M-804-050

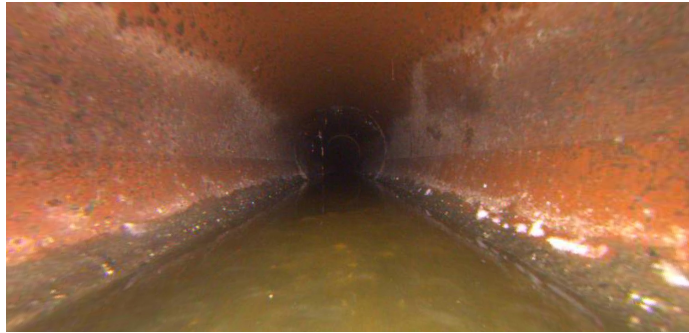
Code: **MWL**  
Description: **Water Level**

Distance (ft): **.0**  
Structural Grade: **0**  
O&M Grade: **0**  
Clock Start/From:  
Clock To:  
1st Value:  
2nd Value:  
Value Percent: **10.000**  
Continuous Index:  
Within 8" of Joint: **NO**  
Remarks:

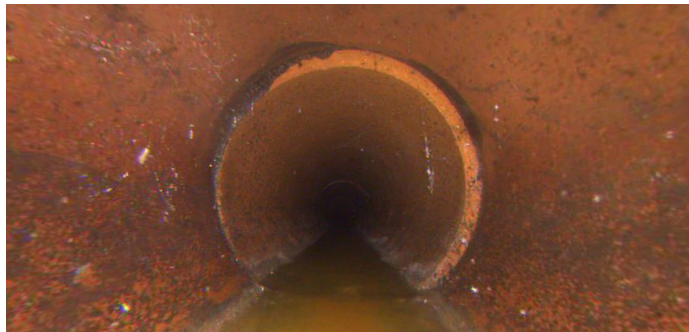
Code: **MSA**  
Description: **Abandoned Survey**

Distance (ft): **6.8**  
Structural Grade: **0**  
O&M Grade: **0**  
Clock Start/From:  
Clock To:  
1st Value:  
2nd Value:  
Value Percent:  
Continuous Index:  
Within 8" of Joint: **NO**  
Remarks: **UNKNOWN**
