Profile/Photo Observation Report

Date:	10/04/2018	Weather:		Coding:	PACP 6.0
Pipe Length (ft):	277.3	Owner:	NA	Pre Clean:	Not Known
P.O.#:		Surveyor:	Justin Gonzales	PSR:	P-804-051-050
Customer:		Clean Date:	01/01/1900	Shape:	C

Street:	N OHIO ST	Flow Control:	Not Controlled
City:	Hobart, IN	Year Renewed:	
Location:	Light Highway	Tape/Media #:	
Purpose:	Routine Assessment	Dia/Height:	12"
Use:	Sanitary	Material:	VCP
Drain Area:	NA	Lining:	
Category:	NA		
Comment:

Location Details:		Direction of Survey:	Downstream
US MH:	M-804-050	DS MH:	M-804-051
		Total Length Surveyed (ft):	159.5

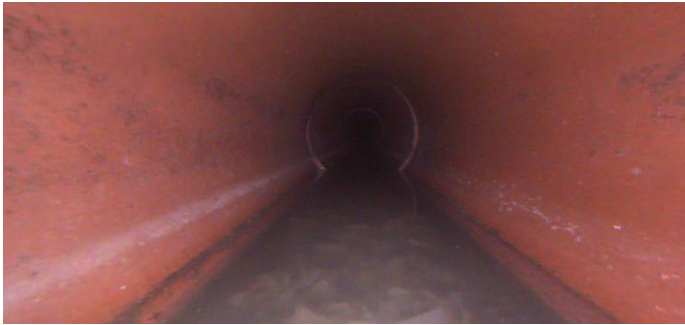
Code:	MWL
Description:	Water Level

Distance (ft):	.0
Structural Grade:	0
O&M Grade:	0
Clock Start/From:	
Clock To:	
1st Value:	
2nd Value:	
Value Percent:	10.000
Continuous Index:	
Within 8" of Joint:	NO
Remarks:

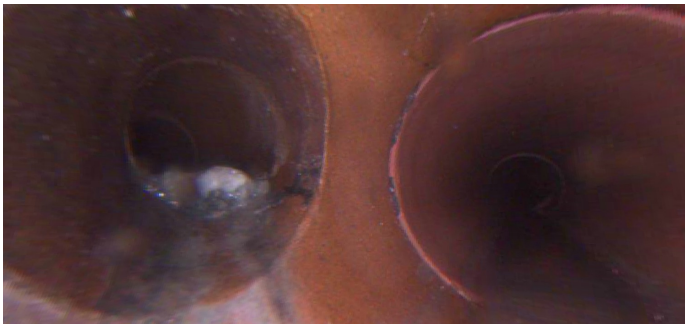
Code:	TF
Description:	Tap Factory

Distance (ft):	65.0
Structural Grade:	0
O&M Grade:	0
Clock Start/From:	9
Clock To:	
1st Value:	4.000
2nd Value:	
Value Percent:	
Continuous Index:	
Within 8" of Joint:	
Remarks:

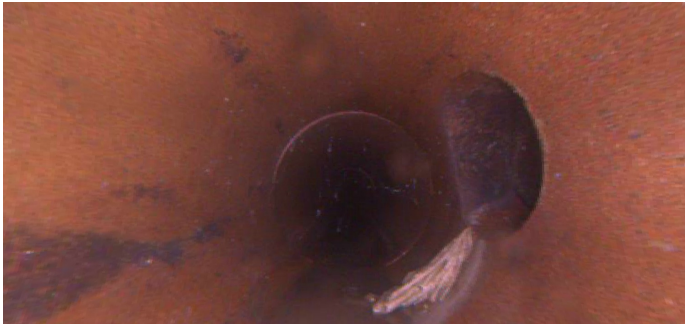
Code: **TF**
Description: **Tap Factory**

Distance (ft): **70.5**
Structural Grade: **0**
O&M Grade: **0**
Clock Start/From: **3**
Clock To:
1st Value: **4.000**
2nd Value:
Value Percent:
Continuous Index:
Within 8" of Joint:
Remarks:

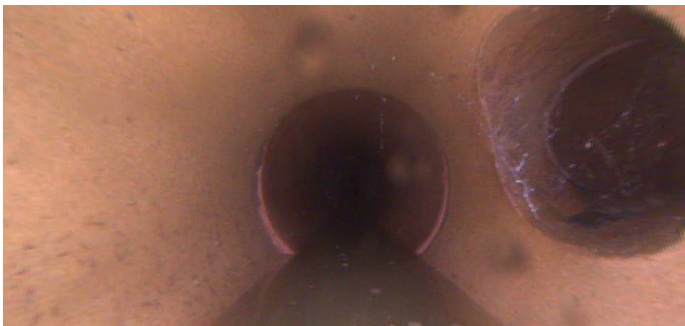
Code: **TF**
Description: **Tap Factory**

Distance (ft): **101.5**
Structural Grade: **0**
O&M Grade: **0**
Clock Start/From: **3**
Clock To:
1st Value: **4.000**
2nd Value:
Value Percent:
Continuous Index:
Within 8" of Joint:
Remarks:

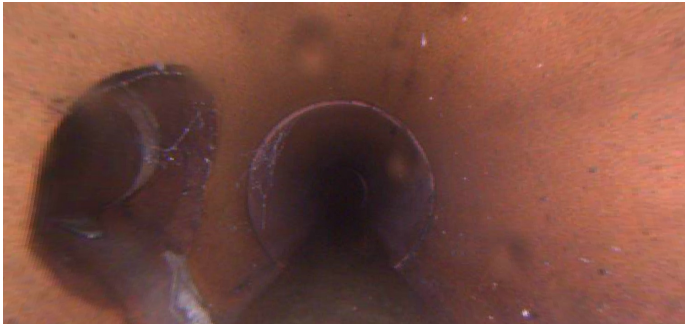
Code: **TF**
Description: **Tap Factory**

Distance (ft): **124.0**
Structural Grade: **0**
O&M Grade: **0**
Clock Start/From: **9**
Clock To:
1st Value: **4.000**
2nd Value:
Value Percent:
Continuous Index:
Within 8" of Joint:
Remarks:

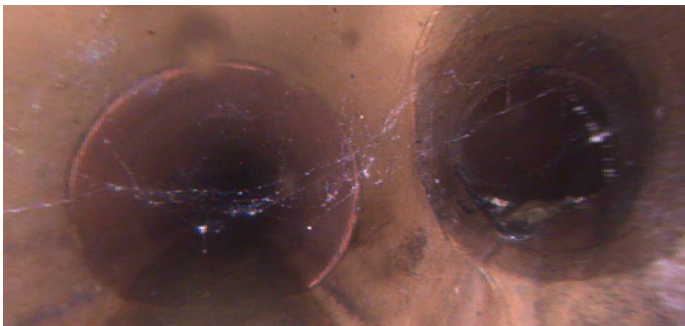
Code: **TF**
Description: **Tap Factory**

Distance (ft): **134.7**
Structural Grade: **0**
O&M Grade: **0**
Clock Start/From: **3**
Clock To:
1st Value: **4.000**
2nd Value:
Value Percent:
Continuous Index:
Within 8" of Joint:
Remarks:

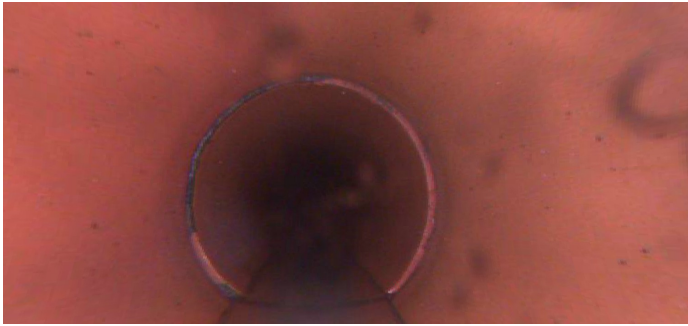
Code:	MSA
Description:	Abandoned Survey
Distance (ft):	159.5
Structural Grade:	0
O&M Grade:	0
Clock Start/From:	
Clock To:	
1st Value:	
2nd Value:	
Value Percent:	
Continuous Index:	
Within 8" of Joint:	NO
Remarks:	ROBOT HAAS STOPPED
