Profile/Photo Observation Report

Street:	Ohio St.	Flow Control:	Not Controlled
City:	Hobart, IN	Year Renewed:	
Location:	Light Highway	Tape/Media #:	
Purpose:	Routine Assessment	Dia/Height:	12"
Use:	Sanitary	Material:	VCP
Drain Area:	NA	Lining:	
Category:	NA		
Comment:

Location Details:		Direction of Survey:	Downstream
US MH:	M-804-050	DS MH:	M-804-051
		Total Length Surveyed (ft):	159.5

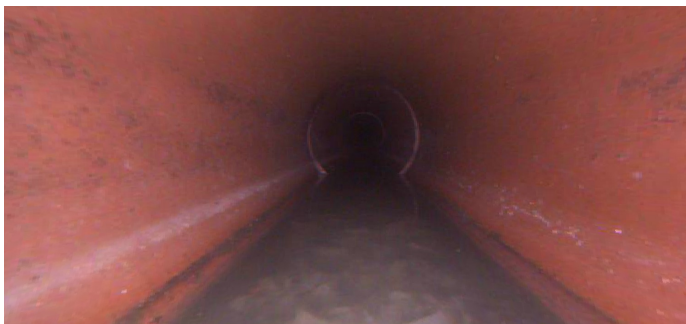
Code: **AMH**
Description: **Manhole**

Distance (ft): **.0**
Structural Grade: **0**
O&M Grade: **0**
Clock Start/From:
Clock To:
1st Value:
2nd Value:
Value Percent:
Continuous Index:
Within 8" of Joint: **NO**
Remarks: **M-804-050**

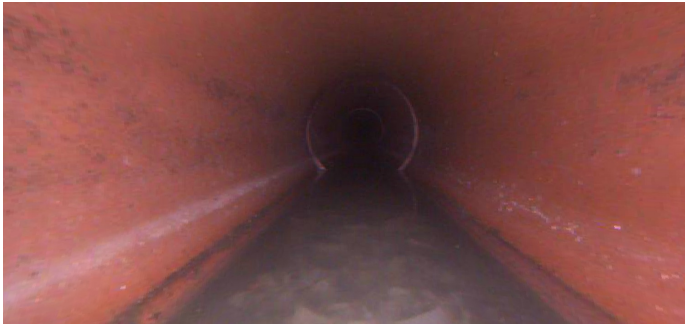
Code:	MWL
Description:	Water Level

Distance (ft):	.0
Structural Grade:	0
O&M Grade:	0
Clock Start/From:	
Clock To:	
1st Value:	
2nd Value:	
Value Percent:	10.000
Continuous Index:	
Within 8" of Joint:	NO
Remarks:

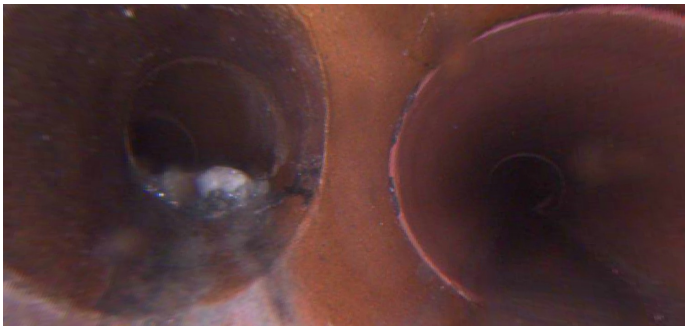
Code:	TF
Description:	Tap Factory

Distance (ft):	65.0
Structural Grade:	0
O&M Grade:	0
Clock Start/From:	9
Clock To:	
1st Value:	4.000
2nd Value:	
Value Percent:	
Continuous Index:	
Within 8" of Joint:	
Remarks:

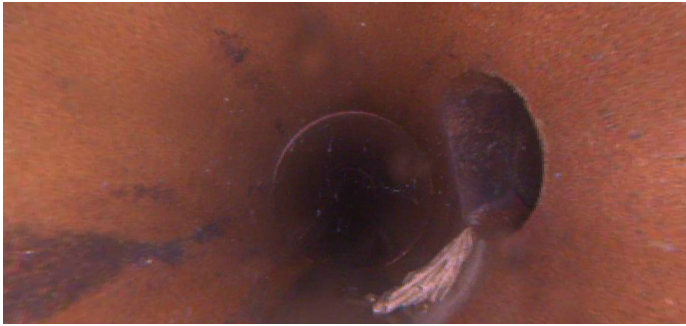
Code: **TF**
Description: **Tap Factory**

Distance (ft): **70.5**
Structural Grade: **0**
O&M Grade: **0**
Clock Start/From: **3**
Clock To:
1st Value: **4.000**
2nd Value:
Value Percent:
Continuous Index:
Within 8" of Joint:
Remarks:

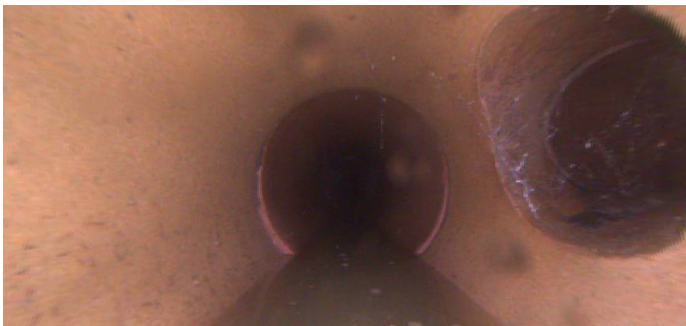
Code: **TF**
Description: **Tap Factory**

Distance (ft): **101.5**
Structural Grade: **0**
O&M Grade: **0**
Clock Start/From: **3**
Clock To:
1st Value: **4.000**
2nd Value:
Value Percent:
Continuous Index:
Within 8" of Joint:
Remarks:

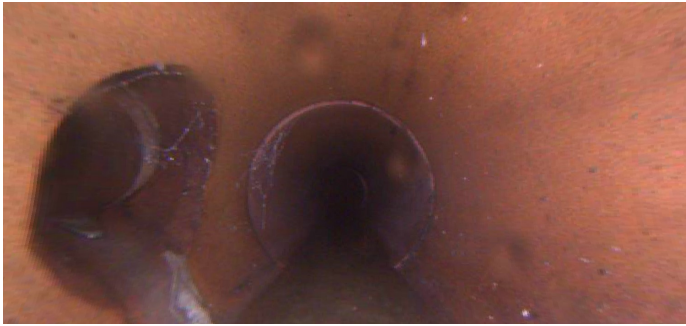
Code: **TF**
Description: **Tap Factory**

Distance (ft): **124.0**
Structural Grade: **0**
O&M Grade: **0**
Clock Start/From: **9**
Clock To:
1st Value: **4.000**
2nd Value:
Value Percent:
Continuous Index:
Within 8" of Joint:
Remarks:

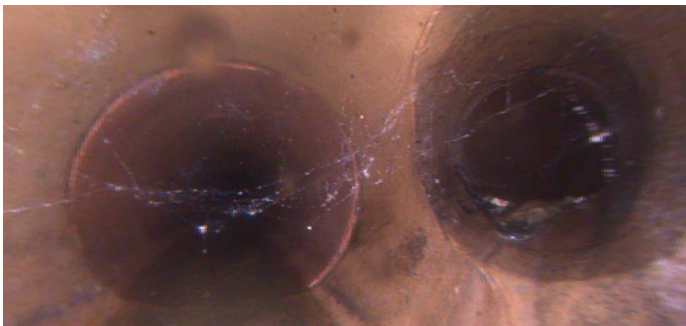
Code: **TF**
Description: **Tap Factory**

Distance (ft): **134.7**
Structural Grade: **0**
O&M Grade: **0**
Clock Start/From: **3**
Clock To:
1st Value: **4.000**
2nd Value:
Value Percent:
Continuous Index:
Within 8" of Joint:
Remarks:

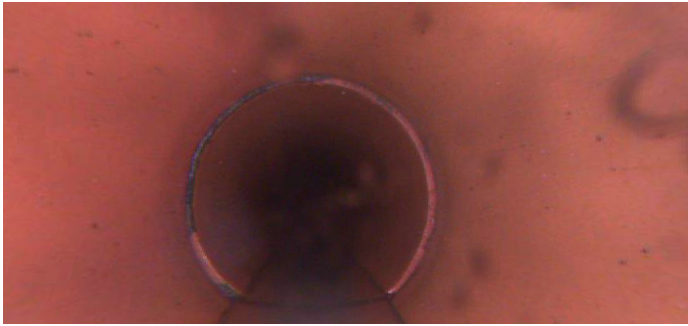
Code:	MSA
Description:	Abandoned Survey
Distance (ft):	159.5
Structural Grade:	0
O&M Grade:	0
Clock Start/From:	
Clock To:	
1st Value:	
2nd Value:	
Value Percent:	
Continuous Index:	
Within 8" of Joint:	NO
Remarks:	ROBOT HAAS STOPPED
