Profile/Photo Observation Report

Date:	10/18/2021	Weather:		Coding:	PACP 7.0
Pipe Length (ft):	213.4	Owner:	City of Hobart	Pre Clean:	Heavy Cleaning
P.O.#:	YES502259	Surveyor:	S. Bucklin	PSR:	P-804-052-023
Customer:	City of Hobart	Clean Date:	10/15/2021	Shape:	C

Street:	North Kelly Street	Flow Control:	Not Controlled
City:	Hobart, IN	Year Renewed:	
Location:	Local rural streets with light traffic, t	Tape/Media #:	
Purpose:	Routine Assessment	Dia/Height:	12"
Use:	Sanitary Sewage Pipe	Material:	VCP
Drain Area:		Lining:	
Category:	NA		
Comment:			
Location Details:		Direction of Survey:	Downstream
US MH:	M-804-052	DS MH:	M-804-023
		Total Length Surveyed (ft):	213.4

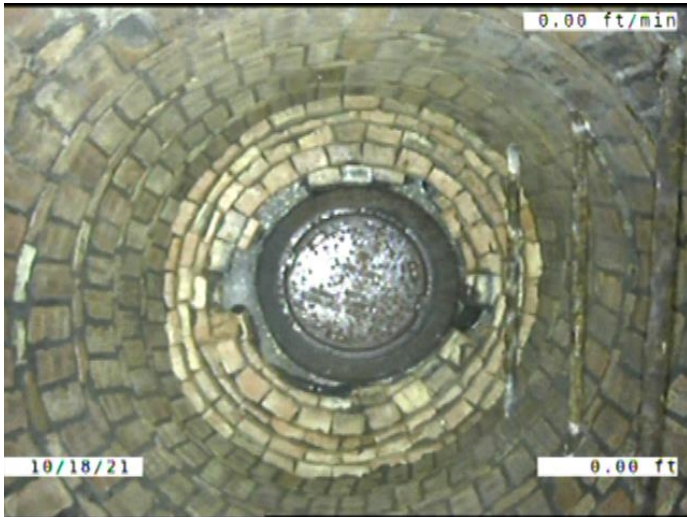
Code: **AMH**
 Description: **Manhole**

Distance (ft): **.0**
 Structural Grade: **0**
 O&M Grade: **0**
 Clock Start/From:
 Clock To:
 1st Value:
 2nd Value:
 Value Percent:
 Continuous Index:
 Within 8" of Joint: **NO**
 Remarks: **M-804-052**

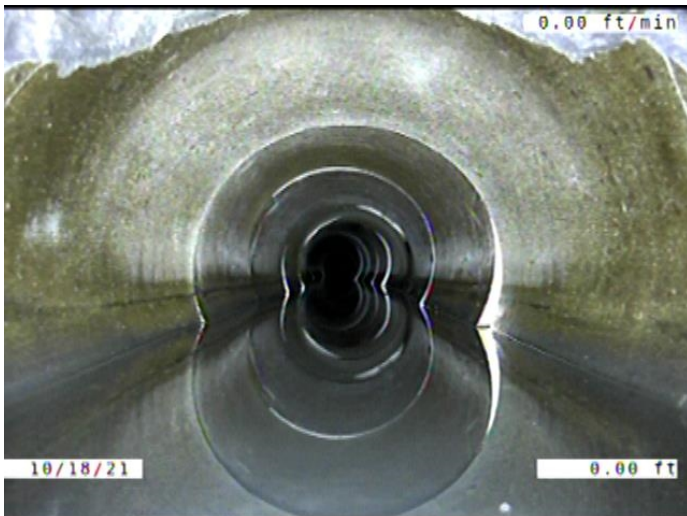
Code: **MWL**
 Description: **Miscellaneous Water Level**

Distance (ft): **.0**
 Structural Grade: **0**
 O&M Grade: **0**
 Clock Start/From:
 Clock To:
 1st Value:
 2nd Value:
 Value Percent: **10.000**
 Continuous Index:
 Within 8" of Joint: **NO**
 Remarks:

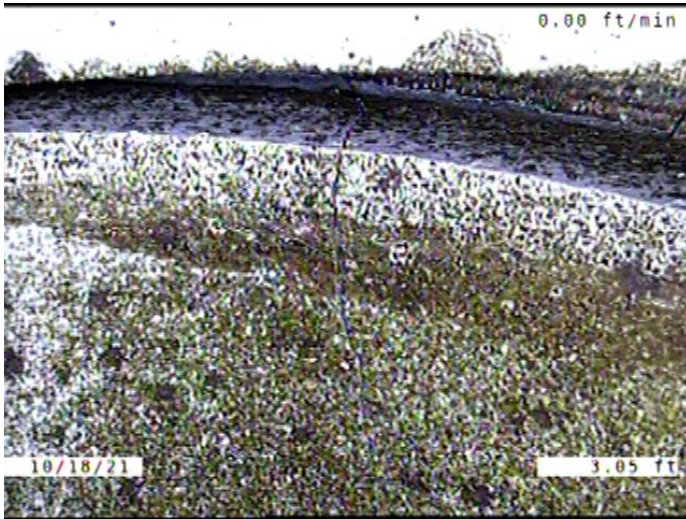
Code: **FM**
Description: **Fracture Multiple**

Distance (ft): **3.1**
Structural Grade: **4**
O&M Grade: **0**
Clock Start/From: **1**
Clock To: **3**
1st Value:
2nd Value:
Value Percent:
Continuous Index:
Within 8" of Joint: **YES**
Remarks:

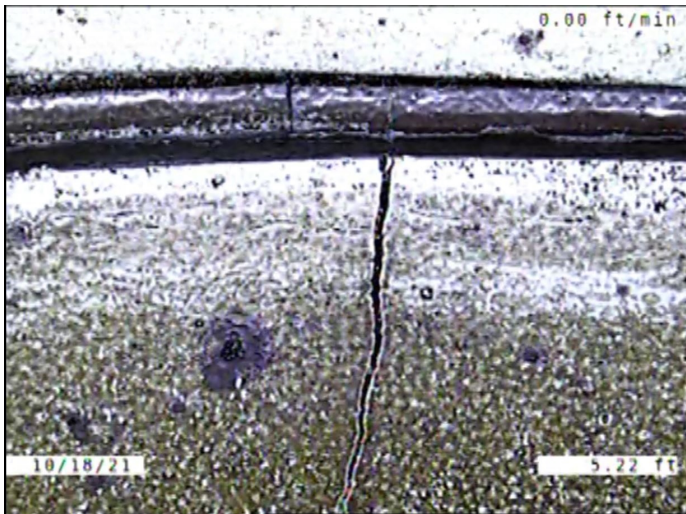
Code: **FL**
Description: **Fracture Longitudinal**

Distance (ft): **5.2**
Structural Grade: **3**
O&M Grade: **0**
Clock Start/From: **12**
Clock To:
1st Value:
2nd Value:
Value Percent:
Continuous Index:
Within 8" of Joint: **YES**
Remarks:

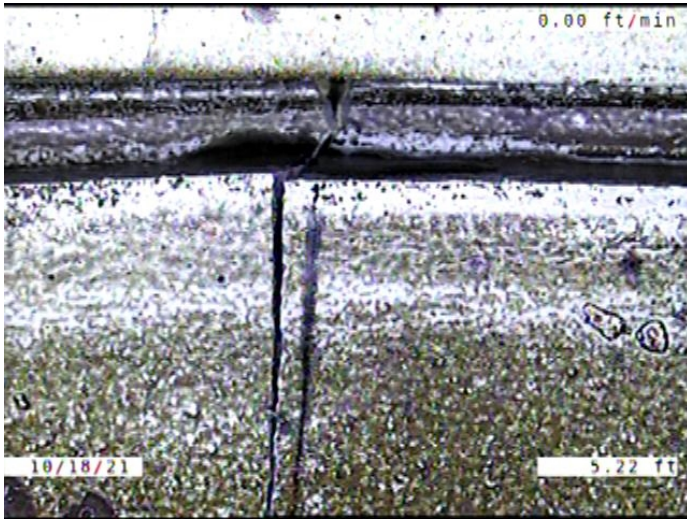
Code: **B**
 Description: **Broken**

Distance (ft): **5.2**
 Structural Grade: **4**
 O&M Grade: **0**
 Clock Start/From: **8**
 Clock To: **10**
 1st Value:
 2nd Value:
 Value Percent:
 Continuous Index:
 Within 8" of Joint: **YES**
 Remarks:

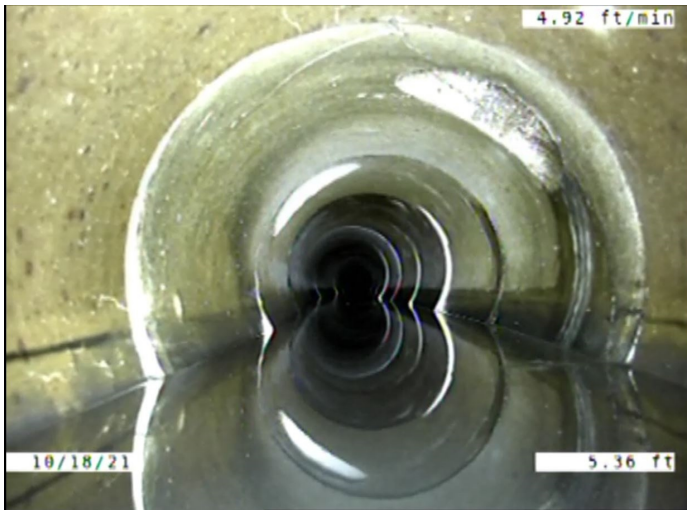
Code: **FM**
 Description: **Fracture Multiple**

Distance (ft): **5.4**
 Structural Grade: **4**
 O&M Grade: **0**
 Clock Start/From: **8**
 Clock To: **4**
 1st Value:
 2nd Value:
 Value Percent:
 Continuous Index: **S04**
 Within 8" of Joint: **YES**
 Remarks: **Wandering**

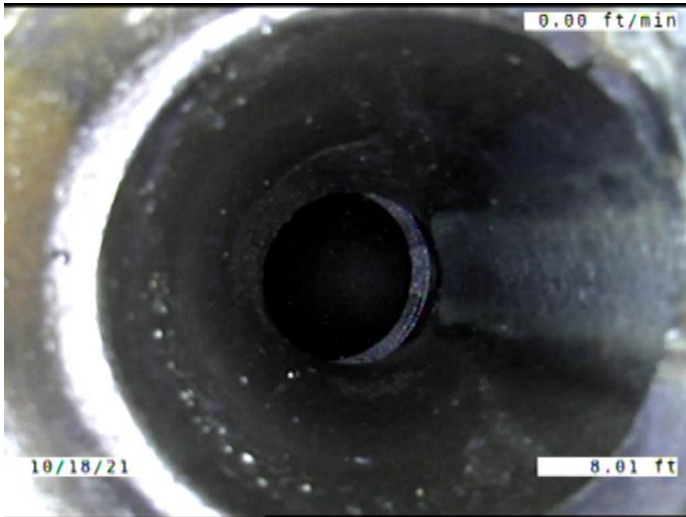
Code: **TFD**
Description: **Tap Factory Defective**

Distance (ft): **8.0**
Structural Grade: **0**
O&M Grade: **3**
Clock Start/From: **1**
Clock To:
1st Value: **4.000**
2nd Value:
Value Percent:
Continuous Index:
Within 8" of Joint: **YES**
Remarks: **Defective**

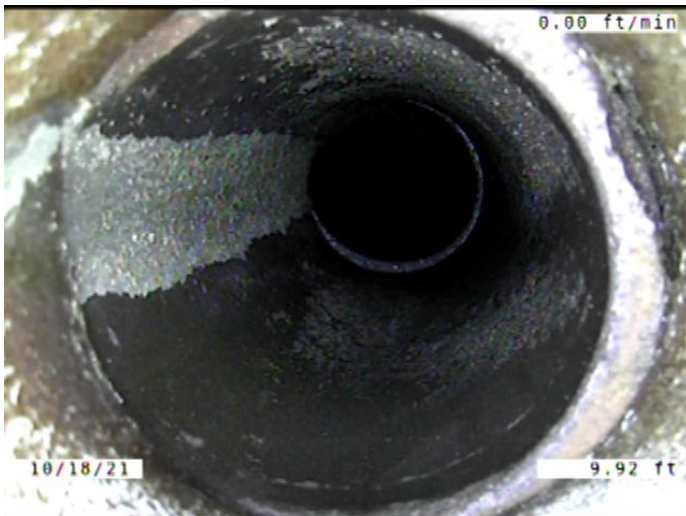
Code: **TF**
Description: **Tap Factory**

Distance (ft): **9.9**
Structural Grade: **0**
O&M Grade: **0**
Clock Start/From: **11**
Clock To:
1st Value: **4.000**
2nd Value:
Value Percent:
Continuous Index:
Within 8" of Joint: **YES**
Remarks:

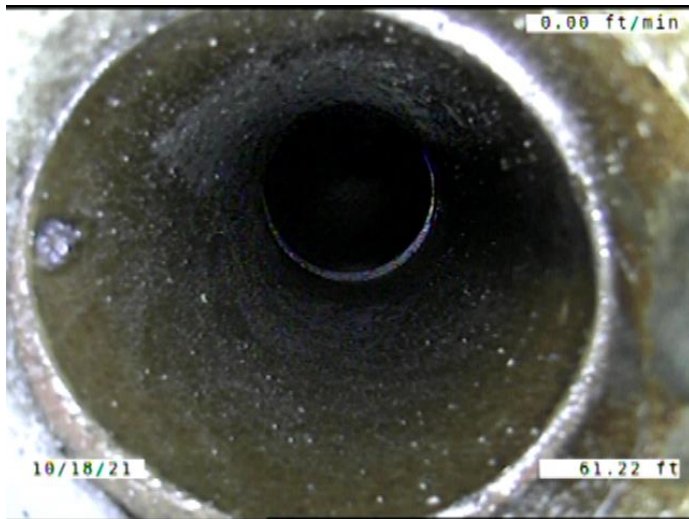
Code: **TFD**
Description: **Tap Factory Defective**

Distance (ft): **61.2**
Structural Grade: **0**
O&M Grade: **3**
Clock Start/From: **1**
Clock To:
1st Value: **4.000**
2nd Value:
Value Percent:
Continuous Index:
Within 8" of Joint: **YES**
Remarks: **Defective**

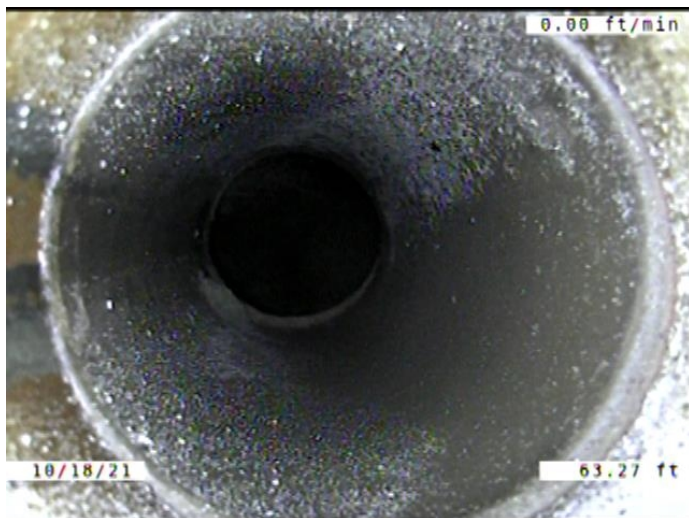
Code: **TF**
Description: **Tap Factory**

Distance (ft): **63.3**
Structural Grade: **0**
O&M Grade: **0**
Clock Start/From: **11**
Clock To:
1st Value: **4.000**
2nd Value:
Value Percent:
Continuous Index:
Within 8" of Joint: **YES**
Remarks:

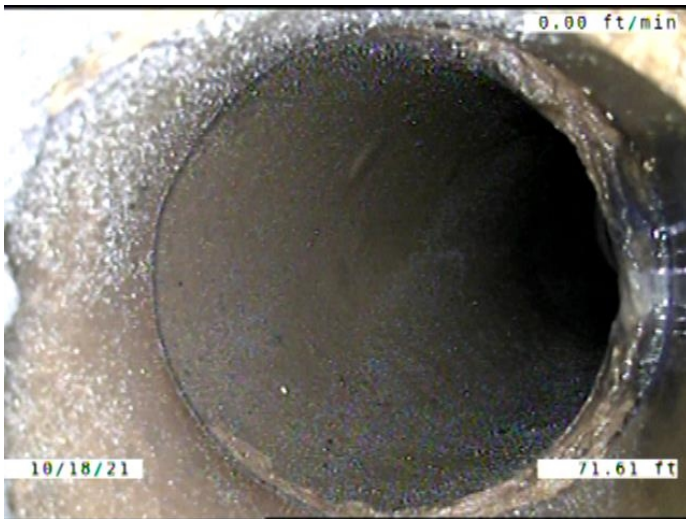
Code: **TB**
 Description: **Tap Break-in/Hammer**

Distance (ft): **71.6**
 Structural Grade: **0**
 O&M Grade: **0**
 Clock Start/From: **2**
 Clock To:
 1st Value: **4.000**
 2nd Value:
 Value Percent:
 Continuous Index:
 Within 8" of Joint: **YES**
 Remarks:

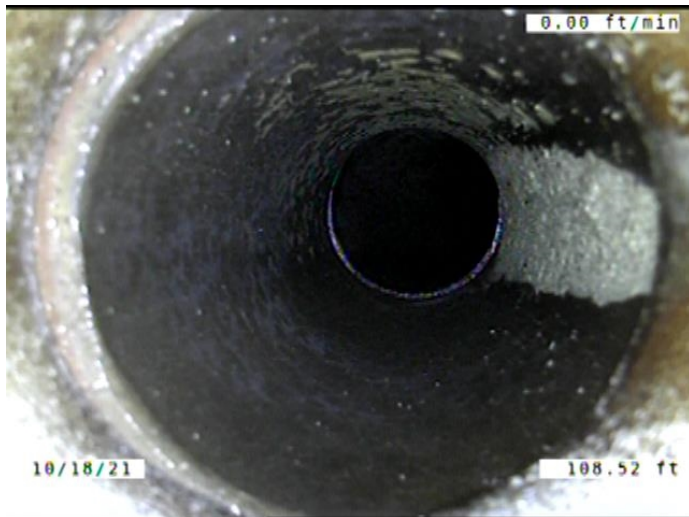
Code: **TF**
Description: **Tap Factory**

Distance (ft): **108.5**
Structural Grade: **0**
O&M Grade: **0**
Clock Start/From: **1**
Clock To:
1st Value: **4.000**
2nd Value:
Value Percent:
Continuous Index:
Within 8" of Joint: **YES**
Remarks:

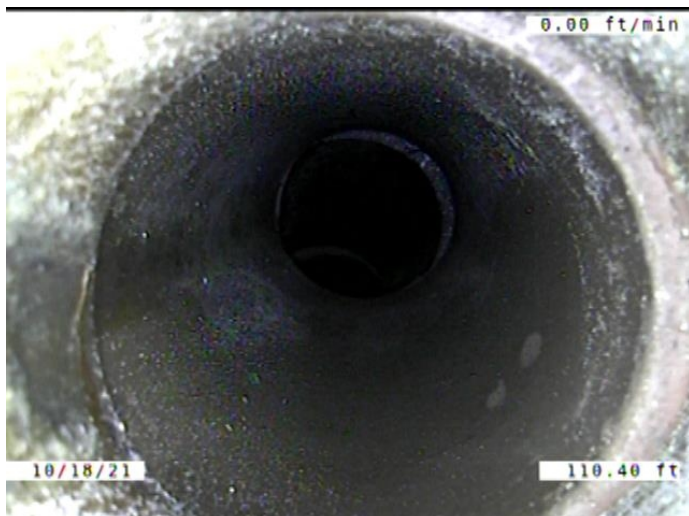
Code: **TF**
Description: **Tap Factory**

Distance (ft): **110.4**
Structural Grade: **0**
O&M Grade: **0**
Clock Start/From: **11**
Clock To:
1st Value: **4.000**
2nd Value:
Value Percent:
Continuous Index:
Within 8" of Joint: **YES**
Remarks:

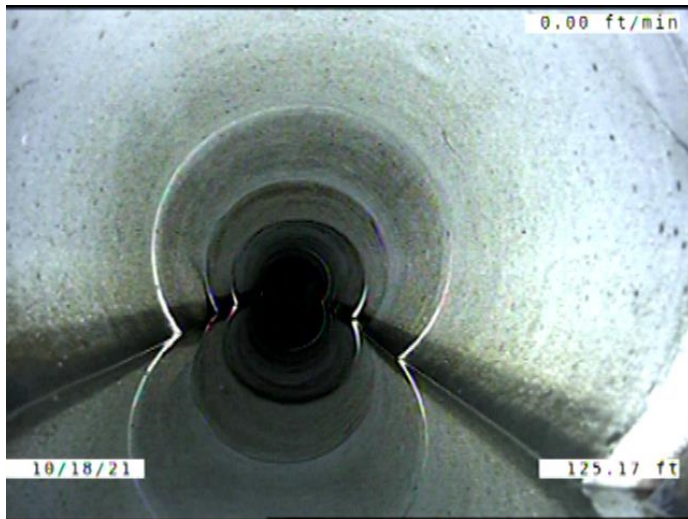
Code: **DSF**
 Description: **Deposits Settled Fine**

Distance (ft): **125.2**
 Structural Grade: **0**
 O&M Grade: **2**
 Clock Start/From: **4**
 Clock To: **8**
 1st Value:
 2nd Value:
 Value Percent: **10.000**
 Continuous Index: **F02**
 Within 8" of Joint: **YES**
 Remarks:

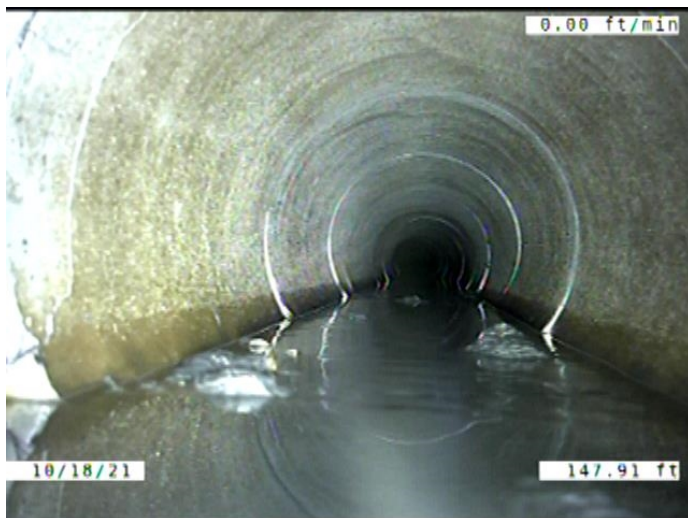
Code: **DSF**
 Description: **Deposits Settled Fine**

Distance (ft): **147.9**
 Structural Grade: **0**
 O&M Grade: **2**
 Clock Start/From: **4**
 Clock To: **8**
 1st Value:
 2nd Value:
 Value Percent: **10.000**
 Continuous Index: **S03**
 Within 8" of Joint: **YES**
 Remarks:

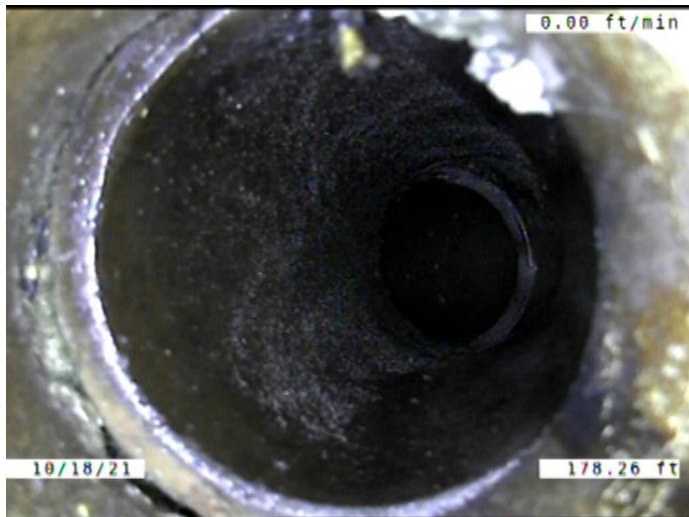
Code: **TFD**
 Description: **Tap Factory Defective**

Distance (ft): **178.3**
 Structural Grade: **0**
 O&M Grade: **3**
 Clock Start/From: **1**
 Clock To:
 1st Value: **4.000**
 2nd Value:
 Value Percent:
 Continuous Index:
 Within 8" of Joint: **YES**
 Remarks: **Defective**

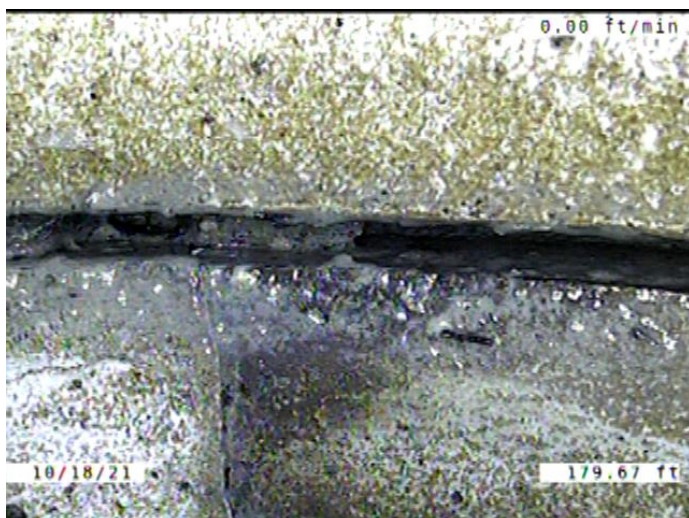
Code: **ISJ**
 Description: **Infiltration Stain Joint**

Distance (ft): **179.7**
 Structural Grade: **0**
 O&M Grade: **1**
 Clock Start/From: **1**
 Clock To: **4**
 1st Value:
 2nd Value:
 Value Percent:
 Continuous Index:
 Within 8" of Joint: **YES**
 Remarks:

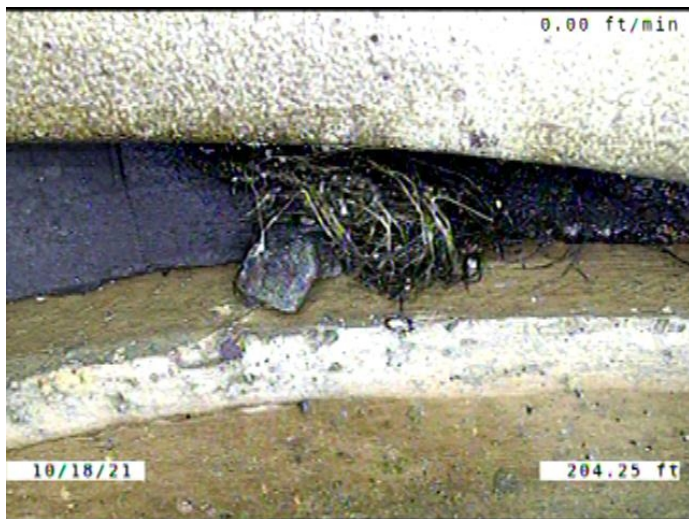
Code: **RFJ**
 Description: **Roots Fine Joint**

Distance (ft): **204.2**
 Structural Grade: **0**
 O&M Grade: **1**
 Clock Start/From: **4**
 Clock To: **5**
 1st Value:
 2nd Value:
 Value Percent:
 Continuous Index:
 Within 8" of Joint: **YES**
 Remarks:

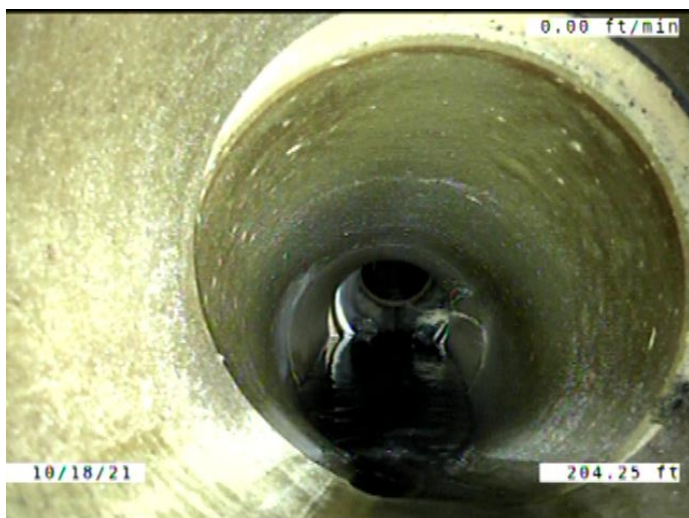
Code: **LLD**
 Description: **Line Left Down**

Distance (ft): **204.2**
 Structural Grade: **0**
 O&M Grade: **2**
 Clock Start/From:
 Clock To:
 1st Value:
 2nd Value:
 Value Percent: **15.000**
 Continuous Index:
 Within 8" of Joint: **NO**
 Remarks:

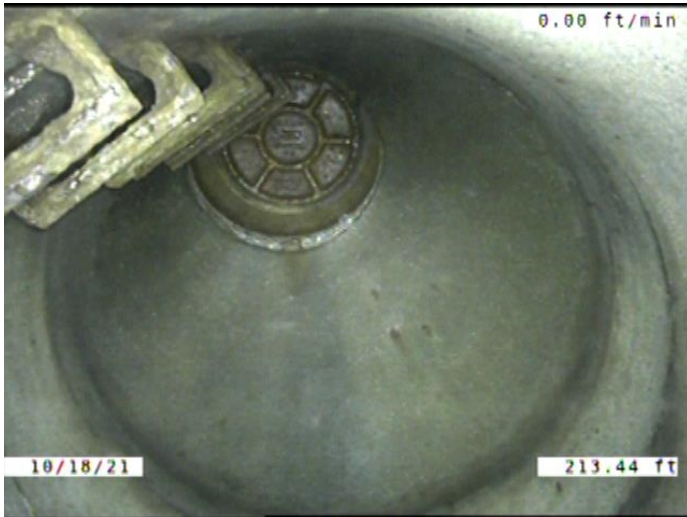
Code:	AMH
Description:	Manhole
Distance (ft):	213.4
Structural Grade:	0
O&M Grade:	0
Clock Start/From:	
Clock To:	
1st Value:	
2nd Value:	
Value Percent:	
Continuous Index:	
Within 8" of Joint:	NO
Remarks:	M-804-023
