## Profile/Photo Observation Report

Date:	<b>10/18/2021</b>	Weather:		Coding:	<b>PACP 7.0</b>
Pipe Length (ft):	<b>213.4</b>	Owner:	<b>City of Hobart</b>	Pre Clean:	<b>Heavy Cleaning</b>
P.O.#:	<b>YES502259</b>	Surveyor:	<b>S. Bucklin</b>	PSR:	<b>P-804-052-023</b>
Customer:	<b>City of Hobart</b>	Clean Date:	<b>10/15/2021</b>	Shape:	<b>C</b>

Street:	<b>North Kelly Street</b>	Flow Control:	<b>Not Controlled</b>
City:	<b>Hobart, IN</b>	Year Renewed:	
Location:	<b>Local rural streets with light traffic, t</b>	Tape/Media #:	
Purpose:	<b>Routine Assessment</b>	Dia/Height:	<b>12"</b>
Use:	<b>Sanitary Sewage Pipe</b>	Material:	<b>VCP</b>
Drain Area:		Lining:	
Category:	<b>NA</b>		
Comment:			
Location Details:		Direction of Survey:	<b>Downstream</b>
US MH:	<b>M-804-052</b>	DS MH:	<b>M-804-023</b>
		Total Length Surveyed (ft):	<b>213.4</b>

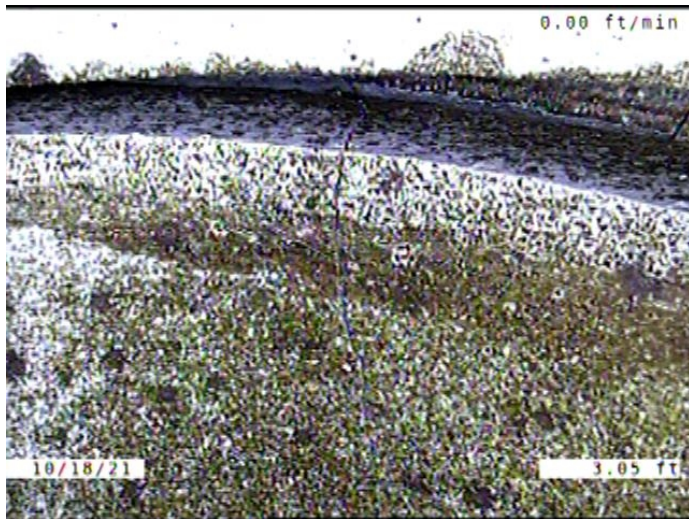
Code: **FM**  
 Description: **Fracture Multiple**

Distance (ft): **3.1**  
 Structural Grade: **4**  
 O&M Grade: **0**  
 Clock Start/From: **1**  
 Clock To: **3**  
 1st Value:  
 2nd Value:  
 Value Percent:  
 Continuous Index:  
 Within 8" of Joint: **YES**  
 Remarks:

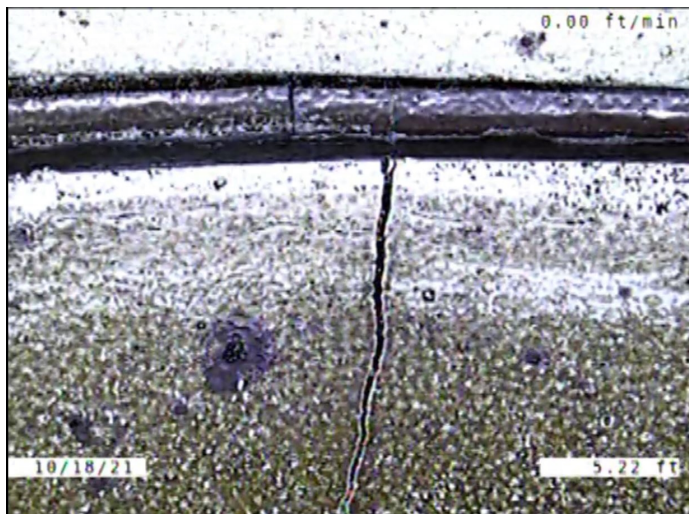
Code: **FL**  
 Description: **Fracture Longitudinal**

Distance (ft): **5.2**  
 Structural Grade: **3**  
 O&M Grade: **0**  
 Clock Start/From: **12**  
 Clock To:  
 1st Value:  
 2nd Value:  
 Value Percent:  
 Continuous Index:  
 Within 8" of Joint: **YES**  
 Remarks:

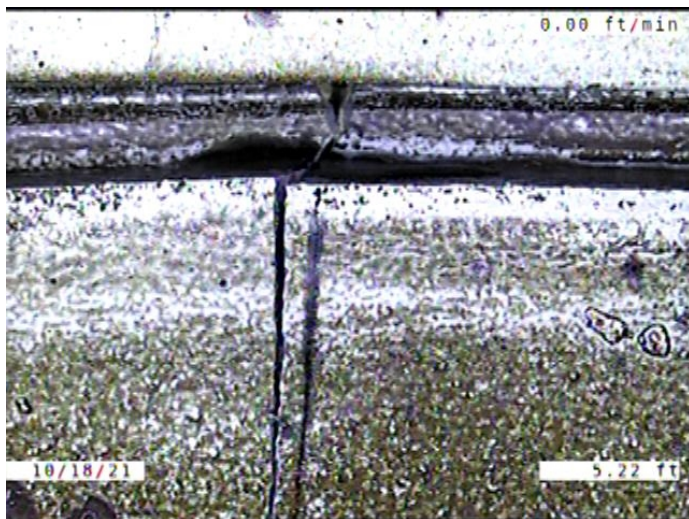
Code: **B**  
 Description: **Broken**

Distance (ft): **5.2**  
 Structural Grade: **4**  
 O&M Grade: **0**  
 Clock Start/From: **8**  
 Clock To: **10**  
 1st Value:  
 2nd Value:  
 Value Percent:  
 Continuous Index:  
 Within 8" of Joint: **YES**  
 Remarks:

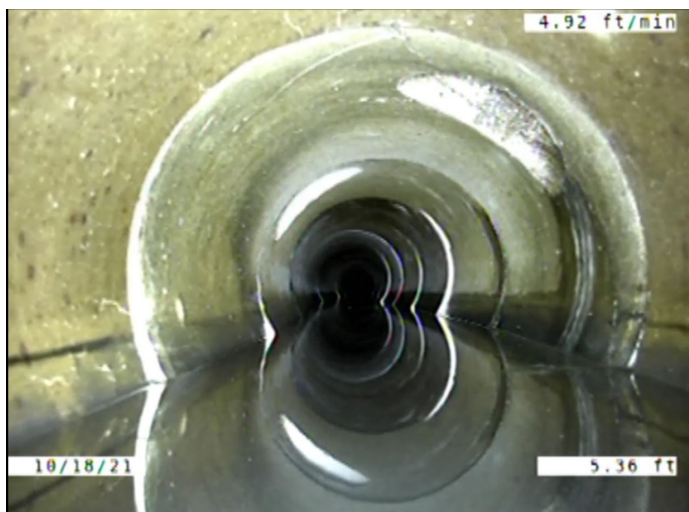
Code: **FM**  
 Description: **Fracture Multiple**

Distance (ft): **5.4**  
 Structural Grade: **4**  
 O&M Grade: **0**  
 Clock Start/From: **8**  
 Clock To: **4**  
 1st Value:  
 2nd Value:  
 Value Percent:  
 Continuous Index: **S04**  
 Within 8" of Joint: **YES**  
 Remarks: **Wandering**

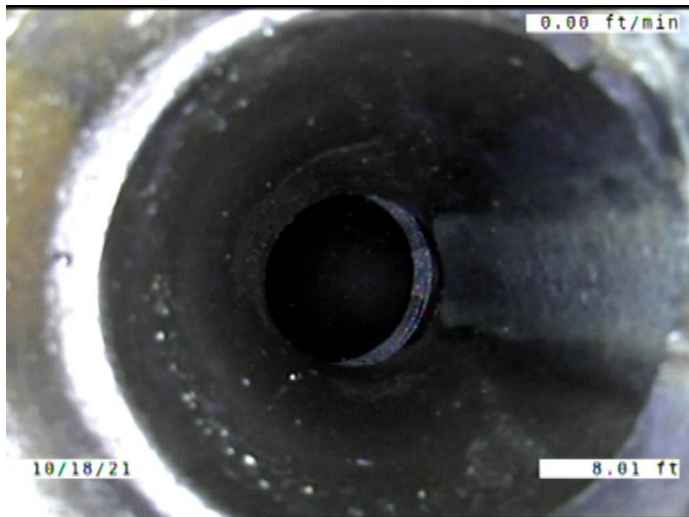
Code: **TFD**  
 Description: **Tap Factory Defective**

Distance (ft): **8.0**  
 Structural Grade: **0**  
 O&M Grade: **3**  
 Clock Start/From: **1**  
 Clock To:  
 1st Value: **4.000**  
 2nd Value:  
 Value Percent:  
 Continuous Index:  
 Within 8" of Joint: **YES**  
 Remarks: **Defective**

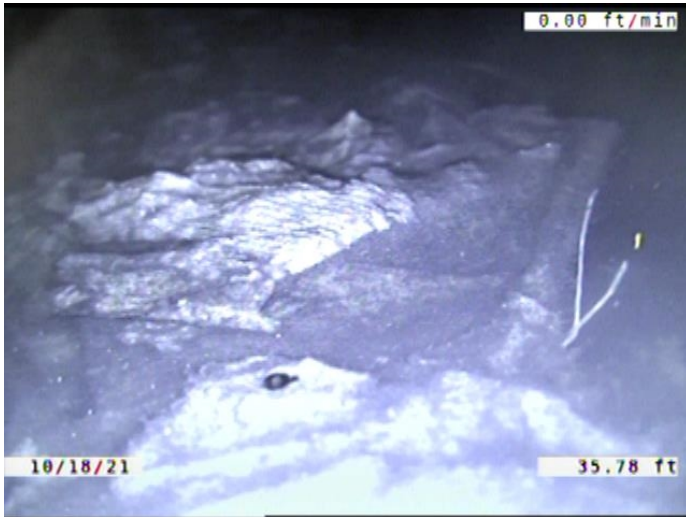
Code: **DAR**  
 Description: **Deposits Attached Ragging**

Distance (ft): **35.8**  
 Structural Grade: **0**  
 O&M Grade: **2**  
 Clock Start/From: **5**  
 Clock To: **7**  
 1st Value:  
 2nd Value:  
 Value Percent: **5.000**  
 Continuous Index:  
 Within 8" of Joint: **YES**  
 Remarks:

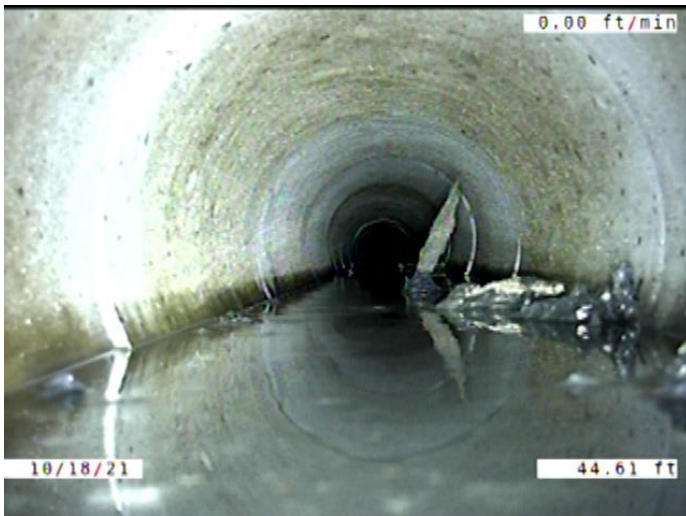
Code: **DSF**  
 Description: **Deposits Settled Fine**

Distance (ft): **44.6**  
 Structural Grade: **0**  
 O&M Grade: **2**  
 Clock Start/From: **4**  
 Clock To: **8**  
 1st Value:  
 2nd Value:  
 Value Percent: **10.000**  
 Continuous Index: **S02**  
 Within 8" of Joint: **YES**  
 Remarks:

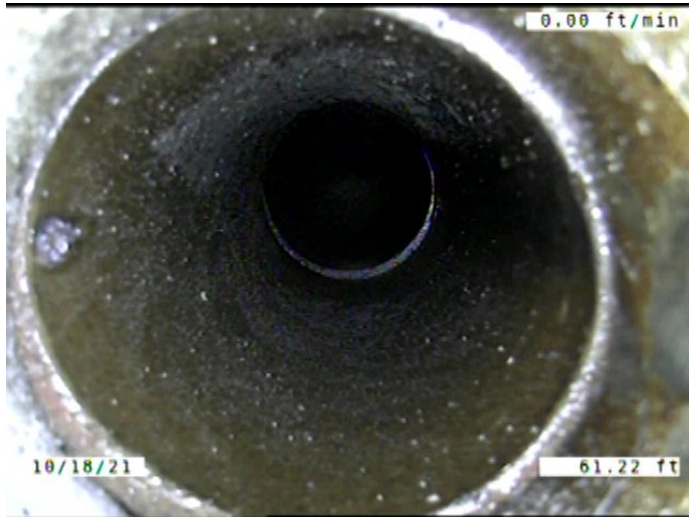
Code: **TFD**  
 Description: **Tap Factory Defective**

Distance (ft): **61.2**  
 Structural Grade: **0**  
 O&M Grade: **3**  
 Clock Start/From: **1**  
 Clock To:  
 1st Value: **4.000**  
 2nd Value:  
 Value Percent:  
 Continuous Index:  
 Within 8" of Joint: **YES**  
 Remarks: **Defective**

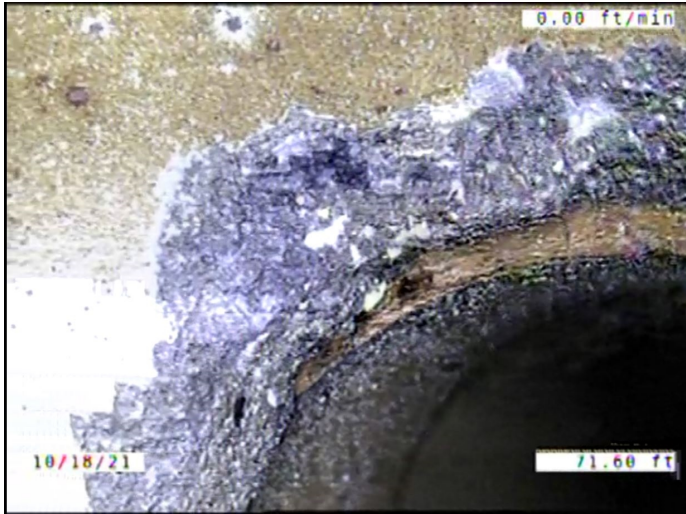
Code: **SSS**  
 Description: **Surface Damage Surface Spalling**

Distance (ft): **71.6**  
 Structural Grade: **2**  
 O&M Grade: **0**  
 Clock Start/From: **1**  
 Clock To: **2**  
 1st Value:  
 2nd Value:  
 Value Percent:  
 Continuous Index:  
 Within 8" of Joint: **NO**  
 Remarks:

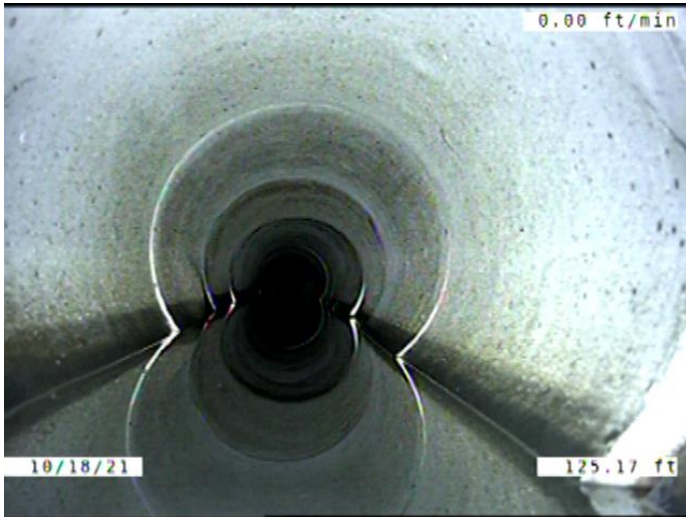
Code: **DSF**  
 Description: **Deposits Settled Fine**

Distance (ft): **125.2**  
 Structural Grade: **0**  
 O&M Grade: **2**  
 Clock Start/From: **4**  
 Clock To: **8**  
 1st Value:  
 2nd Value:  
 Value Percent: **10.000**  
 Continuous Index: **F02**  
 Within 8" of Joint: **YES**  
 Remarks:

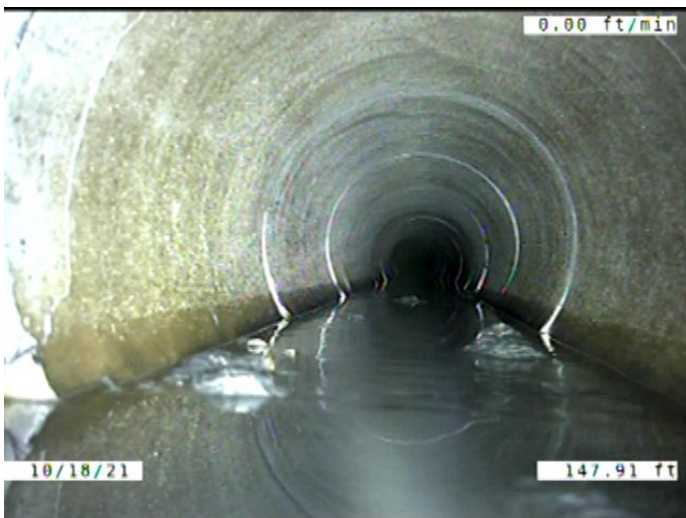
Code: **DSF**  
 Description: **Deposits Settled Fine**

Distance (ft): **147.9**  
 Structural Grade: **0**  
 O&M Grade: **2**  
 Clock Start/From: **4**  
 Clock To: **8**  
 1st Value:  
 2nd Value:  
 Value Percent: **10.000**  
 Continuous Index: **S03**  
 Within 8" of Joint: **YES**  
 Remarks:

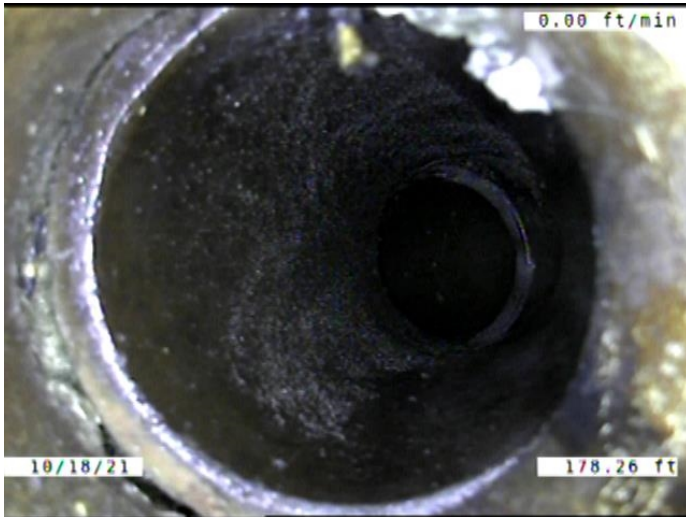
Code: **TFD**  
 Description: **Tap Factory Defective**

Distance (ft): **178.3**  
 Structural Grade: **0**  
 O&M Grade: **3**  
 Clock Start/From: **1**  
 Clock To:  
 1st Value: **4.000**  
 2nd Value:  
 Value Percent:  
 Continuous Index:  
 Within 8" of Joint: **YES**  
 Remarks: **Defective**

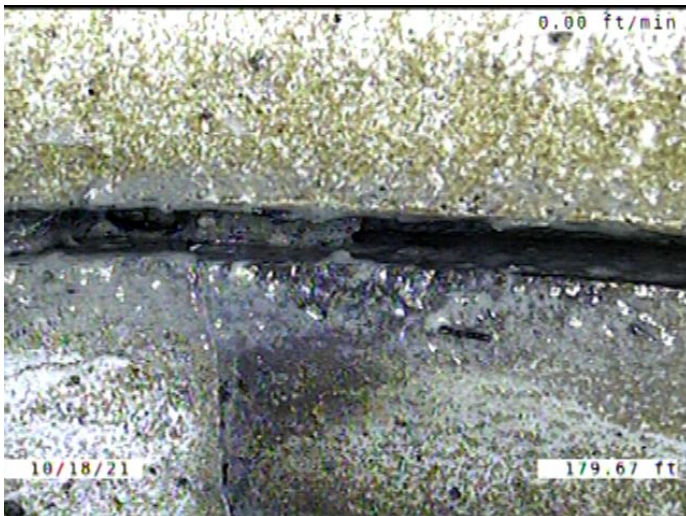
Code: **ISJ**  
 Description: **Infiltration Stain Joint**

Distance (ft): **179.7**  
 Structural Grade: **0**  
 O&M Grade: **1**  
 Clock Start/From: **1**  
 Clock To: **4**  
 1st Value:  
 2nd Value:  
 Value Percent:  
 Continuous Index:  
 Within 8" of Joint: **YES**  
 Remarks:

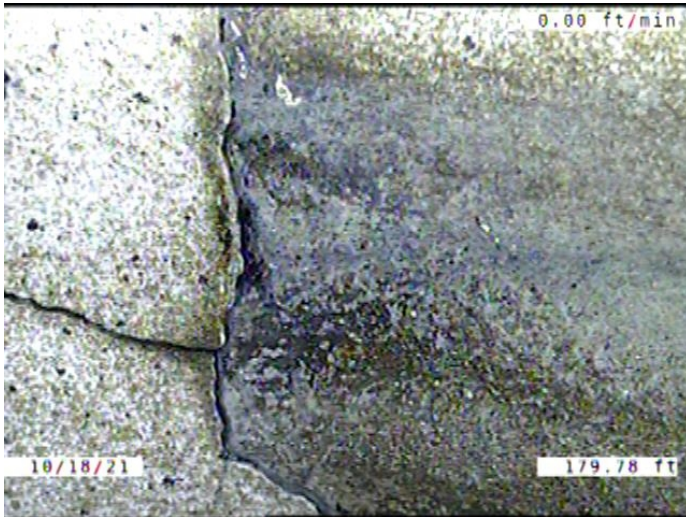
Code: **ISB**  
 Description: **Infiltration Stain Barrel**

Distance (ft): **179.8**  
 Structural Grade: **0**  
 O&M Grade: **1**  
 Clock Start/From: **2**  
 Clock To: **4**  
 1st Value:  
 2nd Value:  
 Value Percent:  
 Continuous Index:  
 Within 8" of Joint: **YES**  
 Remarks:

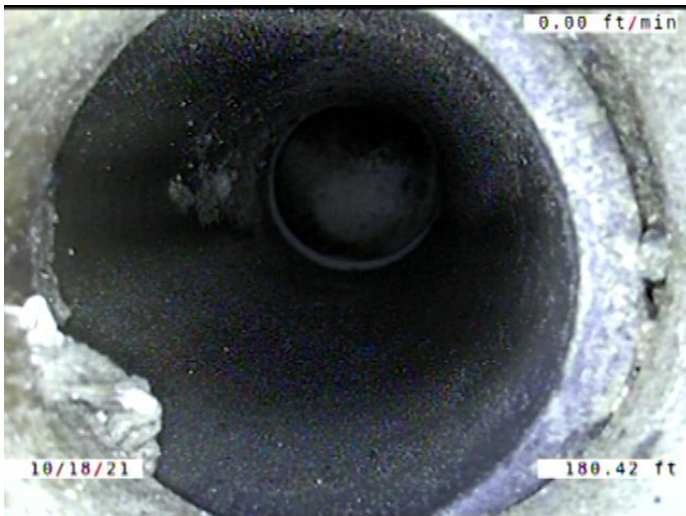
Code: **TFD**  
 Description: **Tap Factory Defective**

Distance (ft): **180.4**  
 Structural Grade: **0**  
 O&M Grade: **3**  
 Clock Start/From: **10**  
 Clock To:  
 1st Value: **4.000**  
 2nd Value:  
 Value Percent:  
 Continuous Index:  
 Within 8" of Joint: **YES**  
 Remarks: **Defective**

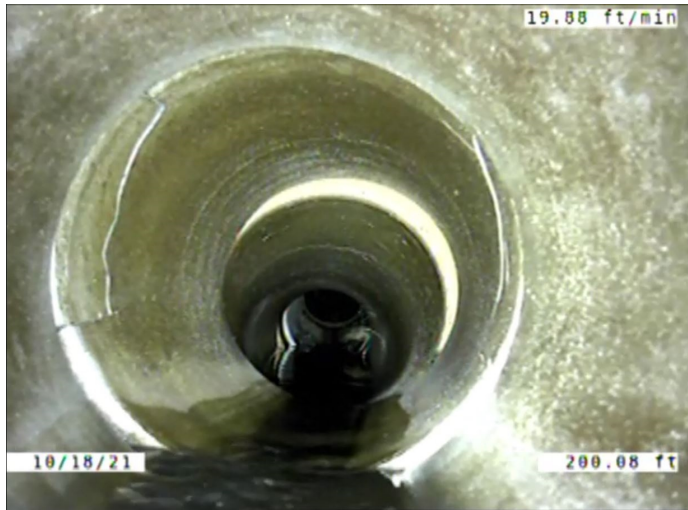
Code: **B**  
 Description: **Broken**

Distance (ft): **200.1**  
 Structural Grade: **4**  
 O&M Grade: **0**  
 Clock Start/From: **9**  
 Clock To: **1**  
 1st Value:  
 2nd Value:  
 Value Percent:  
 Continuous Index:  
 Within 8" of Joint: **YES**  
 Remarks:

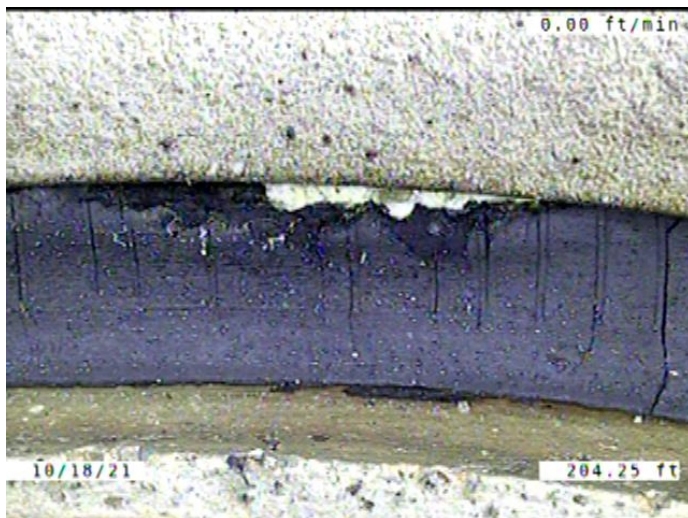
Code: **JAL**  
 Description: **Joint Angular Large**

Distance (ft): **204.2**  
 Structural Grade: **4**  
 O&M Grade: **0**  
 Clock Start/From:  
 Clock To:  
 1st Value:  
 2nd Value:  
 Value Percent:  
 Continuous Index:  
 Within 8" of Joint: **NO**  
 Remarks:

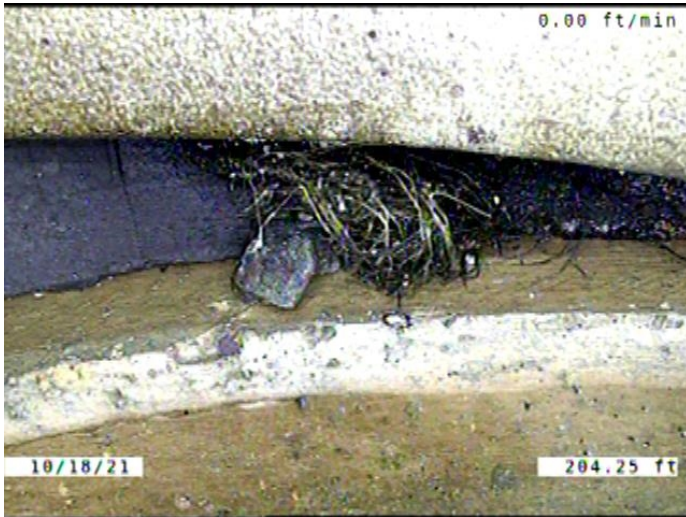
Code: **RFJ**  
 Description: **Roots Fine Joint**

Distance (ft): **204.2**  
 Structural Grade: **0**  
 O&M Grade: **1**  
 Clock Start/From: **4**  
 Clock To: **5**  
 1st Value:  
 2nd Value:  
 Value Percent:  
 Continuous Index:  
 Within 8" of Joint: **YES**  
 Remarks:

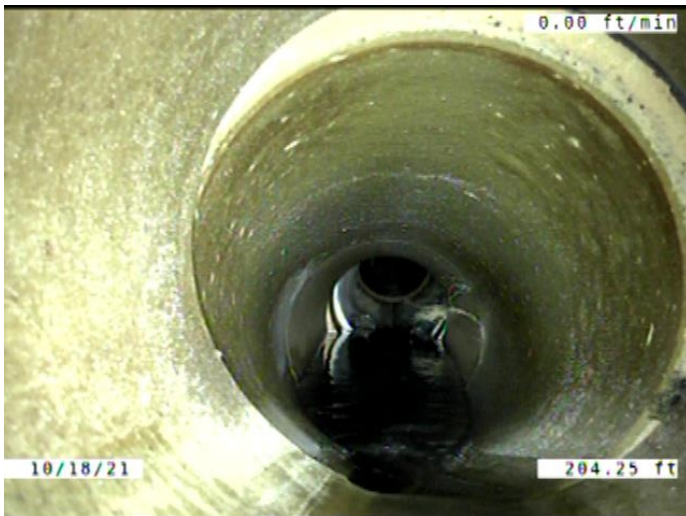
Code: **LLD**  
 Description: **Line Left Down**

Distance (ft): **204.2**  
 Structural Grade: **0**  
 O&M Grade: **2**  
 Clock Start/From:  
 Clock To:  
 1st Value:  
 2nd Value:  
 Value Percent: **15.000**  
 Continuous Index:  
 Within 8" of Joint: **NO**  
 Remarks:

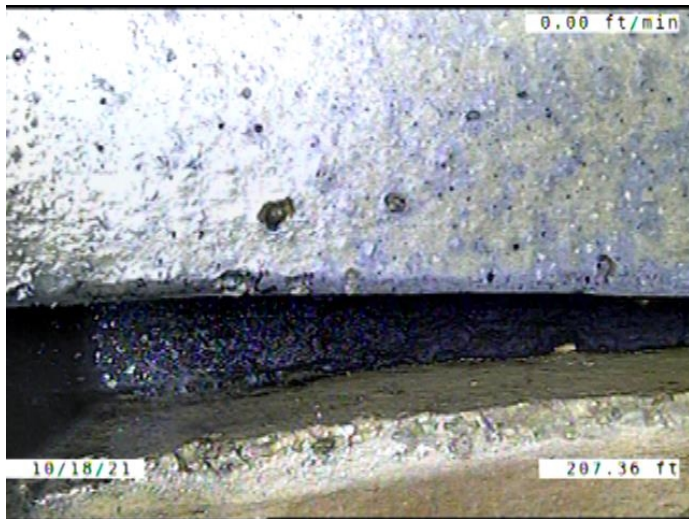
Code: **JAM**  
 Description: **Joint Angular Medium**

Distance (ft): **207.4**  
 Structural Grade: **3**  
 O&M Grade: **0**  
 Clock Start/From:  
 Clock To:  
 1st Value:  
 2nd Value:  
 Value Percent:  
 Continuous Index:  
 Within 8" of Joint: **NO**  
 Remarks:

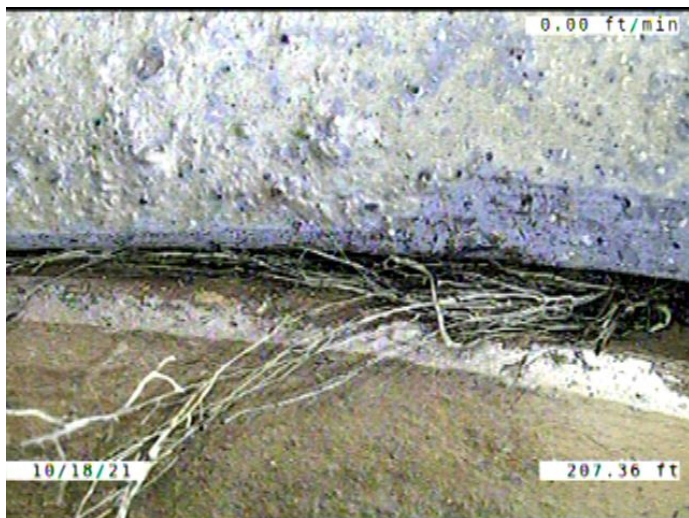
Code: **RFJ**  
 Description: **Roots Fine Joint**

Distance (ft): **207.4**  
 Structural Grade: **0**  
 O&M Grade: **1**  
 Clock Start/From: **1**  
 Clock To: **3**  
 1st Value:  
 2nd Value:  
 Value Percent:  
 Continuous Index:  
 Within 8" of Joint: **YES**  
 Remarks:

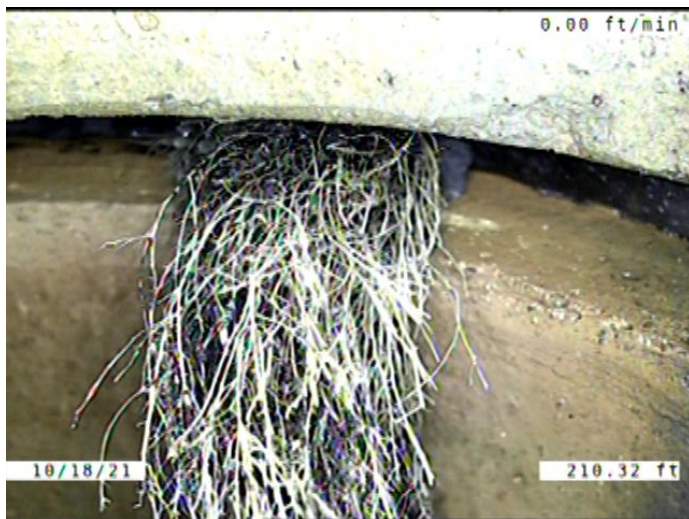
Code: **RFJ**  
 Description: **Roots Fine Joint**

Distance (ft): **210.3**  
 Structural Grade: **0**  
 O&M Grade: **1**  
 Clock Start/From: **2**  
 Clock To: **3**  
 1st Value:  
 2nd Value:  
 Value Percent:  
 Continuous Index:  
 Within 8" of Joint: **YES**  
 Remarks:

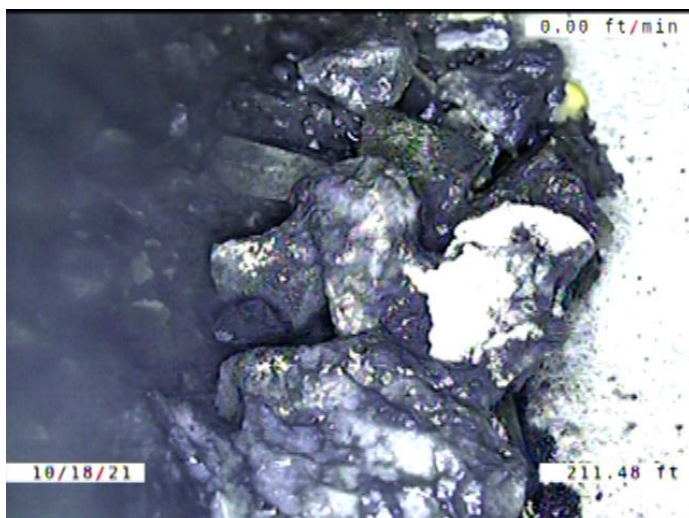
Code: **DSGV**  
 Description: **Deposits Settled Gravel**

Distance (ft): **211.5**  
 Structural Grade: **0**  
 O&M Grade: **2**  
 Clock Start/From: **5**  
 Clock To: **7**  
 1st Value:  
 2nd Value:  
 Value Percent: **5.000**  
 Continuous Index:  
 Within 8" of Joint: **YES**  
 Remarks:

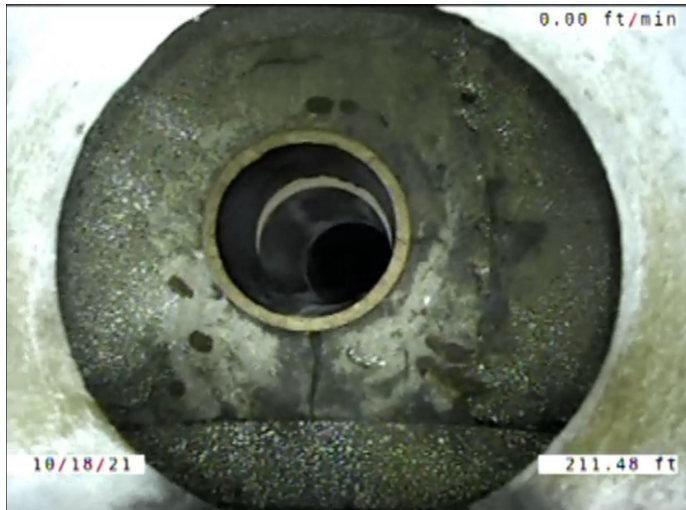
Code: **FM**  
 Description: **Fracture Multiple**

Distance (ft): **211.5**  
 Structural Grade: **4**  
 O&M Grade: **0**  
 Clock Start/From: **8**  
 Clock To: **4**  
 1st Value:  
 2nd Value:  
 Value Percent:  
 Continuous Index: **F04**  
 Within 8" of Joint: **YES**  
 Remarks: **Wandering**

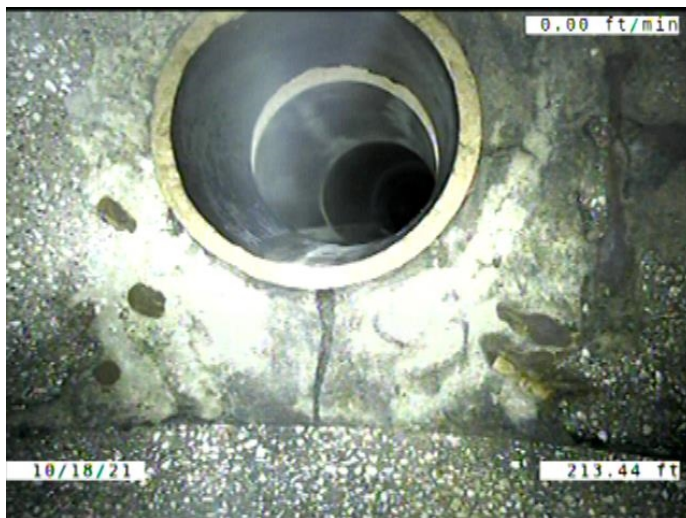
Code: **DSF**  
 Description: **Deposits Settled Fine**

Distance (ft): **213.4**  
 Structural Grade: **0**  
 O&M Grade: **2**  
 Clock Start/From: **4**  
 Clock To: **8**  
 1st Value:  
 2nd Value:  
 Value Percent: **10.000**  
 Continuous Index: **F03**  
 Within 8" of Joint: **YES**  
 Remarks:
