Profile/Photo Observation Report

Street:	N KELLY ST	Flow Control:	Not Controlled
City:	Hobart, IN	Year Renewed:	
Location:	Other	Tape/Media #:	
Purpose:	Not Known	Dia/Height:	12"
Use:	Sanitary	Material:	VCP
Drain Area:	NA	Lining:	
Category:	NA		
Comment:

Location Details:		Direction of Survey:	Downstream
US MH:	M-804-053	DS MH:	M-804-052
		Total Length Surveyed (ft):	4.9

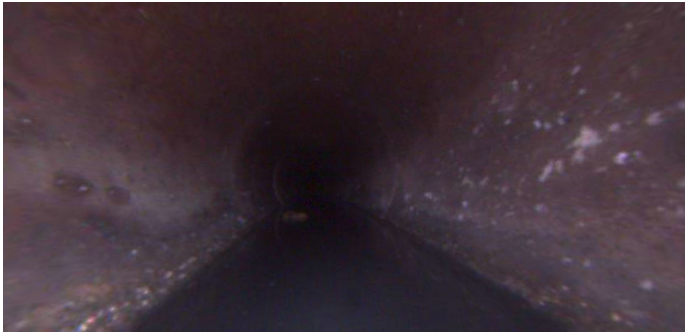
Code:	MWL
Description:	Water Level

Distance (ft):	.0
Structural Grade:	0
O&M Grade:	0
Clock Start/From:	
Clock To:	
1st Value:	
2nd Value:	
Value Percent:	10.000
Continuous Index:	
Within 8" of Joint:	NO
Remarks:

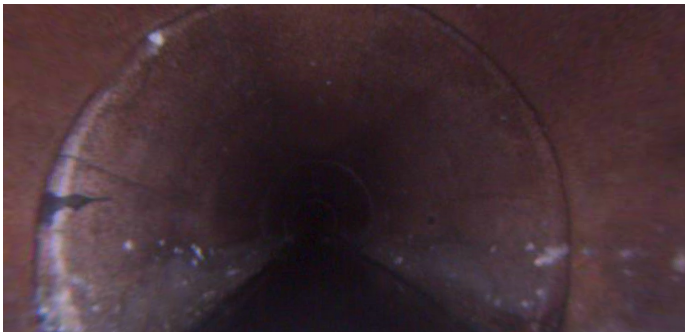
Code:	FL
Description:	Fracture Longitudinal

Distance (ft):	4.2
Structural Grade:	3
O&M Grade:	0
Clock Start/From:	9
Clock To:	
1st Value:	
2nd Value:	
Value Percent:	
Continuous Index:	
Within 8" of Joint:	YES
Remarks:

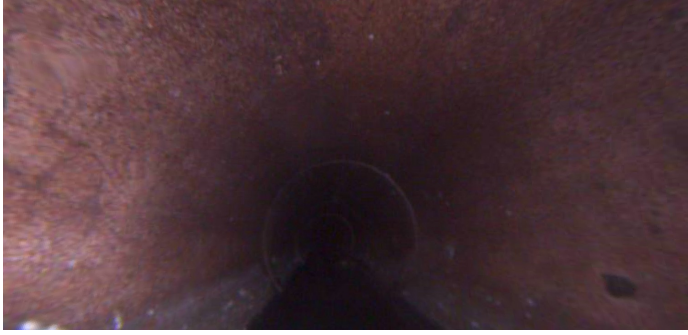
Code:	MSA
Description:	Abandoned Survey
Distance (ft):	4.9
Structural Grade:	0
O&M Grade:	0
Clock Start/From:	
Clock To:	
1st Value:	
2nd Value:	
Value Percent:	
Continuous Index:	
Within 8" of Joint:	NO
Remarks:	debris
