Profile/Photo Observation Report

Street:	N Kelly St.	Flow Control:	Not Controlled
City:	Hobart, IN	Year Renewed:	
Location:	Other	Tape/Media #:	
Purpose:	Not Known	Dia/Height:	12"
Use:	Sanitary	Material:	VCP
Drain Area:	NA	Lining:	
Category:	NA		
Comment:

Location Details:		Direction of Survey:	Downstream
US MH:	M-804-053	DS MH:	M-804-052
		Total Length Surveyed (ft):	4.9

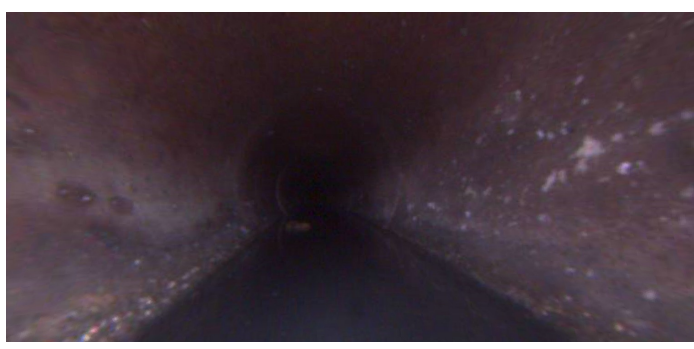
Code: **AMH**
Description: **Manhole**

Distance (ft): **.0**
Structural Grade: **0**
O&M Grade: **0**
Clock Start/From:
Clock To:
1st Value:
2nd Value:
Value Percent:
Continuous Index:
Within 8" of Joint: **NO**
Remarks: **M-804-053**

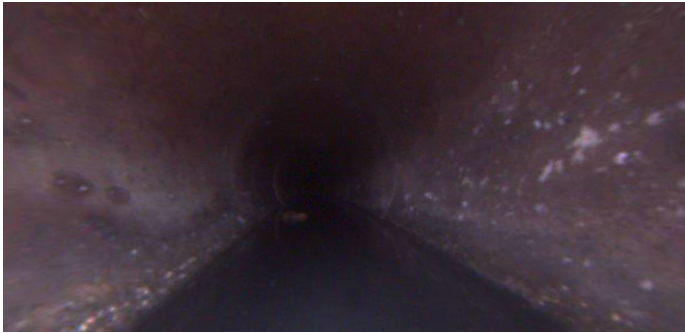
Code:	MWL
Description:	Water Level

Distance (ft):	.0
Structural Grade:	0
O&M Grade:	0
Clock Start/From:	
Clock To:	
1st Value:	
2nd Value:	
Value Percent:	10.000
Continuous Index:	
Within 8" of Joint:	NO
Remarks:

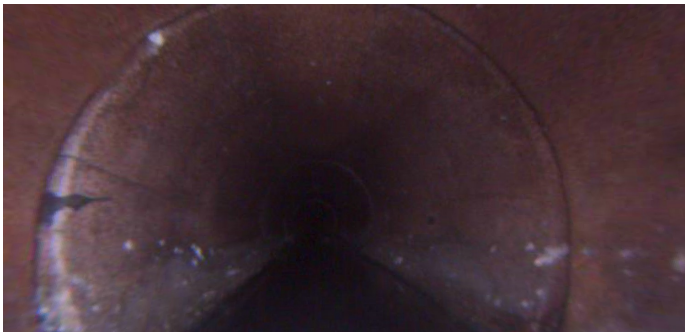
Code:	FL
Description:	Fracture Longitudinal

Distance (ft):	4.2
Structural Grade:	3
O&M Grade:	0
Clock Start/From:	9
Clock To:	
1st Value:	
2nd Value:	
Value Percent:	
Continuous Index:	
Within 8" of Joint:	YES
Remarks:

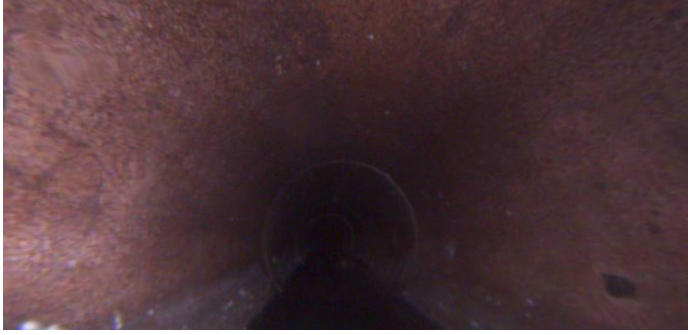
Code:	MSA
Description:	Abandoned Survey
Distance (ft):	4.9
Structural Grade:	0
O&M Grade:	0
Clock Start/From:	
Clock To:	
1st Value:	
2nd Value:	
Value Percent:	
Continuous Index:	
Within 8" of Joint:	NO
Remarks:	debris
