## Profile/Photo Observation Report

Street:	<b>N KELLY ST</b>	Flow Control:	<b>Not Controlled</b>
City:	<b>Hobart, IN</b>	Year Renewed:	
Location:	<b>Other</b>	Tape/Media #:	
Purpose:	<b>Not Known</b>	Dia/Height:	<b>12"</b>
Use:	<b>Sanitary</b>	Material:	<b>VCP</b>
Drain Area:	<b>NA</b>	Lining:	
Category:	<b>NA</b>		
Comment:

Location Details:		Direction of Survey:	<b>Upstream</b>
US MH:	<b>M-804-053</b>	DS MH:	<b>M-804-052</b>
		Total Length Surveyed (ft):	<b>7.0</b>

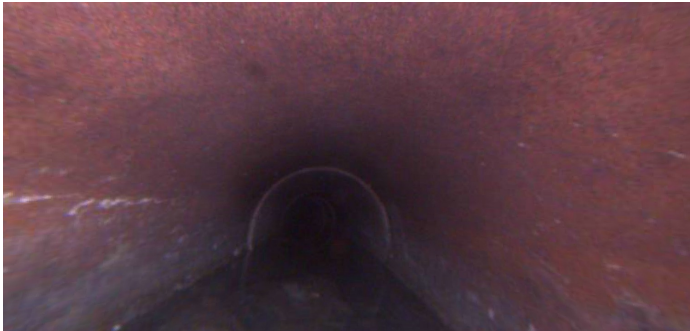
Code: AMH

Description: Manhole

Remarks: M-804-052

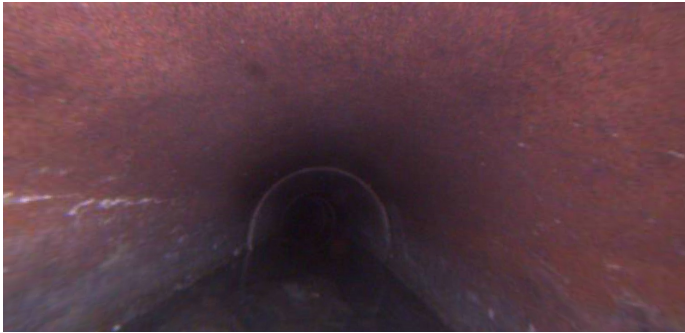
Code:	<b>MWL</b>
Description:	<b>Water Level</b>

Distance (ft):	<b>.0</b>
Structural Grade:	<b>0</b>
O&M Grade:	<b>0</b>
Clock Start/From:	
Clock To:	
1st Value:	
2nd Value:	
Value Percent:	<b>20.000</b>
Continuous Index:	
Within 8" of Joint:	<b>NO</b>
Remarks:

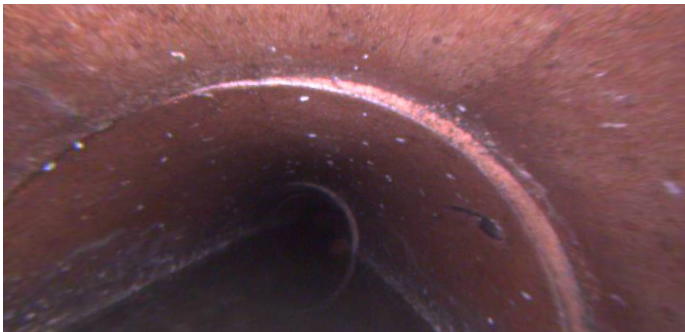
Code:	<b>MSA</b>
Description:	<b>Abandoned Survey</b>

Distance (ft):	<b>7.0</b>
Structural Grade:	<b>0</b>
O&M Grade:	<b>0</b>
Clock Start/From:	
Clock To:	
1st Value:	
2nd Value:	
Value Percent:	
Continuous Index:	
Within 8" of Joint:	<b>NO</b>
Remarks:	<b>debris</b>
