## Profile/Photo Observation Report

Street:	<b>N Kelly St.</b>	Flow Control:	<b>Not Controlled</b>
City:	<b>Hobart, IN</b>	Year Renewed:	
Location:	<b>Other</b>	Tape/Media #:	
Purpose:	<b>Not Known</b>	Dia/Height:	<b>12"</b>
Use:	<b>Sanitary</b>	Material:	<b>VCP</b>
Drain Area:	<b>NA</b>	Lining:	
Category:	<b>NA</b>		
Comment:

Location Details:		Direction of Survey:	<b>Upstream</b>
US MH:	<b>M-804-053</b>	DS MH:	<b>M-804-052</b>
		Total Length Surveyed (ft):	<b>7.0</b>

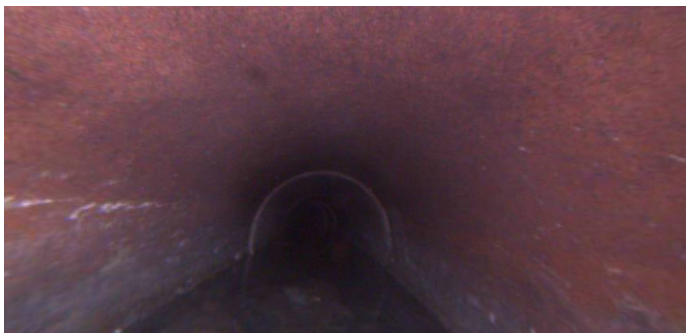
Code: **AMH**  
Description: **Manhole**

Distance (ft): **.0**  
Structural Grade: **0**  
O&M Grade: **0**  
Clock Start/From:  
Clock To:  
1st Value:  
2nd Value:  
Value Percent:  
Continuous Index:  
Within 8" of Joint: **NO**  
Remarks: **M-804-052**

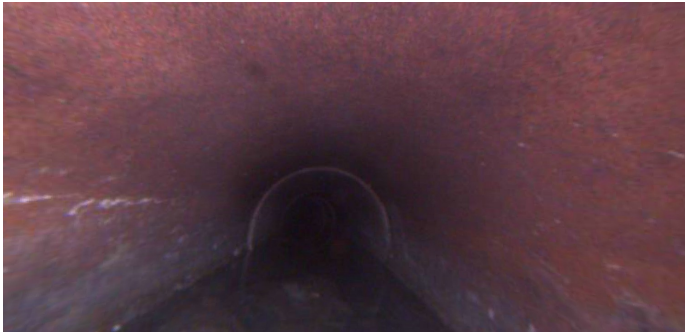
Code:	<b>MWL</b>
Description:	<b>Water Level</b>

Distance (ft):	<b>.0</b>
Structural Grade:	<b>0</b>
O&M Grade:	<b>0</b>
Clock Start/From:	
Clock To:	
1st Value:	
2nd Value:	
Value Percent:	<b>20.000</b>
Continuous Index:	
Within 8" of Joint:	<b>NO</b>
Remarks:

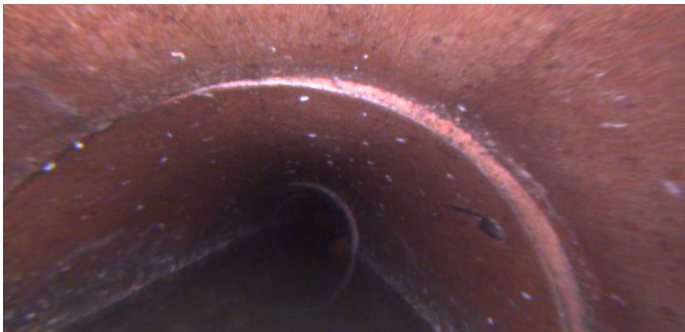
Code:	<b>MSA</b>
Description:	<b>Abandoned Survey</b>

Distance (ft):	<b>7.0</b>
Structural Grade:	<b>0</b>
O&M Grade:	<b>0</b>
Clock Start/From:	
Clock To:	
1st Value:	
2nd Value:	
Value Percent:	
Continuous Index:	
Within 8" of Joint:	<b>NO</b>
Remarks:	<b>debris</b>
