## Profile/Photo Observation Report

Date:	<b>10/18/2021</b>	Weather:		Coding:	<b>PACP 7.0</b>
Pipe Length (ft):	<b>216.6</b>	Owner:	<b>City of Hobart</b>	Pre Clean:	<b>Heavy Cleaning</b>
P.O.#:	<b>YES502259</b>	Surveyor:	<b>S. Bucklin</b>	PSR:	<b>P-804-053-052</b>
Customer:	<b>City of Hobart</b>	Clean Date:	<b>10/14/2021</b>	Shape:	<b>C</b>

Street:	<b>North Kelly Street</b>	Flow Control:	<b>Not Controlled</b>
City:	<b>Hobart, IN</b>	Year Renewed:	
Location:	<b>Local rural streets with light traffic, t</b>	Tape/Media #:	
Purpose:	<b>Routine Assessment</b>	Dia/Height:	<b>12"</b>
Use:	<b>Sanitary Sewage Pipe</b>	Material:	<b>VCP</b>
Drain Area:		Lining:	
Category:	<b>NA</b>		
Comment:			
Location Details:		Direction of Survey:	<b>Downstream</b>
US MH:	<b>M-804-053</b>	DS MH:	<b>M-804-052</b>
		Total Length Surveyed (ft):	<b>216.6</b>

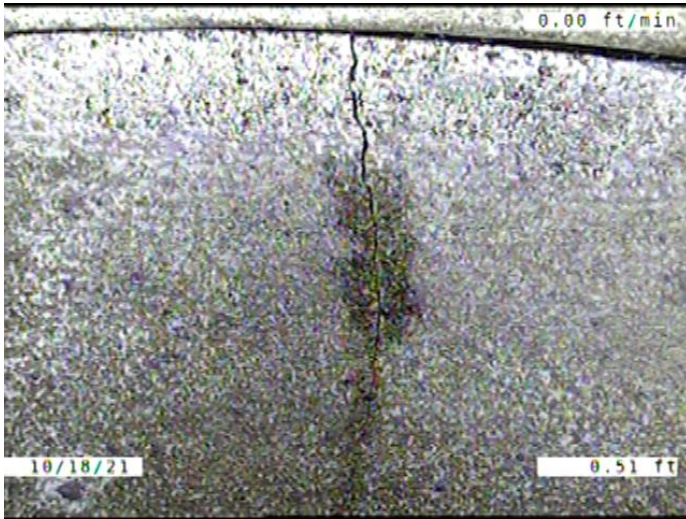
Code: **CS**  
Description: **Crack Spiral**

Distance (ft): **.5**  
Structural Grade: **2**  
O&M Grade: **0**  
Clock Start/From: **12**  
Clock To: **2**  
1st Value:  
2nd Value:  
Value Percent:  
Continuous Index:  
Within 8" of Joint: **YES**  
Remarks:

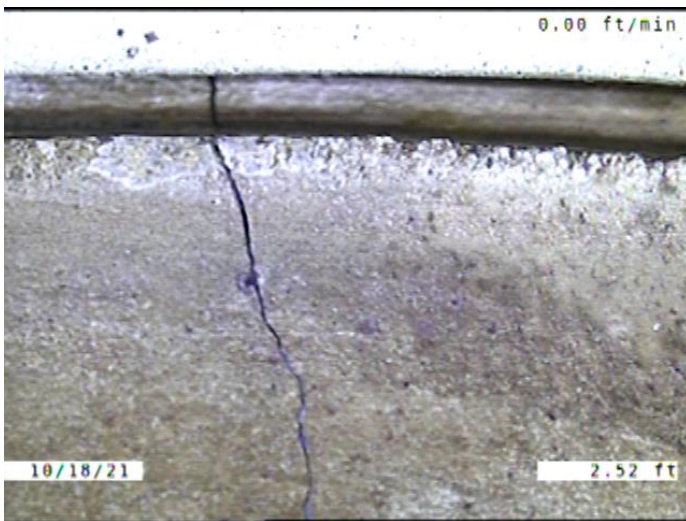
Code: **CS**  
Description: **Crack Spiral**

Distance (ft): **2.5**  
Structural Grade: **2**  
O&M Grade: **0**  
Clock Start/From: **1**  
Clock To: **3**  
1st Value:  
2nd Value:  
Value Percent:  
Continuous Index:  
Within 8" of Joint: **YES**  
Remarks:

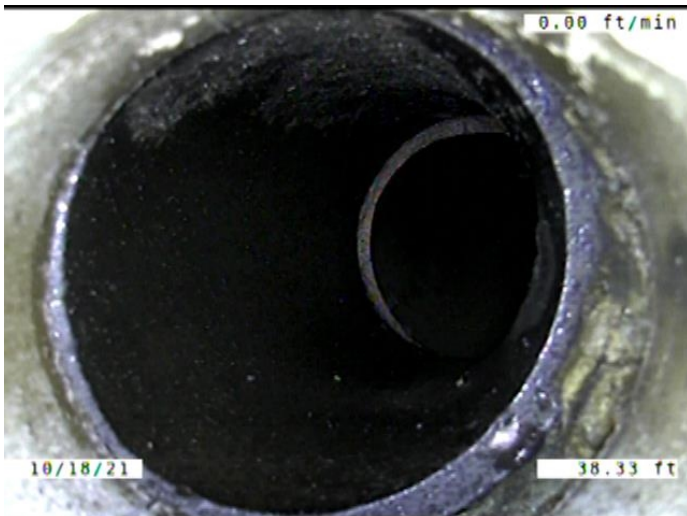
Code: **TFD**  
Description: **Tap Factory Defective**

Distance (ft): **38.3**  
Structural Grade: **0**  
O&M Grade: **3**  
Clock Start/From: **1**  
Clock To:  
1st Value: **4.000**  
2nd Value:  
Value Percent:  
Continuous Index:  
Within 8" of Joint: **YES**  
Remarks: **Defective**

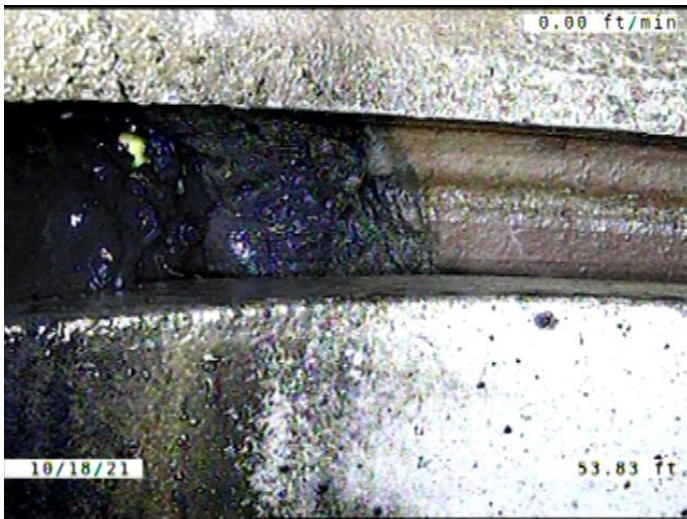
Code: **JAM**  
 Description: **Joint Angular Medium**

Distance (ft): **53.8**  
 Structural Grade: **3**  
 O&M Grade: **0**  
 Clock Start/From:  
 Clock To:  
 1st Value:  
 2nd Value:  
 Value Percent:  
 Continuous Index:  
 Within 8" of Joint: **NO**  
 Remarks:

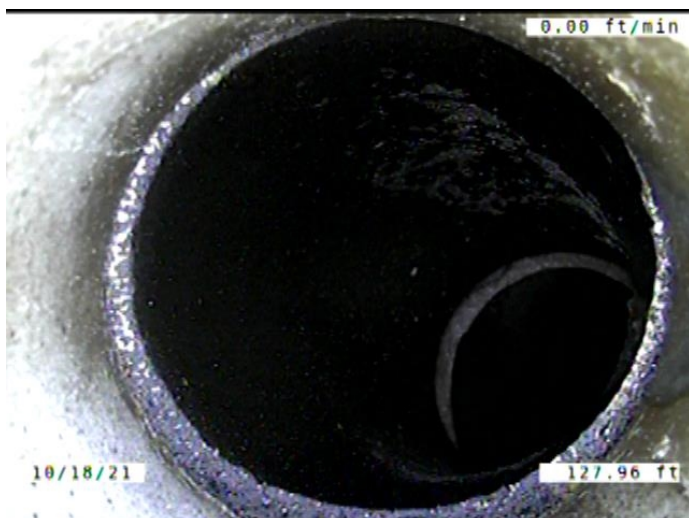
Code: **TF**  
Description: **Tap Factory**

Distance (ft): **128.0**  
Structural Grade: **0**  
O&M Grade: **0**  
Clock Start/From: **1**  
Clock To:  
1st Value: **4.000**  
2nd Value:  
Value Percent:  
Continuous Index:  
Within 8" of Joint: **YES**  
Remarks:

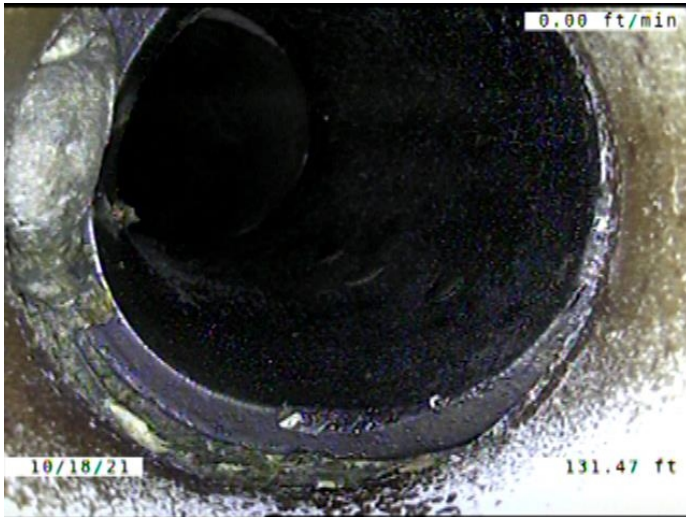
Code: **TF**  
 Description: **Tap Factory**

Distance (ft): **131.5**  
 Structural Grade: **0**  
 O&M Grade: **0**  
 Clock Start/From: **10**  
 Clock To:  
 1st Value: **4.000**  
 2nd Value:  
 Value Percent:  
 Continuous Index:  
 Within 8" of Joint: **YES**  
 Remarks:

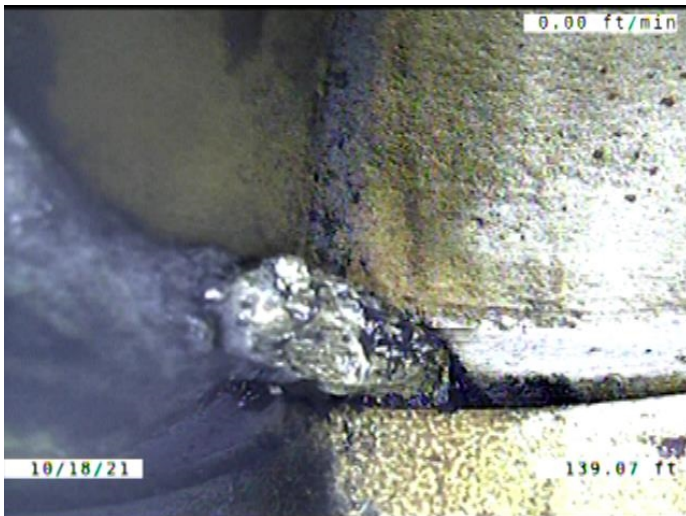
Code: **DAE**  
 Description: **Deposits Attached Encrustation**

Distance (ft): **139.1**  
 Structural Grade: **0**  
 O&M Grade: **2**  
 Clock Start/From: **4**  
 Clock To: **7**  
 1st Value:  
 2nd Value:  
 Value Percent: **5.000**  
 Continuous Index:  
 Within 8" of Joint: **YES**  
 Remarks:

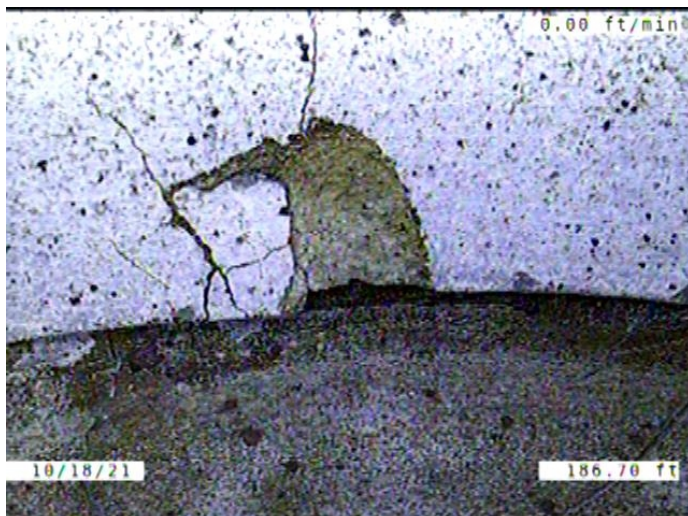
Code: **SSS**  
 Description: **Surface Damage Surface Spalling**

Distance (ft): **186.7**  
 Structural Grade: **2**  
 O&M Grade: **0**  
 Clock Start/From: **10**  
 Clock To: **11**  
 1st Value:  
 2nd Value:  
 Value Percent:  
 Continuous Index:  
 Within 8" of Joint: **YES**  
 Remarks: **A PIECE CHIPPED AWAY FROM THE JOINT**

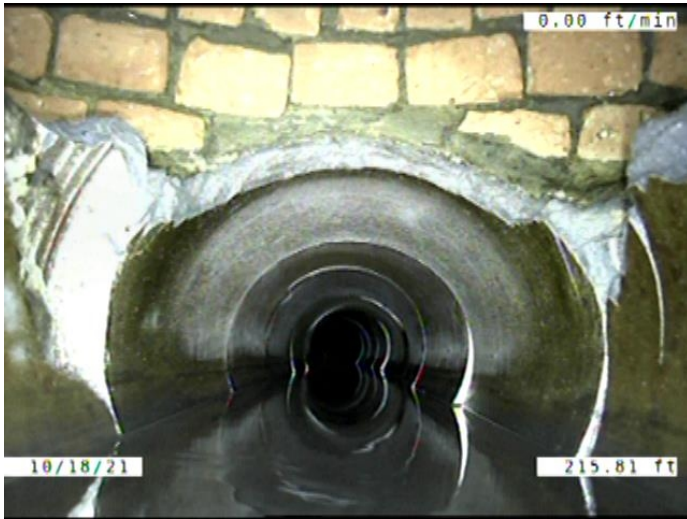
Code: **FM**  
 Description: **Fracture Multiple**

Distance (ft): **215.8**  
 Structural Grade: **4**  
 O&M Grade: **0**  
 Clock Start/From: **7**  
 Clock To: **5**  
 1st Value:  
 2nd Value:  
 Value Percent:  
 Continuous Index: **F01**  
 Within 8" of Joint: **YES**  
 Remarks: **Wandering**

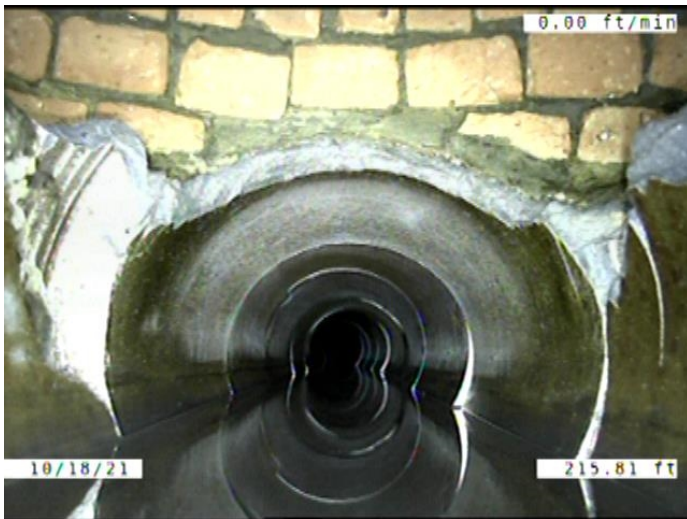
Code: **B**  
 Description: **Broken**

Distance (ft): **215.8**  
 Structural Grade: **4**  
 O&M Grade: **0**  
 Clock Start/From: **8**  
 Clock To: **3**  
 1st Value:  
 2nd Value:  
 Value Percent:  
 Continuous Index: **F02**  
 Within 8" of Joint: **YES**  
 Remarks:

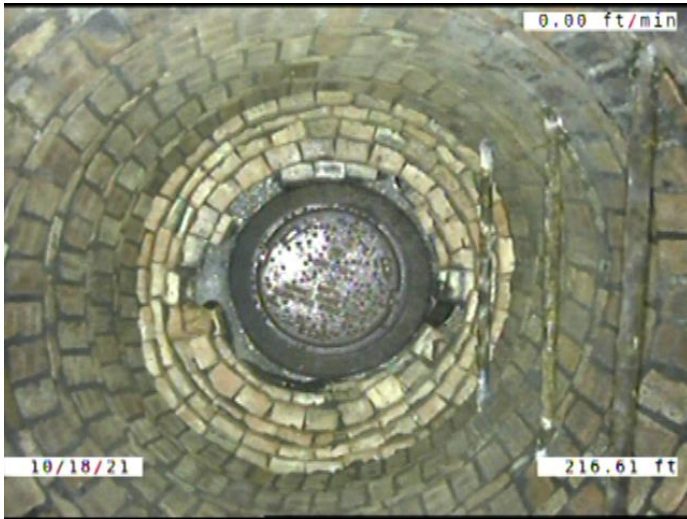
Code:	<b>AMH</b>
Description:	<b>Manhole</b>
Distance (ft):	<b>216.6</b>
Structural Grade:	<b>0</b>
O&M Grade:	<b>0</b>
Clock Start/From:	
Clock To:	
1st Value:	
2nd Value:	
Value Percent:	
Continuous Index:	
Within 8" of Joint:	<b>NO</b>
Remarks:	<b>M-804-052</b>
