Profile/Photo Observation Report

Date:	10/18/2021	Weather:		Coding:	PACP 7.0
Pipe Length (ft):	216.6	Owner:	City of Hobart	Pre Clean:	Heavy Cleaning
P.O.#:	YES502259	Surveyor:	S. Bucklin	PSR:	P-804-053-052
Customer:	City of Hobart	Clean Date:	10/14/2021	Shape:	C

Street:	North Kelly Street	Flow Control:	Not Controlled
City:	Hobart, IN	Year Renewed:	
Location:	Local rural streets with light traffic, t	Tape/Media #:	
Purpose:	Routine Assessment	Dia/Height:	12"
Use:	Sanitary Sewage Pipe	Material:	VCP
Drain Area:		Lining:	
Category:	NA		
Comment:			
Location Details:		Direction of Survey:	Downstream
US MH:	M-804-053	DS MH:	M-804-052
		Total Length Surveyed (ft):	216.6

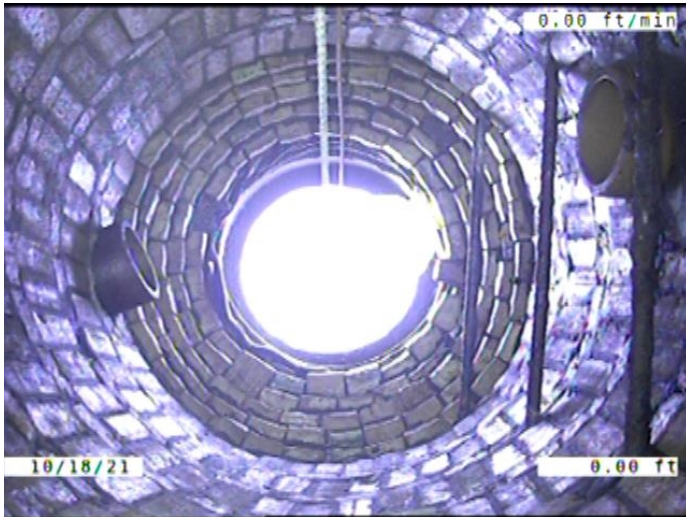
Code: **AMH**
 Description: **Manhole**

Distance (ft): **.0**
 Structural Grade: **0**
 O&M Grade: **0**
 Clock Start/From:
 Clock To:
 1st Value:
 2nd Value:
 Value Percent:
 Continuous Index:
 Within 8" of Joint: **NO**
 Remarks: **M-804-053**

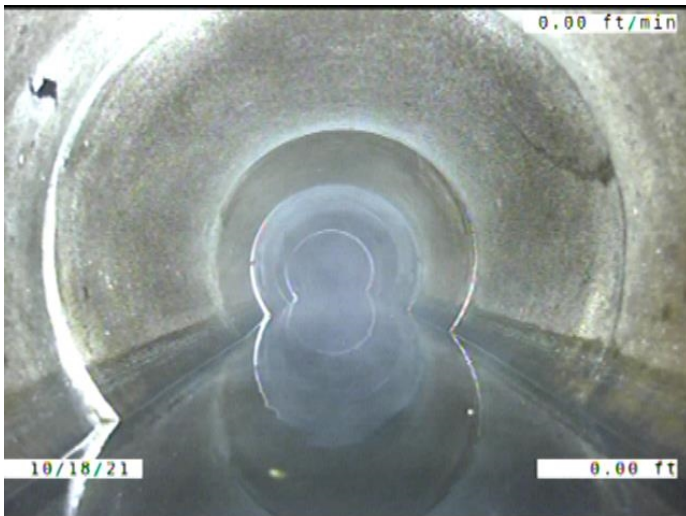
Code: **MWL**
 Description: **Miscellaneous Water Level**

Distance (ft): **.0**
 Structural Grade: **0**
 O&M Grade: **0**
 Clock Start/From:
 Clock To:
 1st Value:
 2nd Value:
 Value Percent: **10.000**
 Continuous Index:
 Within 8" of Joint: **NO**
 Remarks:

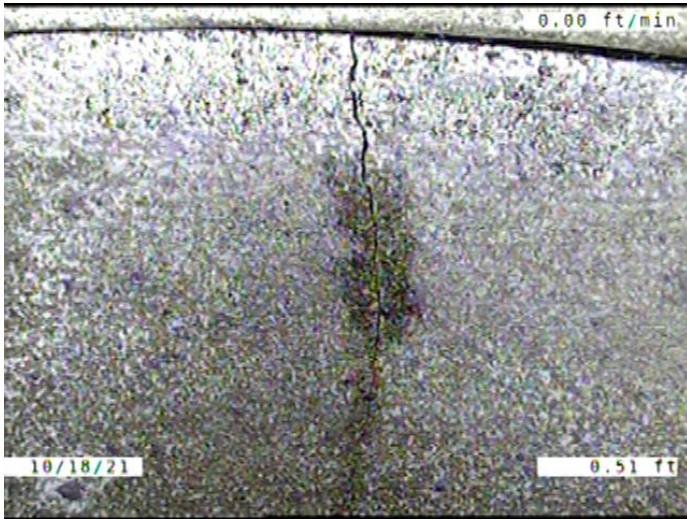
Code: **CS**
 Description: **Crack Spiral**

Distance (ft): **.5**
 Structural Grade: **2**
 O&M Grade: **0**
 Clock Start/From: **12**
 Clock To: **2**
 1st Value:
 2nd Value:
 Value Percent:
 Continuous Index:
 Within 8" of Joint: **YES**
 Remarks:

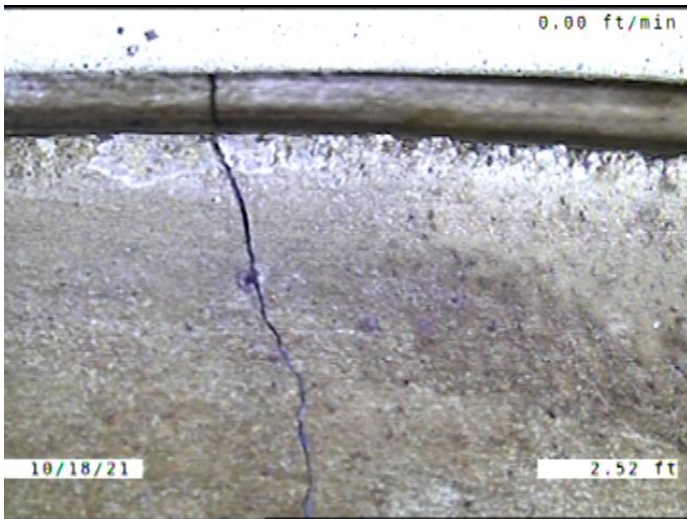
Code: **CS**
 Description: **Crack Spiral**

Distance (ft): **2.5**
 Structural Grade: **2**
 O&M Grade: **0**
 Clock Start/From: **1**
 Clock To: **3**
 1st Value:
 2nd Value:
 Value Percent:
 Continuous Index:
 Within 8" of Joint: **YES**
 Remarks:

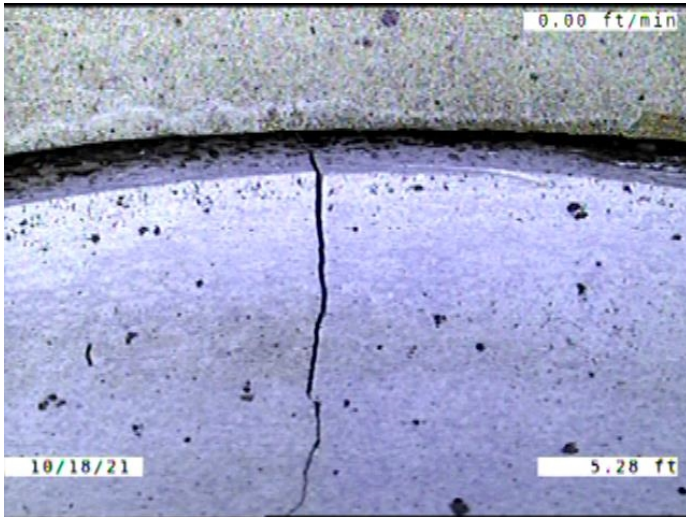
Code: **FM**
 Description: **Fracture Multiple**

Distance (ft): **5.3**
 Structural Grade: **4**
 O&M Grade: **0**
 Clock Start/From: **7**
 Clock To: **5**
 1st Value:
 2nd Value:
 Value Percent:
 Continuous Index: **S01**
 Within 8" of Joint: **YES**
 Remarks: **Wandering**

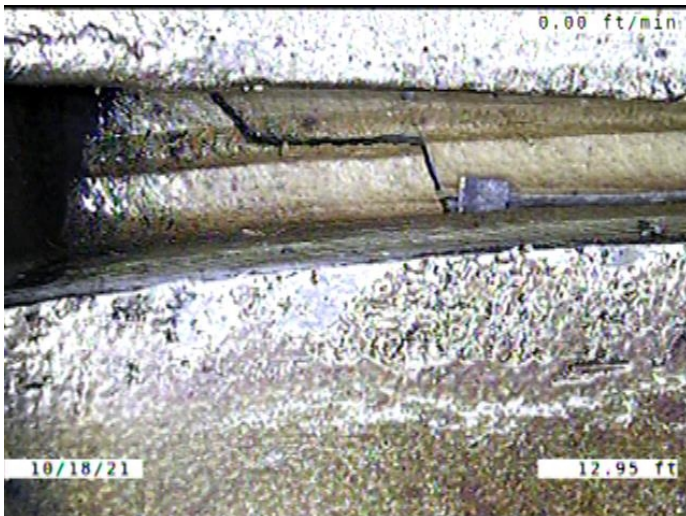
Code: **JAM**
 Description: **Joint Angular Medium**

Distance (ft): **12.9**
 Structural Grade: **3**
 O&M Grade: **0**
 Clock Start/From:
 Clock To:
 1st Value:
 2nd Value:
 Value Percent:
 Continuous Index:
 Within 8" of Joint: **NO**
 Remarks:

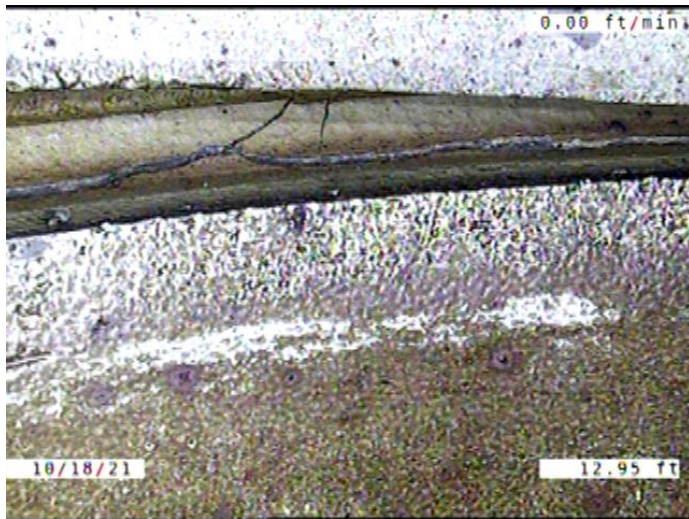
Code: **B**
 Description: **Broken**

Distance (ft): **12.9**
 Structural Grade: **4**
 O&M Grade: **0**
 Clock Start/From: **8**
 Clock To: **10**
 1st Value:
 2nd Value:
 Value Percent:
 Continuous Index:
 Within 8" of Joint: **YES**
 Remarks: **OUTSIDE OF THE JOINT**

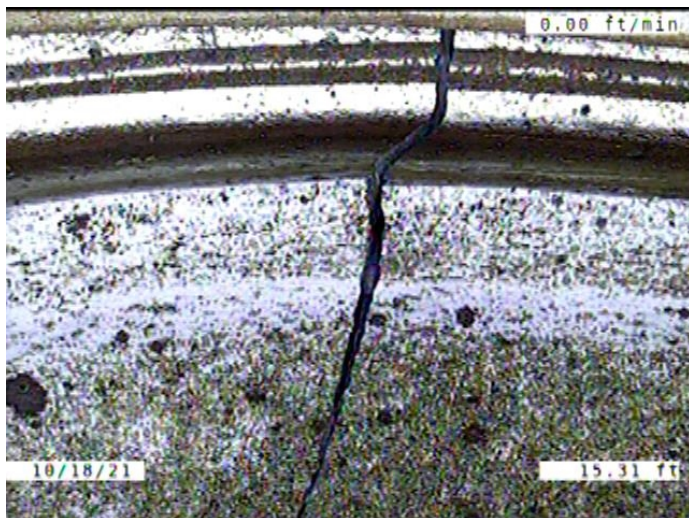
Code: **B**
 Description: **Broken**

Distance (ft): **15.3**
 Structural Grade: **4**
 O&M Grade: **0**
 Clock Start/From: **8**
 Clock To: **3**
 1st Value:
 2nd Value:
 Value Percent:
 Continuous Index: **S02**
 Within 8" of Joint: **YES**
 Remarks:

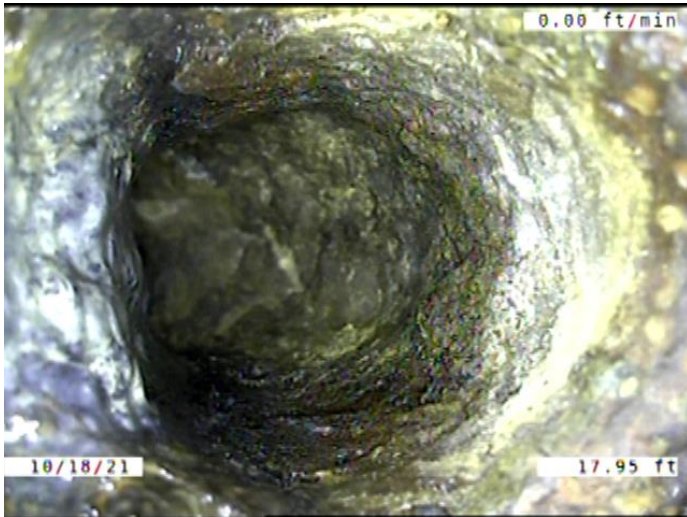
Code: **TBI**
 Description: **Tap Break-in Intruding**

Distance (ft): **18.0**
 Structural Grade: **0**
 O&M Grade: **2**
 Clock Start/From: **11**
 Clock To:
 1st Value: **4.000**
 2nd Value: **1.000**
 Value Percent:
 Continuous Index:
 Within 8" of Joint: **YES**
 Remarks:

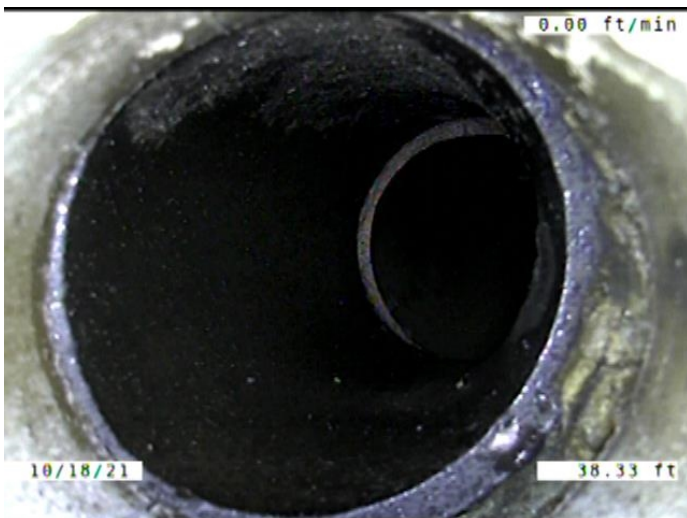
Code: **TFD**
 Description: **Tap Factory Defective**

Distance (ft): **38.3**
 Structural Grade: **0**
 O&M Grade: **3**
 Clock Start/From: **1**
 Clock To:
 1st Value: **4.000**
 2nd Value:
 Value Percent:
 Continuous Index:
 Within 8" of Joint: **YES**
 Remarks: **Defective**

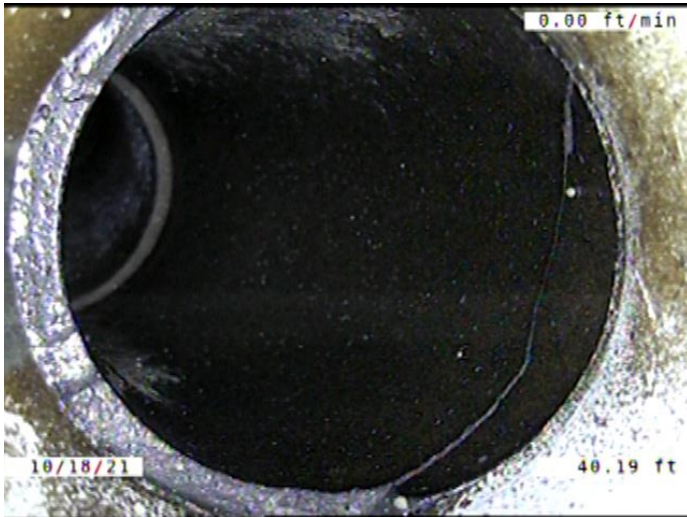
Code: **TF**
 Description: **Tap Factory**

Distance (ft): **40.2**
 Structural Grade: **0**
 O&M Grade: **0**
 Clock Start/From: **11**
 Clock To:
 1st Value: **4.000**
 2nd Value:
 Value Percent:
 Continuous Index:
 Within 8" of Joint: **YES**
 Remarks:

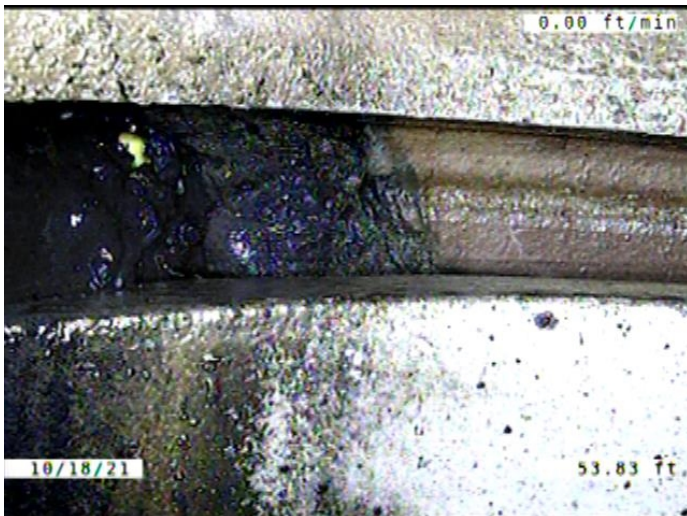
Code: **JAM**
 Description: **Joint Angular Medium**

Distance (ft): **53.8**
 Structural Grade: **3**
 O&M Grade: **0**
 Clock Start/From:
 Clock To:
 1st Value:
 2nd Value:
 Value Percent:
 Continuous Index:
 Within 8" of Joint: **NO**
 Remarks:

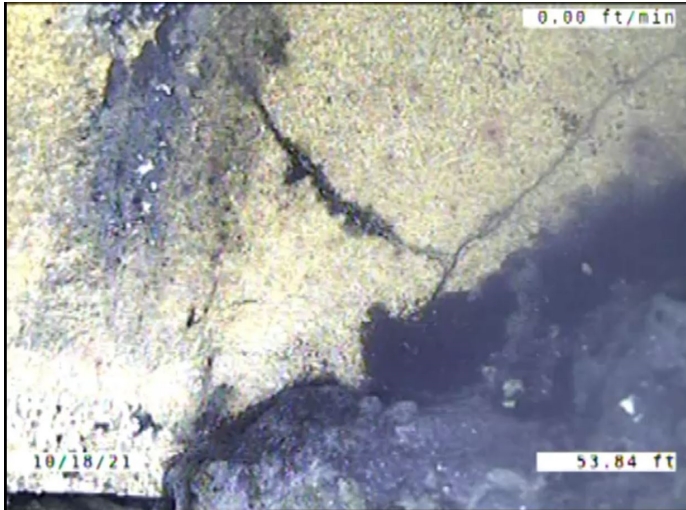
Code: **CM**
Description: **Crack Multiple**

Distance (ft): **53.8**
Structural Grade: **3**
O&M Grade: **0**
Clock Start/From: **5**
Clock To: **7**
1st Value:
2nd Value:
Value Percent:
Continuous Index:
Within 8" of Joint: **NO**
Remarks:

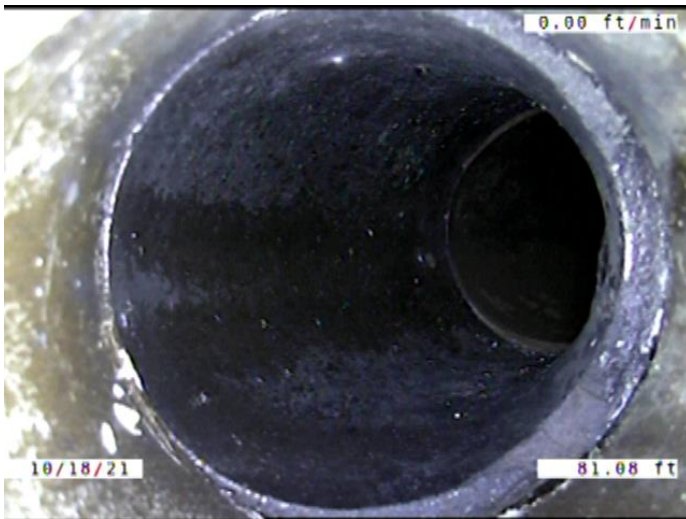
Code: **TFD**
Description: **Tap Factory Defective**

Distance (ft): **81.1**
Structural Grade: **0**
O&M Grade: **3**
Clock Start/From: **1**
Clock To:
1st Value: **4.000**
2nd Value:
Value Percent:
Continuous Index:
Within 8" of Joint: **YES**
Remarks: **Defective**

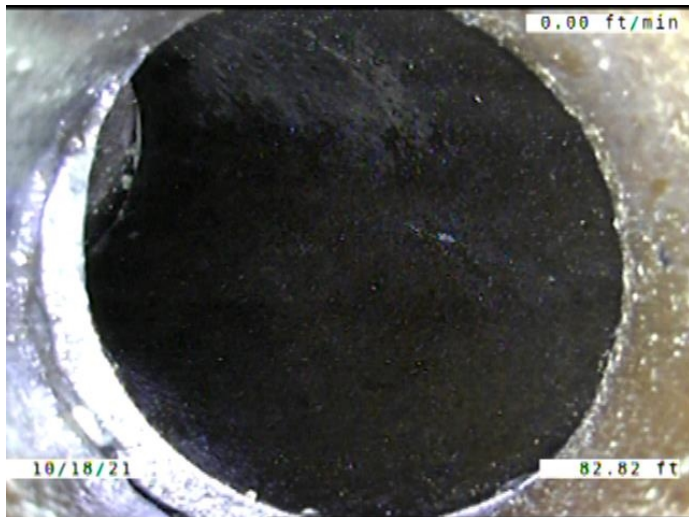
Code:	TF
Description:	Tap Factory
Distance (ft):	82.8
Structural Grade:	0
O&M Grade:	0
Clock Start/From:	10
Clock To:	
1st Value:	4.000
2nd Value:	
Value Percent:	
Continuous Index:	
Within 8" of Joint:	YES
Remarks:	CONSTANTLY RUNNING WATER

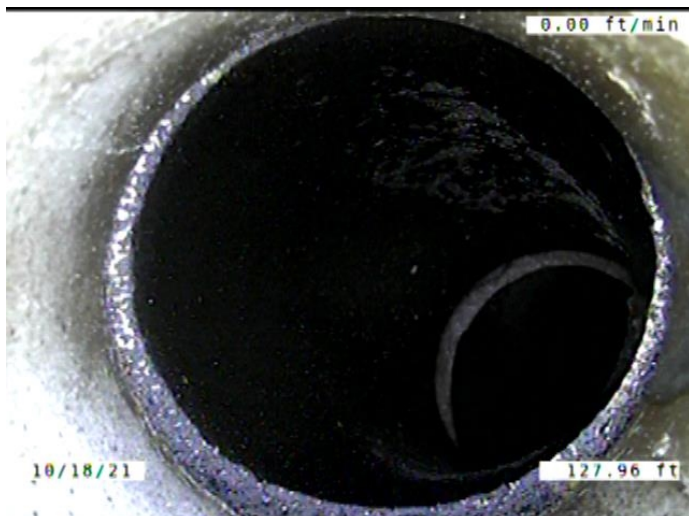
Code:	TF
Description:	Tap Factory
Distance (ft):	128.0
Structural Grade:	0
O&M Grade:	0
Clock Start/From:	1
Clock To:	
1st Value:	4.000
2nd Value:	
Value Percent:	
Continuous Index:	
Within 8" of Joint:	YES
Remarks:

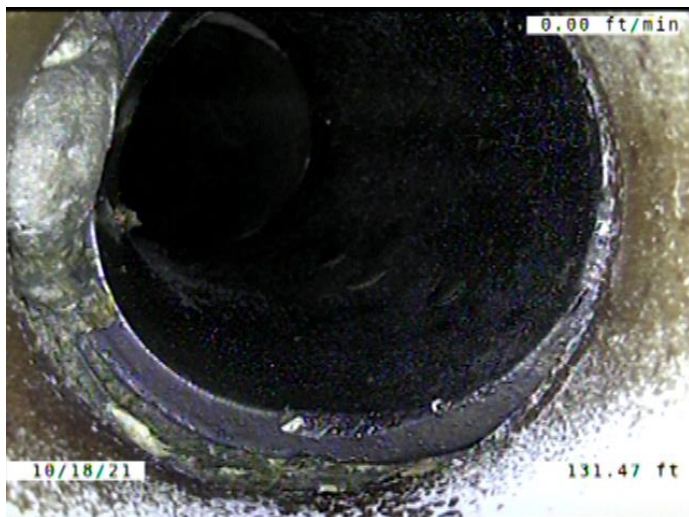
Code: **TF**
 Description: **Tap Factory**

Distance (ft): **131.5**
 Structural Grade: **0**
 O&M Grade: **0**
 Clock Start/From: **10**
 Clock To:
 1st Value: **4.000**
 2nd Value:
 Value Percent:
 Continuous Index:
 Within 8" of Joint: **YES**
 Remarks:

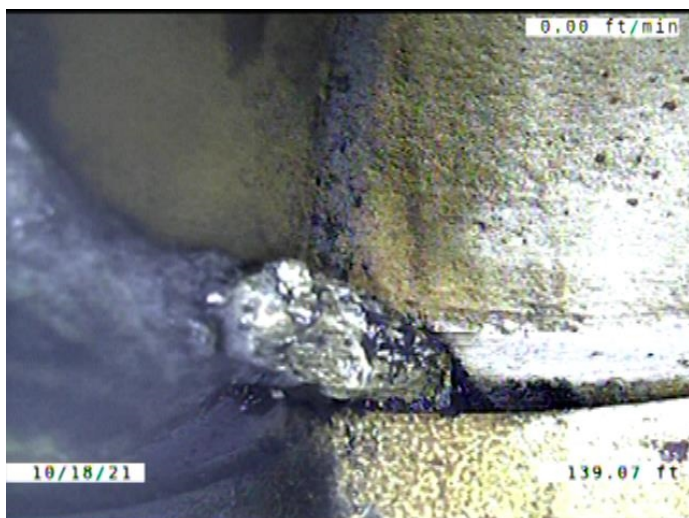
Code: **DAE**
 Description: **Deposits Attached Encrustation**

Distance (ft): **139.1**
 Structural Grade: **0**
 O&M Grade: **2**
 Clock Start/From: **4**
 Clock To: **7**
 1st Value:
 2nd Value:
 Value Percent: **5.000**
 Continuous Index:
 Within 8" of Joint: **YES**
 Remarks:

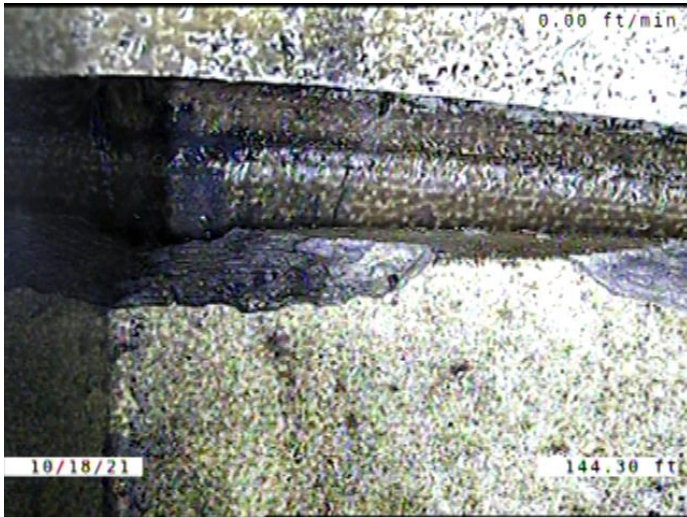
Code: **JAM**
 Description: **Joint Angular Medium**

Distance (ft): **144.3**
 Structural Grade: **3**
 O&M Grade: **0**
 Clock Start/From:
 Clock To:
 1st Value:
 2nd Value:
 Value Percent:
 Continuous Index:
 Within 8" of Joint: **NO**
 Remarks:

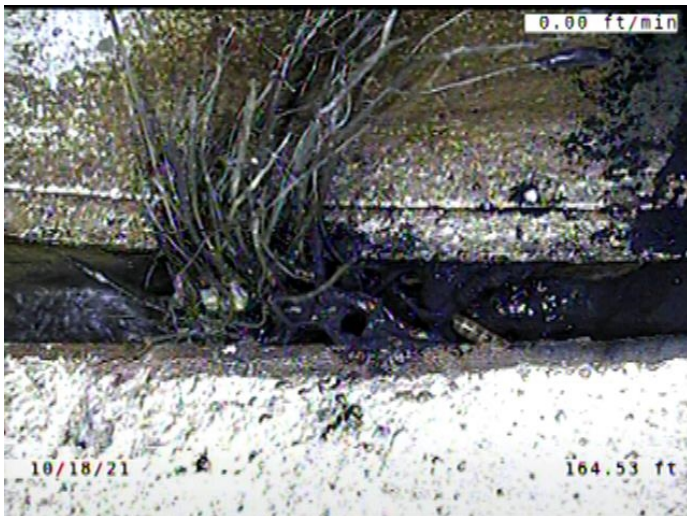
Code: **RFJ**
 Description: **Roots Fine Joint**

Distance (ft): **164.5**
 Structural Grade: **0**
 O&M Grade: **1**
 Clock Start/From: **8**
 Clock To:
 1st Value:
 2nd Value:
 Value Percent:
 Continuous Index:
 Within 8" of Joint: **YES**
 Remarks:

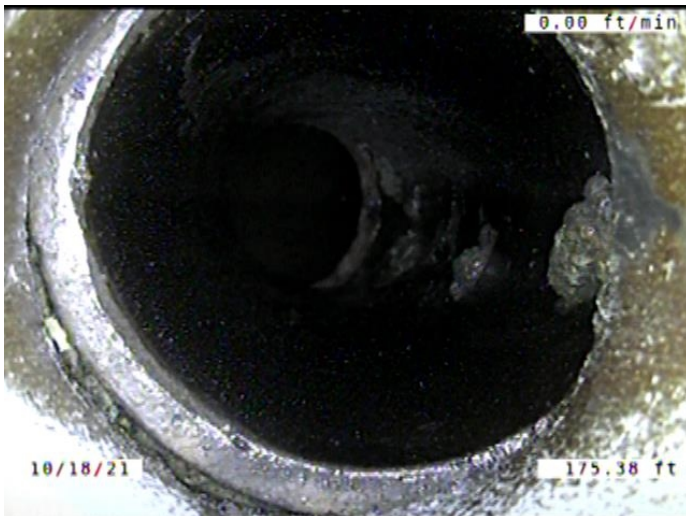
Code: **TF**
Description: **Tap Factory**

Distance (ft): **175.4**
Structural Grade: **0**
O&M Grade: **0**
Clock Start/From: **1**
Clock To:
1st Value: **4.000**
2nd Value:
Value Percent:
Continuous Index:
Within 8" of Joint: **YES**
Remarks:

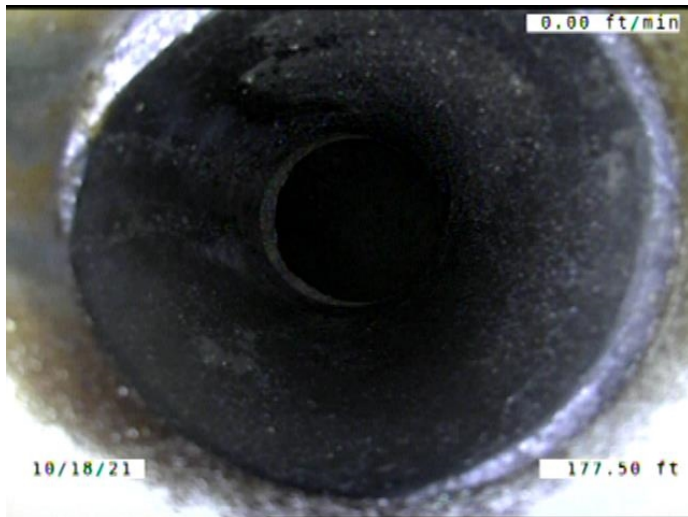
Code: **TF**
 Description: **Tap Factory**

Distance (ft): **177.5**
 Structural Grade: **0**
 O&M Grade: **0**
 Clock Start/From: **10**
 Clock To:
 1st Value: **4.000**
 2nd Value:
 Value Percent:
 Continuous Index:
 Within 8" of Joint: **YES**
 Remarks:

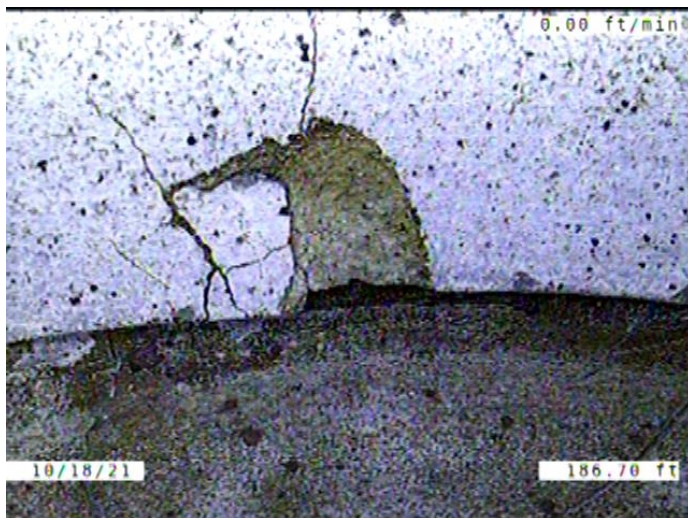
Code: **SSS**
 Description: **Surface Damage Surface Spalling**

Distance (ft): **186.7**
 Structural Grade: **2**
 O&M Grade: **0**
 Clock Start/From: **10**
 Clock To: **11**
 1st Value:
 2nd Value:
 Value Percent:
 Continuous Index:
 Within 8" of Joint: **YES**
 Remarks: **A PIECE CHIPPED AWAY FROM THE JOINT**

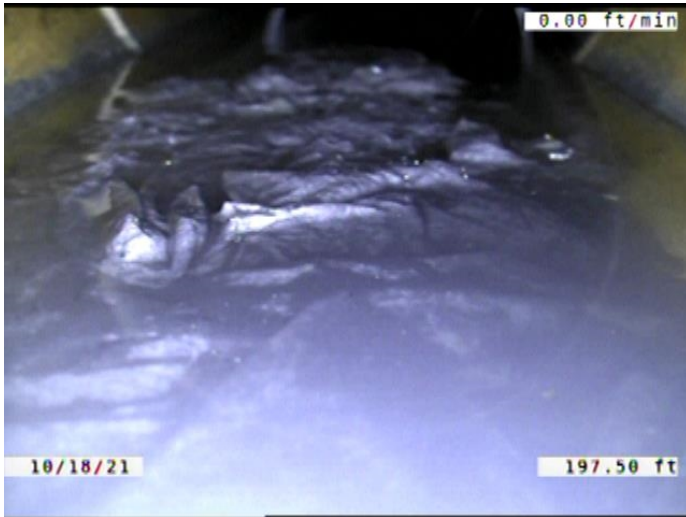
Code: **DAR**
 Description: **Deposits Attached Ragging**

Distance (ft): **197.5**
 Structural Grade: **0**
 O&M Grade: **2**
 Clock Start/From: **5**
 Clock To: **7**
 1st Value:
 2nd Value:
 Value Percent: **5.000**
 Continuous Index:
 Within 8" of Joint: **YES**
 Remarks:

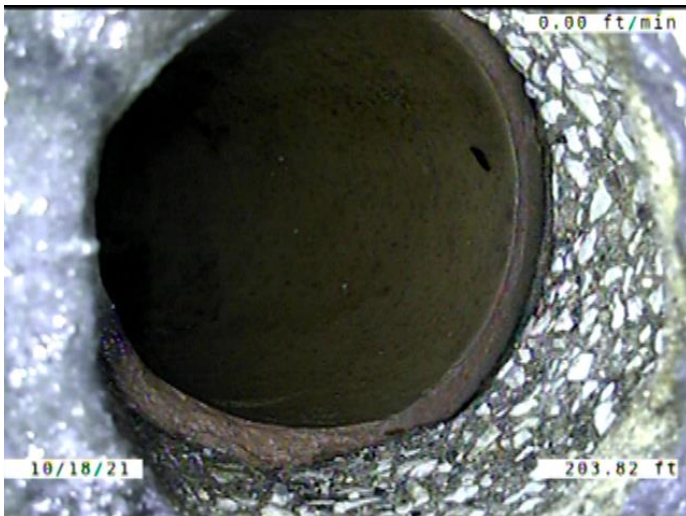
Code: **TB**
 Description: **Tap Break-in/Hammer**

Distance (ft): **203.8**
 Structural Grade: **0**
 O&M Grade: **0**
 Clock Start/From: **11**
 Clock To:
 1st Value: **4.000**
 2nd Value:
 Value Percent:
 Continuous Index:
 Within 8" of Joint: **YES**
 Remarks: **CONSTANTLY RUNNING WATER**

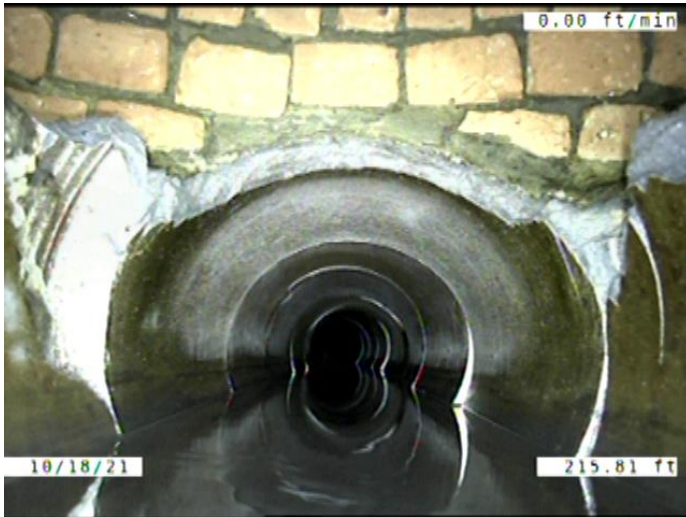
Code: **FM**
 Description: **Fracture Multiple**

Distance (ft): **215.8**
 Structural Grade: **4**
 O&M Grade: **0**
 Clock Start/From: **7**
 Clock To: **5**
 1st Value:
 2nd Value:
 Value Percent:
 Continuous Index: **F01**
 Within 8" of Joint: **YES**
 Remarks: **Wandering**

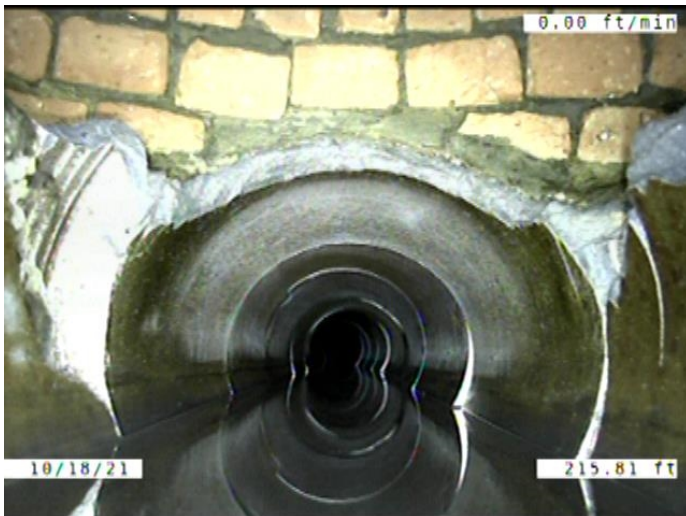
Code: **B**
 Description: **Broken**

Distance (ft): **215.8**
 Structural Grade: **4**
 O&M Grade: **0**
 Clock Start/From: **8**
 Clock To: **3**
 1st Value:
 2nd Value:
 Value Percent:
 Continuous Index: **F02**
 Within 8" of Joint: **YES**
 Remarks:

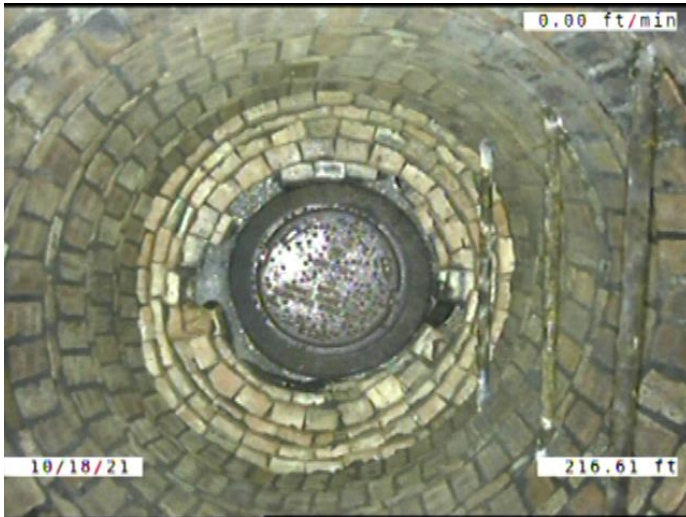
Code:	AMH
Description:	Manhole
Distance (ft):	216.6
Structural Grade:	0
O&M Grade:	0
Clock Start/From:	
Clock To:	
1st Value:	
2nd Value:	
Value Percent:	
Continuous Index:	
Within 8" of Joint:	NO
Remarks:	M-804-052
