## Profile/Photo Observation Report

Street:	<b>N KELLY ST</b>	Flow Control:	<b>Not Controlled</b>
City:	<b>Hobart, IN</b>	Year Renewed:	
Location:	<b>Other</b>	Tape/Media #:	
Purpose:	<b>Not Known</b>	Dia/Height:	<b>12"</b>
Use:	<b>Sanitary</b>	Material:	<b>VCP</b>
Drain Area:	<b>NA</b>	Lining:	
Category:	<b>NA</b>		
Comment:

Location Details:		Direction of Survey:	<b>Upstream</b>
US MH:	<b>M-804-055</b>	DS MH:	<b>M-804-054</b>
		Total Length Surveyed (ft):	<b>13.5</b>

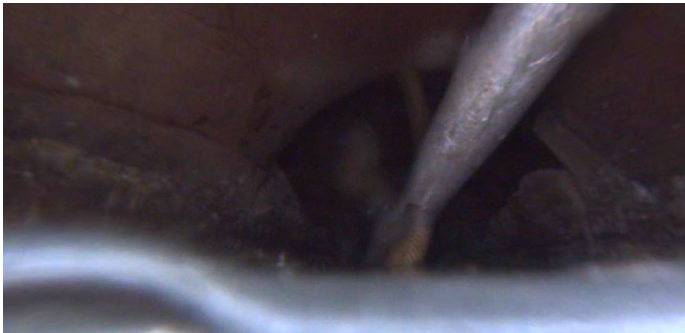
Code:	<b>FL</b>
Description:	<b>Fracture Longitudinal</b>

Distance (ft):	<b>.5</b>
Structural Grade:	<b>3</b>
O&M Grade:	<b>0</b>
Clock Start/From:	<b>2</b>
Clock To:	
1st Value:	
2nd Value:	
Value Percent:	
Continuous Index:	
Within 8" of Joint:	
Remarks:

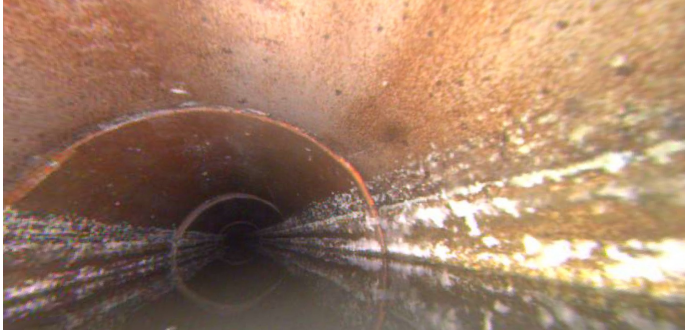
Code: **MWL**  
Description: **Water Level**

Distance (ft): **4.7**  
Structural Grade: **0**  
O&M Grade: **0**  
Clock Start/From:  
Clock To:  
1st Value:  
2nd Value:  
Value Percent: **40.000**  
Continuous Index:  
Within 8" of Joint: **NO**  
Remarks:

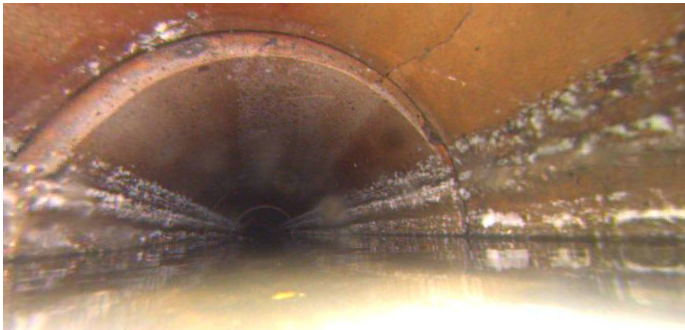
Code: **FL**  
Description: **Fracture Longitudinal**

Distance (ft): **6.9**  
Structural Grade: **3**  
O&M Grade: **0**  
Clock Start/From: **1**  
Clock To:  
1st Value:  
2nd Value:  
Value Percent:  
Continuous Index:  
Within 8" of Joint: **YES**  
Remarks:

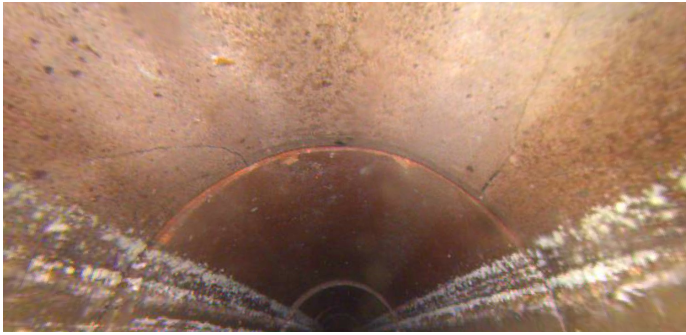
Code: **FM**  
Description: **Fracture Multiple**

Distance (ft): **8.8**  
Structural Grade: **4**  
O&M Grade: **0**  
Clock Start/From: **10**  
Clock To: **2**  
1st Value:  
2nd Value:  
Value Percent:  
Continuous Index:  
Within 8" of Joint: **YES**  
Remarks:

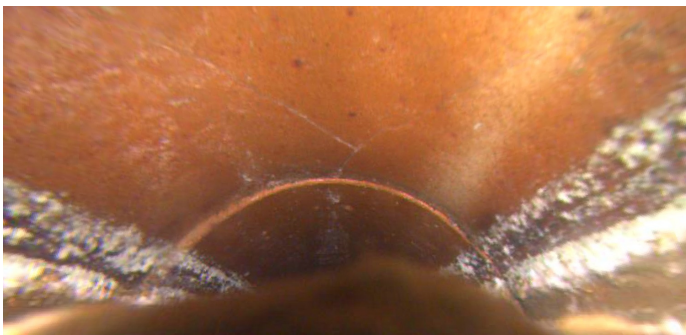
Code: **FM**  
Description: **Fracture Multiple**

Distance (ft): **12.8**  
Structural Grade: **4**  
O&M Grade: **0**  
Clock Start/From: **10**  
Clock To: **2**  
1st Value:  
2nd Value:  
Value Percent:  
Continuous Index:  
Within 8" of Joint:  
Remarks:

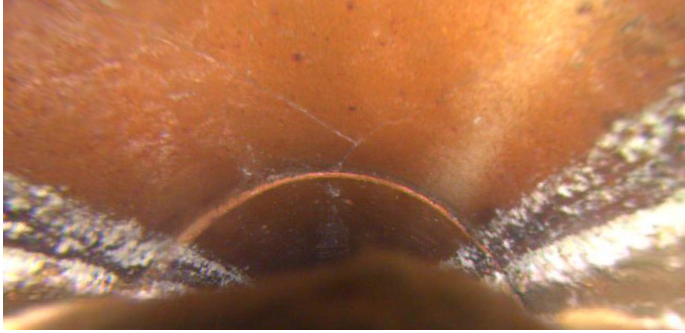
Code: **DAGS**  
Description: **Deposits Attached Grease**

Distance (ft): **12.8**  
Structural Grade: **0**  
O&M Grade: **2**  
Clock Start/From: **8**  
Clock To: **4**  
1st Value:  
2nd Value:  
Value Percent: **5.000**  
Continuous Index:  
Within 8" of Joint: **NO**  
Remarks:

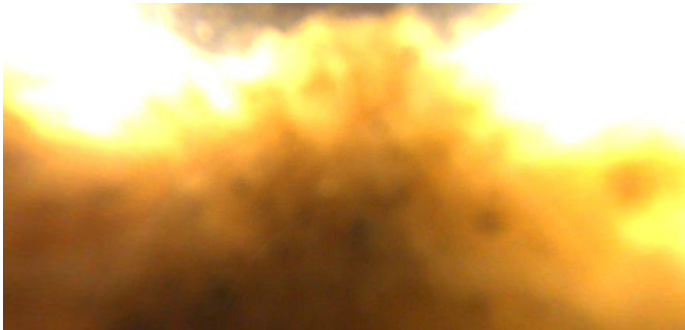
Code: **MCU**  
Description: **Camera Underwater**

Distance (ft): **13.5**  
Structural Grade: **0**  
O&M Grade: **4**  
Clock Start/From:  
Clock To:  
1st Value:  
2nd Value:  
Value Percent:  
Continuous Index:  
Within 8" of Joint: **NO**  
Remarks:

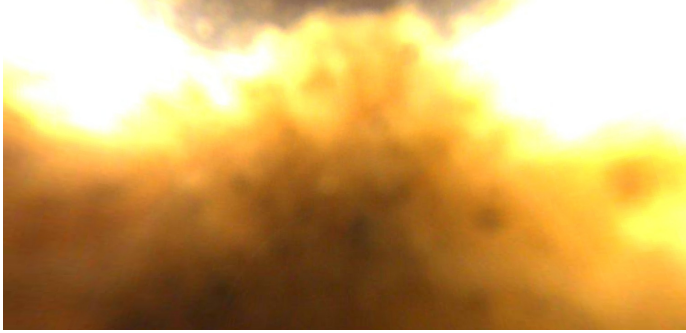
Code:	<b>MSA</b>
Description:	<b>Abandoned Survey</b>
Distance (ft):	<b>13.5</b>
Structural Grade:	<b>0</b>
O&M Grade:	<b>0</b>
Clock Start/From:	
Clock To:	
1st Value:	
2nd Value:	
Value Percent:	
Continuous Index:	
Within 8" of Joint:	<b>NO</b>
Remarks:	<b>MCU</b>
