Profile/Photo Observation Report

Date:	04/09/2018	Weather:		Coding:	PACP 6.0
Pipe Length (ft):	222.0	Owner:	NA	Pre Clean:	Not Known
P.O.#:		Surveyor:	Byrd Fitzgerald	PSR:	P-804-055-054
Customer:		Clean Date:	01/01/1900	Shape:	C

Street:	N KELLY ST	Flow Control:	Not Controlled
City:	Hobart, IN	Year Renewed:	
Location:	Other	Tape/Media #:	
Purpose:	Not Known	Dia/Height:	12"
Use:	Sanitary	Material:	VCP
Drain Area:	NA	Lining:	
Category:	NA		
Comment:

Location Details:		Direction of Survey:	Downstream
US MH:	M-804-055	DS MH:	M-804-054
		Total Length Surveyed (ft):	30.8

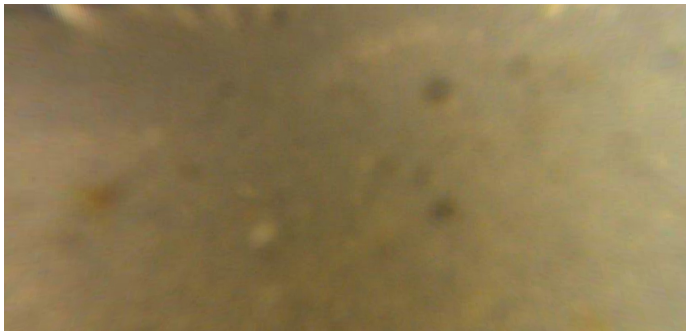
Code: **AMH**
Description: **Manhole**

Distance (ft): **.0**
Structural Grade: **0**
O&M Grade: **0**
Clock Start/From:
Clock To:
1st Value:
2nd Value:
Value Percent:
Continuous Index:
Within 8" of Joint: **NO**
Remarks: **M-804-055**

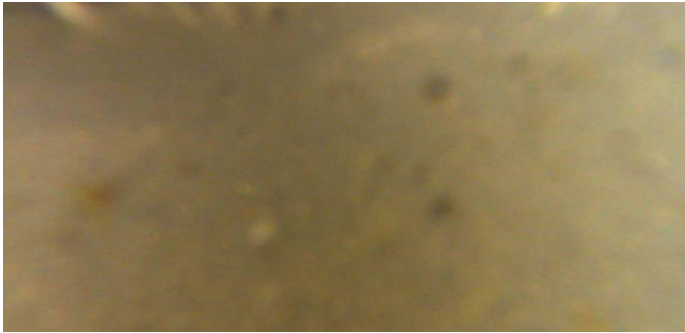
Code:	MWL
Description:	Water Level

Distance (ft):	.0
Structural Grade:	0
O&M Grade:	0
Clock Start/From:	
Clock To:	
1st Value:	
2nd Value:	
Value Percent:	100.000
Continuous Index:	
Within 8" of Joint:	NO
Remarks:	underwater

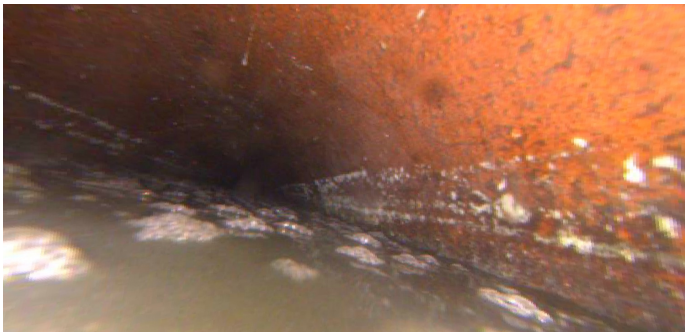
Code:	MWL
Description:	Water Level

Distance (ft):	1.8
Structural Grade:	0
O&M Grade:	0
Clock Start/From:	
Clock To:	
1st Value:	
2nd Value:	
Value Percent:	50.000
Continuous Index:	
Within 8" of Joint:	NO
Remarks:

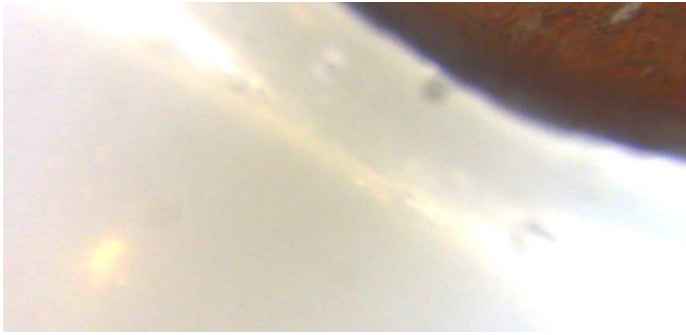
Code: **MCU**
Description: **Camera Underwater**

Distance (ft): **2.9**
Structural Grade: **0**
O&M Grade: **4**
Clock Start/From:
Clock To:
1st Value:
2nd Value:
Value Percent:
Continuous Index: **S01**
Within 8" of Joint: **NO**
Remarks:

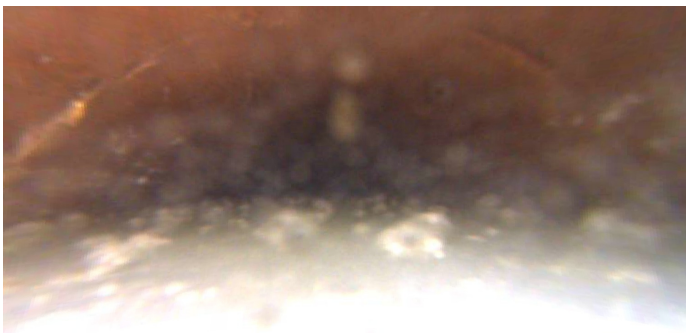
Code: **MCU**
Description: **Camera Underwater**

Distance (ft): **6.8**
Structural Grade: **0**
O&M Grade: **4**
Clock Start/From:
Clock To:
1st Value:
2nd Value:
Value Percent:
Continuous Index: **F01**
Within 8" of Joint: **NO**
Remarks:

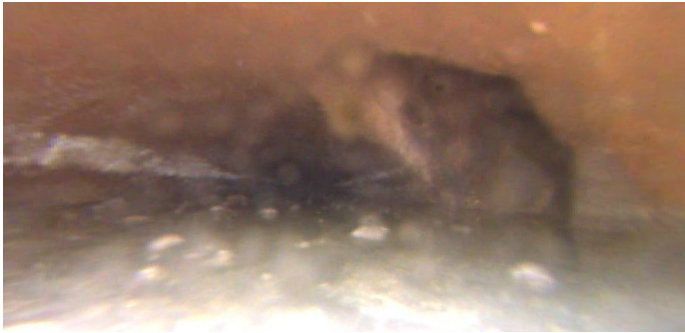
Code: **TF**
Description: **Tap Factory**

Distance (ft): **19.3**
Structural Grade: **0**
O&M Grade: **0**
Clock Start/From: **1**
Clock To:
1st Value: **4.000**
2nd Value:
Value Percent:
Continuous Index:
Within 8" of Joint: **YES**
Remarks:

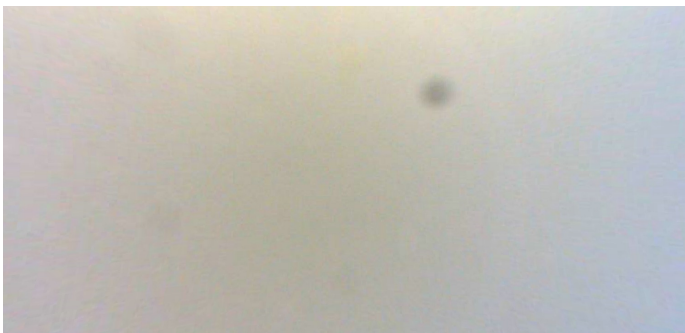
Code: **MCU**
Description: **Camera Underwater**

Distance (ft): **19.9**
Structural Grade: **0**
O&M Grade: **4**
Clock Start/From:
Clock To:
1st Value:
2nd Value:
Value Percent:
Continuous Index: **S02**
Within 8" of Joint: **NO**
Remarks:

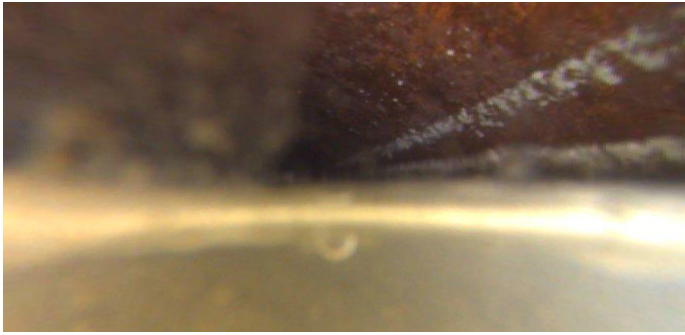
Code: **MCU**
Description: **Camera Underwater**

Distance (ft): **23.5**
Structural Grade: **0**
O&M Grade: **4**
Clock Start/From:
Clock To:
1st Value:
2nd Value:
Value Percent:
Continuous Index: **F02**
Within 8" of Joint: **NO**
Remarks:

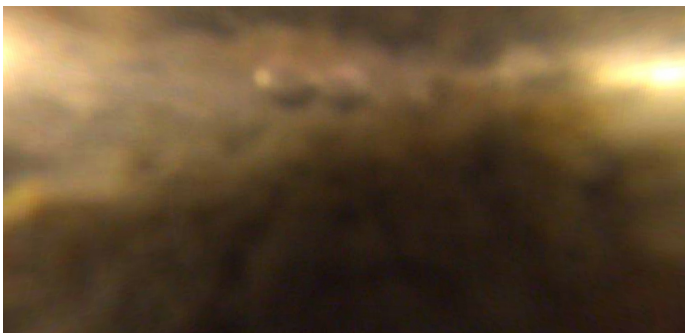
Code: **MCU**
Description: **Camera Underwater**

Distance (ft): **30.8**
Structural Grade: **0**
O&M Grade: **4**
Clock Start/From:
Clock To:
1st Value:
2nd Value:
Value Percent:
Continuous Index:
Within 8" of Joint: **NO**
Remarks:

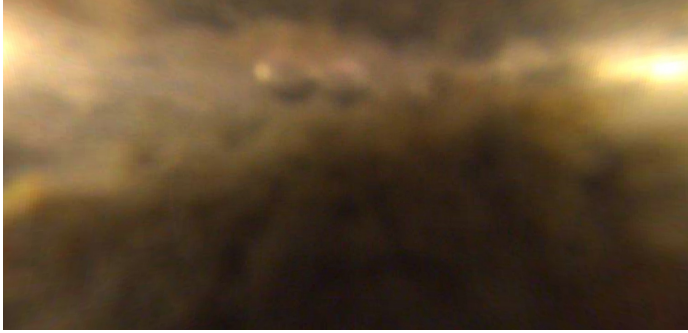
Code:	MSA
Description:	Abandoned Survey
Distance (ft):	30.8
Structural Grade:	0
O&M Grade:	0
Clock Start/From:	
Clock To:	
1st Value:	
2nd Value:	
Value Percent:	
Continuous Index:	
Within 8" of Joint:	NO
Remarks:	mcu
