Profile/Photo Observation Report

Date:	04/09/2018	Weather:		Coding:	PACP 6.0
Pipe Length (ft):	222.0	Owner:	NA	Pre Clean:	Not Known
P.O.#:		Surveyor:	Byrd Fitzgerald	PSR:	P-804-055-054
Customer:		Clean Date:	01/01/1900	Shape:	C

Street:	N Kelly St.	Flow Control:	Not Controlled
City:	Hobart, IN	Year Renewed:	
Location:	Other	Tape/Media #:	
Purpose:	Not Known	Dia/Height:	12"
Use:	Sanitary	Material:	VCP
Drain Area:	NA	Lining:	
Category:	NA		
Comment:			
Location Details:		Direction of Survey:	Downstream
US MH:	M-804-055	DS MH:	M-804-054
		Total Length Surveyed (ft):	30.8

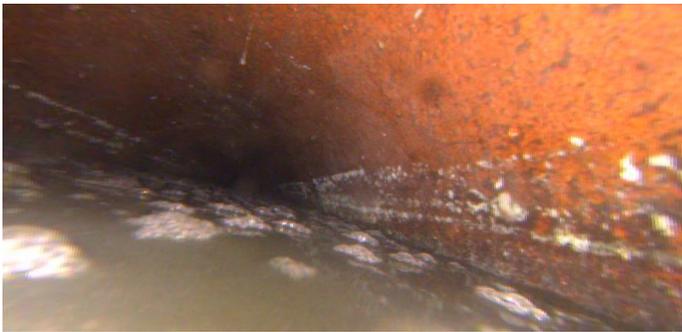
Code: **MWL**
Description: **Water Level**

Distance (ft): **1.8**
Structural Grade: **0**
O&M Grade: **0**
Clock Start/From:
Clock To:
1st Value:
2nd Value:
Value Percent: **50.000**
Continuous Index:
Within 8" of Joint: **NO**
Remarks:

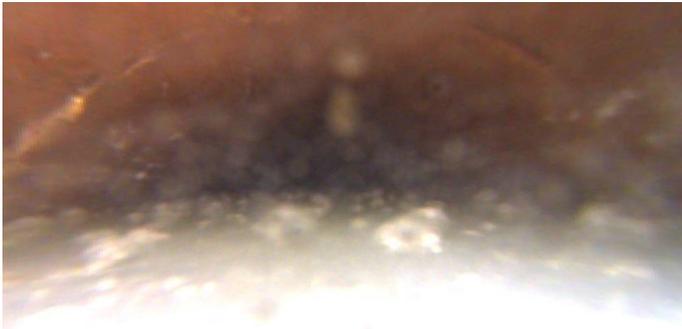
Code: **MCU**
Description: **Camera Underwater**

Distance (ft): **6.8**
Structural Grade: **0**
O&M Grade: **4**
Clock Start/From:
Clock To:
1st Value:
2nd Value:
Value Percent:
Continuous Index: **F01**
Within 8" of Joint: **NO**
Remarks:

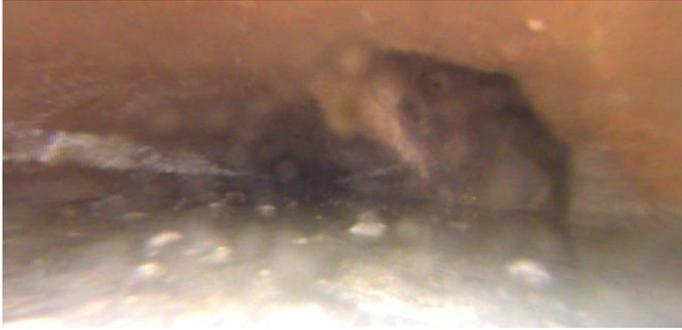
Code: **TF**
Description: **Tap Factory**

Distance (ft): **19.3**
Structural Grade: **0**
O&M Grade: **0**
Clock Start/From: **1**
Clock To:
1st Value: **4.000**
2nd Value:
Value Percent:
Continuous Index:
Within 8" of Joint: **YES**
Remarks:

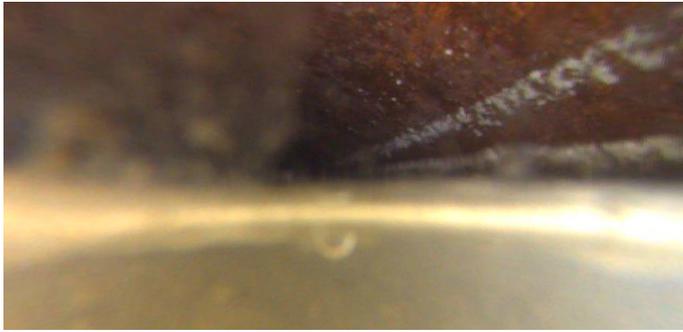
Code: **MCU**
Description: **Camera Underwater**

Distance (ft): **23.5**
Structural Grade: **0**
O&M Grade: **4**
Clock Start/From:
Clock To:
1st Value:
2nd Value:
Value Percent:
Continuous Index: **F02**
Within 8" of Joint: **NO**
Remarks:
