## Profile/Photo Observation Report

Street:	<b>N KELLY ST</b>	Flow Control:	<b>Not Controlled</b>
City:	<b>Hobart, IN</b>	Year Renewed:	
Location:	<b>Other</b>	Tape/Media #:	
Purpose:	<b>Not Known</b>	Dia/Height:	<b>12"</b>
Use:	<b>Sanitary</b>	Material:	<b>VCP</b>
Drain Area:	<b>NA</b>	Lining:	
Category:	<b>NA</b>		
Comment:

Location Details:		Direction of Survey:	<b>Upstream</b>
US MH:	<b>M-804-056</b>	DS MH:	<b>M-804-055</b>
		Total Length Surveyed (ft):	<b>3.1</b>

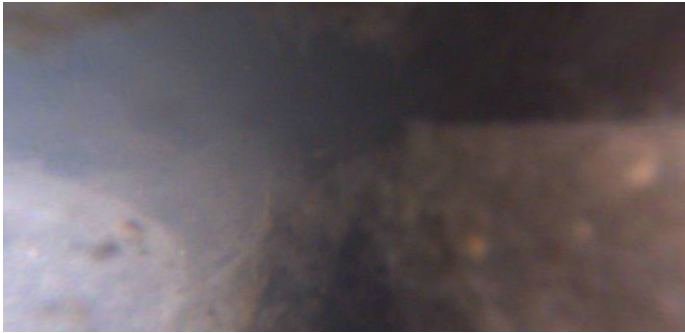
Code:	<b>MWL</b>
Description:	<b>Water Level</b>

Distance (ft):	<b>.0</b>
Structural Grade:	<b>0</b>
O&M Grade:	<b>0</b>
Clock Start/From:	
Clock To:	
1st Value:	
2nd Value:	
Value Percent:	<b>100.000</b>
Continuous Index:	
Within 8" of Joint:	<b>NO</b>
Remarks:
