Profile/Photo Observation Report

Street:	N KELLY ST	Flow Control:	Not Controlled
City:	Hobart, IN	Year Renewed:	
Location:	Other	Tape/Media #:	
Purpose:	Not Known	Dia/Height:	12"
Use:	Sanitary	Material:	VCP
Drain Area:	NA	Lining:	
Category:	NA		
Comment:	NULL - CNA DC at MH-M-804-023

Location Details:		Direction of Survey:	Downstream
US MH:	M-804-056	DS MH:	M-804-055
		Total Length Surveyed (ft):	9.6

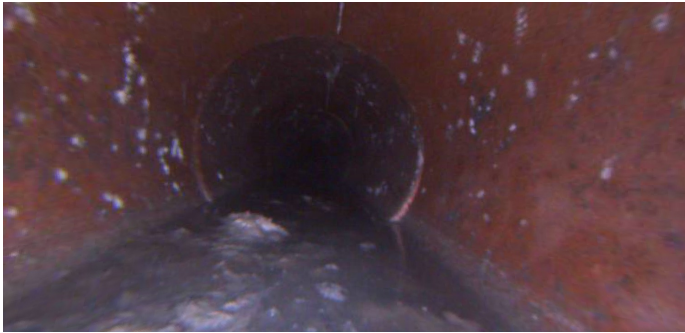
Code:	MWL
Description:	Water Level

Distance (ft):	.0
Structural Grade:	0
O&M Grade:	0
Clock Start/From:	
Clock To:	
1st Value:	
2nd Value:	
Value Percent:	10.000
Continuous Index:	
Within 8" of Joint:	NO
Remarks:

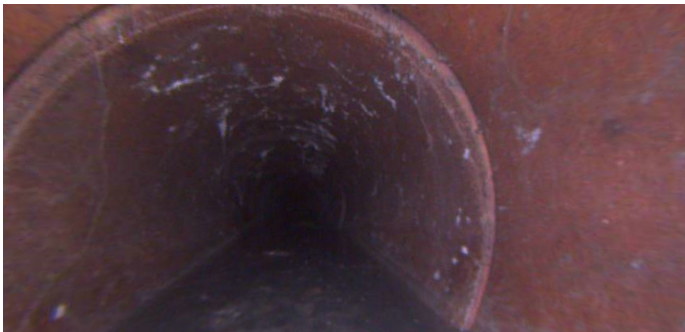
Code:	CM
Description:	Crack Multiple

Distance (ft):	3.9
Structural Grade:	3
O&M Grade:	0
Clock Start/From:	8
Clock To:	4
1st Value:	
2nd Value:	
Value Percent:	
Continuous Index:	
Within 8" of Joint:	YES
Remarks:

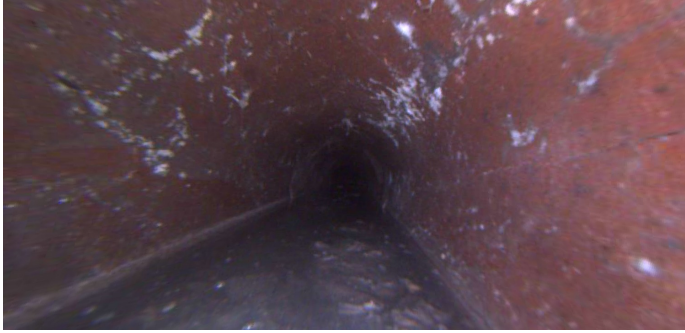
Code: **FM**
Description: **Fracture Multiple**

Distance (ft): **6.3**
Structural Grade: **4**
O&M Grade: **0**
Clock Start/From: **8**
Clock To: **4**
1st Value:
2nd Value:
Value Percent:
Continuous Index:
Within 8" of Joint: **YES**
Remarks:

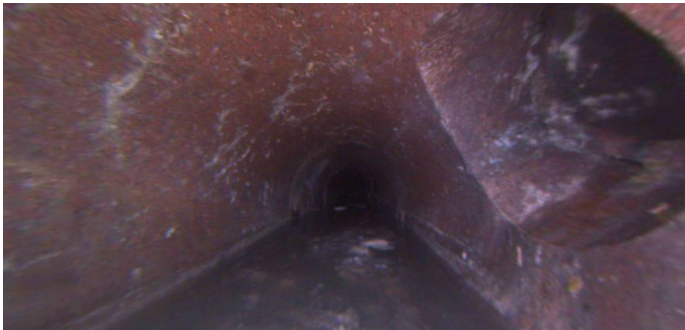
Code: **TF**
Description: **Tap Factory**

Distance (ft): **8.7**
Structural Grade: **0**
O&M Grade: **0**
Clock Start/From: **2**
Clock To:
1st Value: **4.000**
2nd Value:
Value Percent:
Continuous Index:
Within 8" of Joint:
Remarks:

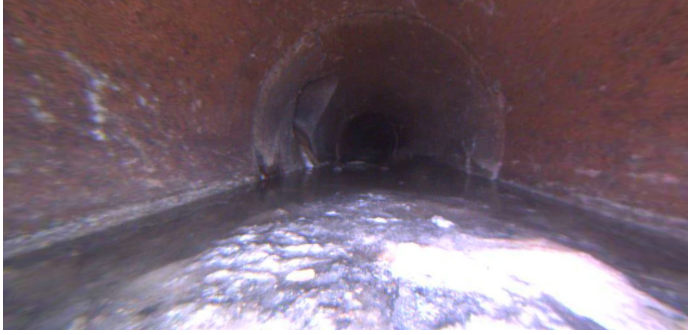
Code:	MSA
Description:	Abandoned Survey
Distance (ft):	9.6
Structural Grade:	0
O&M Grade:	0
Clock Start/From:	
Clock To:	
1st Value:	
2nd Value:	
Value Percent:	
Continuous Index:	
Within 8" of Joint:	NO
Remarks:	DEBRIS UNDER WATER
