Profile/Photo Observation Report

Street:	N Kelly St.	Flow Control:	Not Controlled
City:	Hobart, IN	Year Renewed:	
Location:	Other	Tape/Media #:	
Purpose:	Not Known	Dia/Height:	12"
Use:	Sanitary	Material:	VCP
Drain Area:	NA	Lining:	
Category:	NA		
Comment:	NULL - CNA DC at MH-M-804-023

Location Details:		Direction of Survey:	Downstream
US MH:	M-804-056	DS MH:	M-804-055
		Total Length Surveyed (ft):	9.6

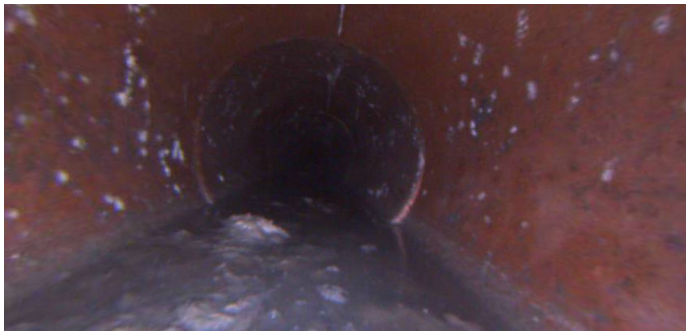
Code: **AMH**
Description: **Manhole**

Distance (ft): **.0**
Structural Grade: **0**
O&M Grade: **0**
Clock Start/From:
Clock To:
1st Value:
2nd Value:
Value Percent:
Continuous Index:
Within 8" of Joint: **NO**
Remarks: **M-804-056**

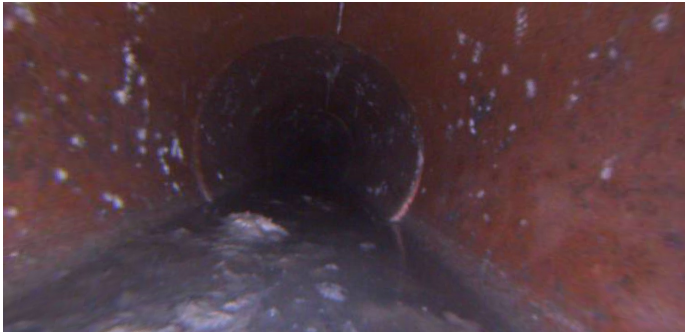
Code:	MWL
Description:	Water Level

Distance (ft):	.0
Structural Grade:	0
O&M Grade:	0
Clock Start/From:	
Clock To:	
1st Value:	
2nd Value:	
Value Percent:	10.000
Continuous Index:	
Within 8" of Joint:	NO
Remarks:

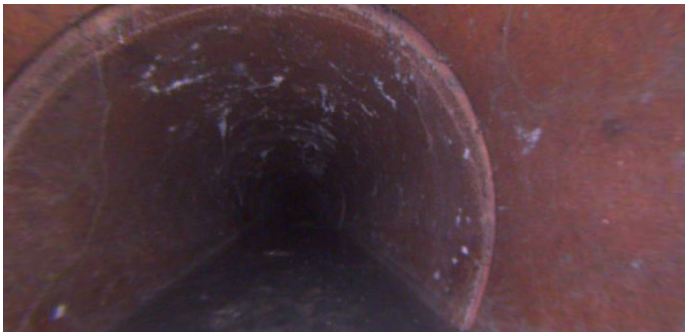
Code:	CM
Description:	Crack Multiple

Distance (ft):	3.9
Structural Grade:	3
O&M Grade:	0
Clock Start/From:	8
Clock To:	4
1st Value:	
2nd Value:	
Value Percent:	
Continuous Index:	
Within 8" of Joint:	YES
Remarks:

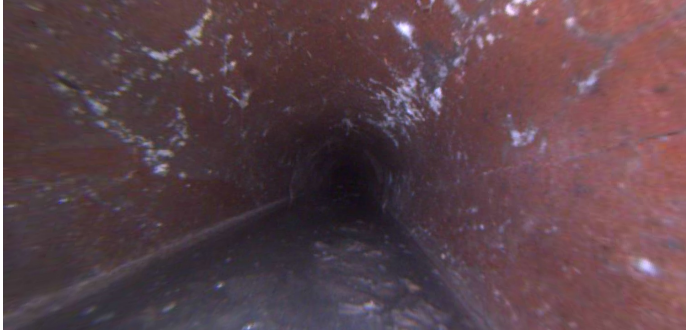
Code: **FM**
Description: **Fracture Multiple**

Distance (ft): **6.3**
Structural Grade: **4**
O&M Grade: **0**
Clock Start/From: **8**
Clock To: **4**
1st Value:
2nd Value:
Value Percent:
Continuous Index:
Within 8" of Joint: **YES**
Remarks:

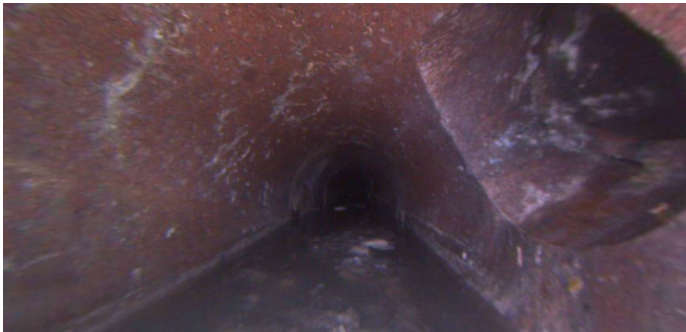
Code: **TF**
Description: **Tap Factory**

Distance (ft): **8.7**
Structural Grade: **0**
O&M Grade: **0**
Clock Start/From: **2**
Clock To:
1st Value: **4.000**
2nd Value:
Value Percent:
Continuous Index:
Within 8" of Joint:
Remarks:

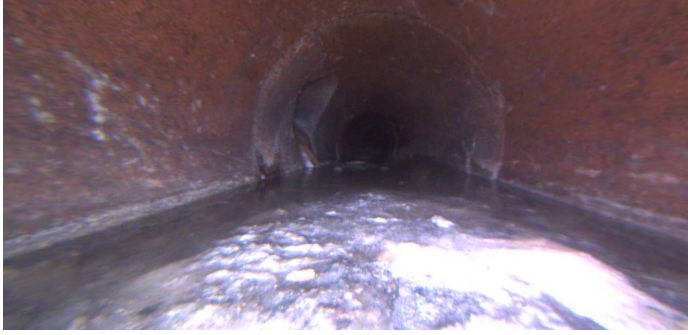
Code:	MSA
Description:	Abandoned Survey
Distance (ft):	9.6
Structural Grade:	0
O&M Grade:	0
Clock Start/From:	
Clock To:	
1st Value:	
2nd Value:	
Value Percent:	
Continuous Index:	
Within 8" of Joint:	NO
Remarks:	DEBRIS UNDER WATER
