Profile/Photo Observation Report

Location Details:		Direction of Survey:	Downstream
US MH:	M-804-056	DS MH:	M-804-055
		Total Length Surveyed (ft):	9.9

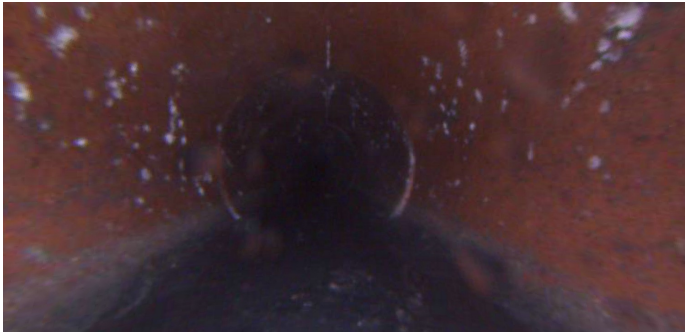
Code:	MWL
Description:	Water Level

Distance (ft):	.0
Structural Grade:	0
O&M Grade:	0
Clock Start/From:	
Clock To:	
1st Value:	
2nd Value:	
Value Percent:	10.000
Continuous Index:	
Within 8" of Joint:	NO
Remarks:

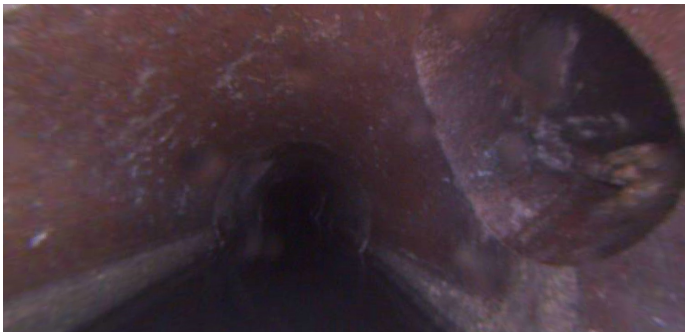
Code:	TF
Description:	Tap Factory

Distance (ft):	8.6
Structural Grade:	0
O&M Grade:	0
Clock Start/From:	2
Clock To:	
1st Value:	4.000
2nd Value:	
Value Percent:	
Continuous Index:	
Within 8" of Joint:	
Remarks:

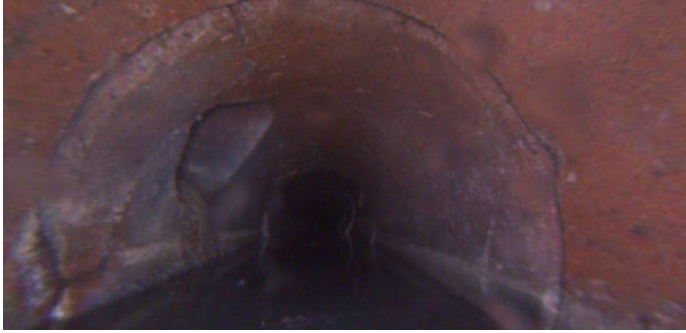
Code: **FM**
Description: **Fracture Multiple**

Distance (ft): **9.9**
Structural Grade: **4**
O&M Grade: **0**
Clock Start/From: **8**
Clock To: **4**
1st Value:
2nd Value:
Value Percent:
Continuous Index:
Within 8" of Joint: **YES**
Remarks:

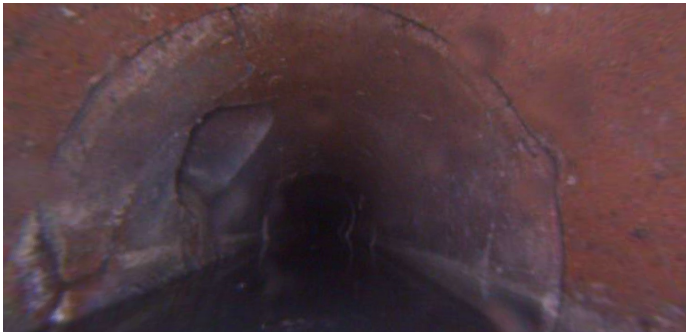
Code: **MSA**
Description: **Abandoned Survey**

Distance (ft): **9.9**
Structural Grade: **0**
O&M Grade: **0**
Clock Start/From:
Clock To:
1st Value:
2nd Value:
Value Percent:
Continuous Index:
Within 8" of Joint: **NO**
Remarks: **debris under water**
