Profile/Photo Observation Report

Street:	N Kelly St.	Flow Control:	Not Controlled
City:	Hobart, IN	Year Renewed:	
Location:	Other	Tape/Media #:	
Purpose:	Not Known	Dia/Height:	12"
Use:	Sanitary	Material:	VCP
Drain Area:	NA	Lining:	
Category:	NA		
Comment:	NULL - CNA DC at MH-M-804-023

Location Details:		Direction of Survey:	Downstream
US MH:	M-804-056	DS MH:	M-804-055
		Total Length Surveyed (ft):	9.9

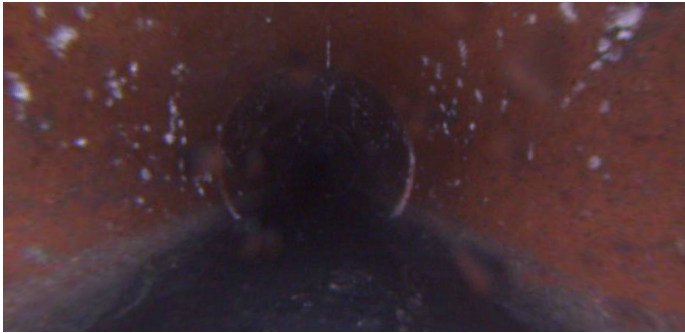
Code:	MWL
Description:	Water Level

Distance (ft):	.0
Structural Grade:	0
O&M Grade:	0
Clock Start/From:	
Clock To:	
1st Value:	
2nd Value:	
Value Percent:	10.000
Continuous Index:	
Within 8" of Joint:	NO
Remarks:

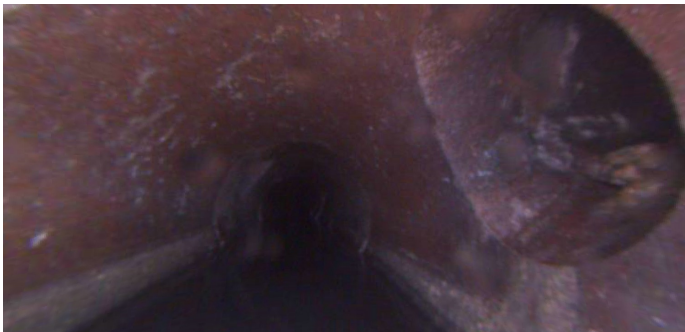
Code:	TF
Description:	Tap Factory

Distance (ft):	8.6
Structural Grade:	0
O&M Grade:	0
Clock Start/From:	2
Clock To:	
1st Value:	4.000
2nd Value:	
Value Percent:	
Continuous Index:	
Within 8" of Joint:	
Remarks:

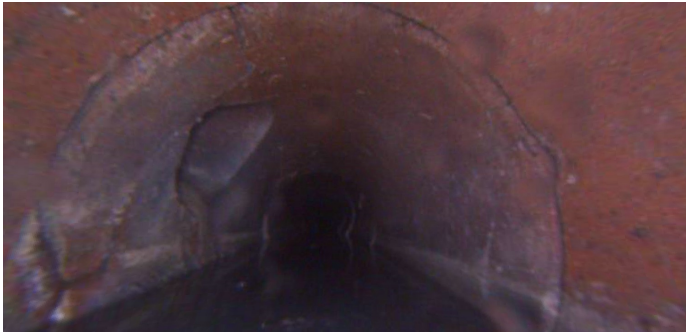
Code: **FM**
Description: **Fracture Multiple**

Distance (ft): **9.9**
Structural Grade: **4**
O&M Grade: **0**
Clock Start/From: **8**
Clock To: **4**
1st Value:
2nd Value:
Value Percent:
Continuous Index:
Within 8" of Joint: **YES**
Remarks:

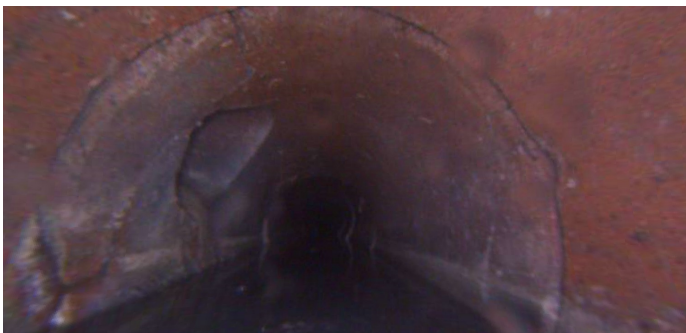
Code: **MSA**
Description: **Abandoned Survey**

Distance (ft): **9.9**
Structural Grade: **0**
O&M Grade: **0**
Clock Start/From:
Clock To:
1st Value:
2nd Value:
Value Percent:
Continuous Index:
Within 8" of Joint: **NO**
Remarks: **debris under water**
