## Profile/Photo Observation Report

Date:	<b>10/17/2021</b>	Weather:		Coding:	<b>PACP 7.0</b>
Pipe Length (ft):	<b>216.9</b>	Owner:	<b>City of Hobart</b>	Pre Clean:	<b>Heavy Cleaning</b>
P.O.#:	<b>YES502259</b>	Surveyor:	<b>S. Bucklin</b>	PSR:	<b>P-804-056-055</b>
Customer:	<b>City of Hobart</b>	Clean Date:	<b>10/13/2021</b>	Shape:	<b>C</b>

Street:	<b>North Kelly Street</b>	Flow Control:	<b>Not Controlled</b>
City:	<b>Hobart, IN</b>	Year Renewed:	
Location:	<b>Local rural streets with light traffic, t</b>	Tape/Media #:	
Purpose:	<b>Routine Assessment</b>	Dia/Height:	<b>12"</b>
Use:	<b>Sanitary Sewage Pipe</b>	Material:	<b>VCP</b>
Drain Area:		Lining:	
Category:	<b>NA</b>		
Comment:			
Location Details:		Direction of Survey:	<b>Downstream</b>
US MH:	<b>M-804-056</b>	DS MH:	<b>M-804-055</b>
		Total Length Surveyed (ft):	<b>216.9</b>

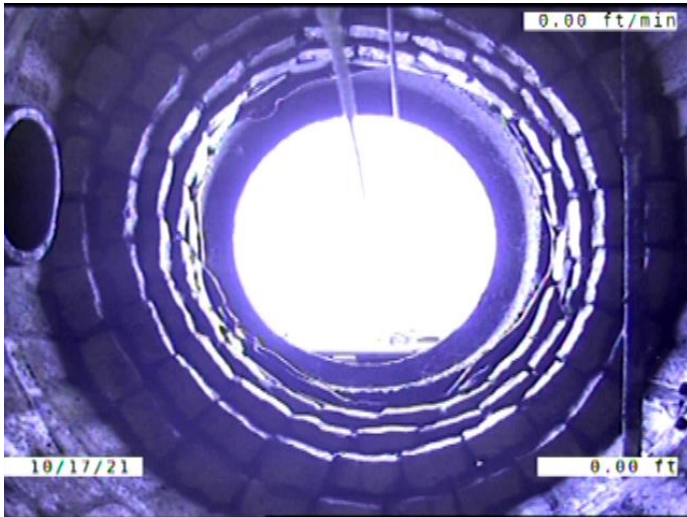
Code: **AMH**  
Description: **Manhole**

Distance (ft): **.0**  
Structural Grade: **0**  
O&M Grade: **0**  
Clock Start/From:  
Clock To:  
1st Value:  
2nd Value:  
Value Percent:  
Continuous Index:  
Within 8" of Joint: **NO**  
Remarks: **M-804-056**

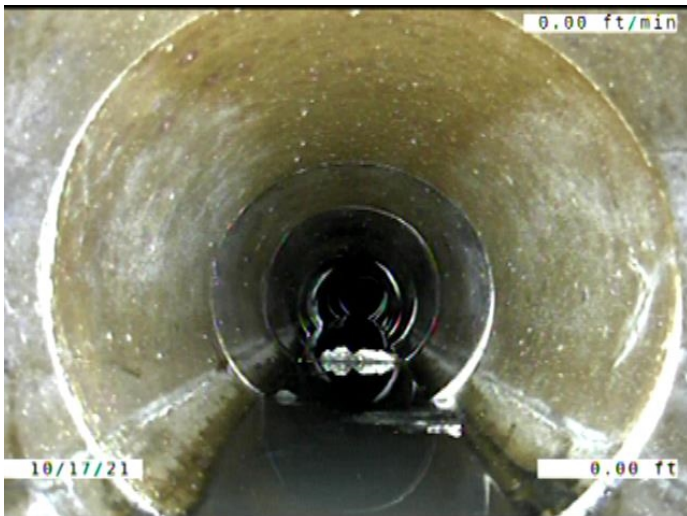
Code: **MWL**  
Description: **Miscellaneous Water Level**

Distance (ft): **.0**  
Structural Grade: **0**  
O&M Grade: **0**  
Clock Start/From:  
Clock To:  
1st Value:  
2nd Value:  
Value Percent: **5.000**  
Continuous Index:  
Within 8" of Joint: **NO**  
Remarks:

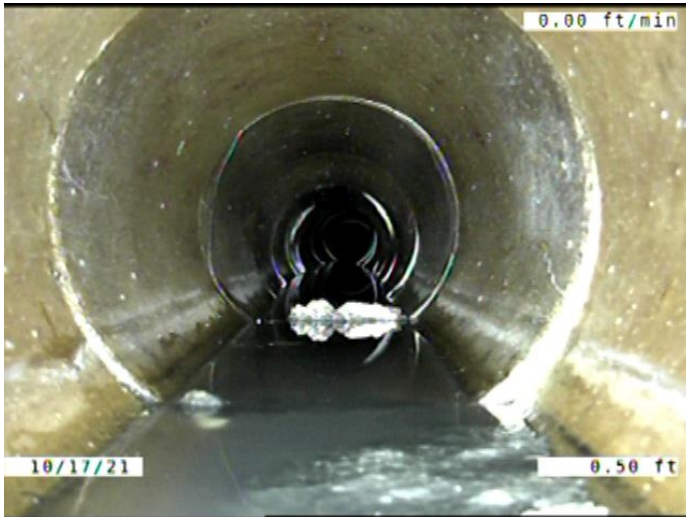
Code: **DSF**  
 Description: **Deposits Settled Fine**

Distance (ft): **.5**  
 Structural Grade: **0**  
 O&M Grade: **2**  
 Clock Start/From: **5**  
 Clock To: **7**  
 1st Value:  
 2nd Value:  
 Value Percent: **5.000**  
 Continuous Index: **S01**  
 Within 8" of Joint: **YES**  
 Remarks:

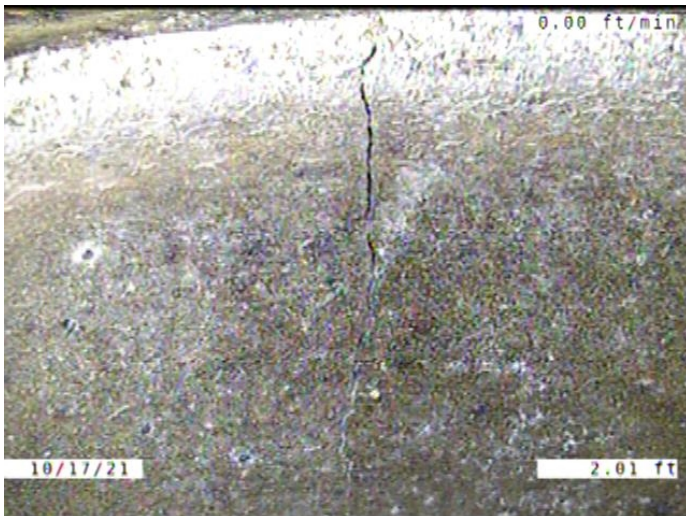
Code: **CL**  
 Description: **Crack Longitudinal**

Distance (ft): **2.0**  
 Structural Grade: **2**  
 O&M Grade: **0**  
 Clock Start/From: **10**  
 Clock To:  
 1st Value:  
 2nd Value:  
 Value Percent:  
 Continuous Index:  
 Within 8" of Joint: **YES**  
 Remarks:

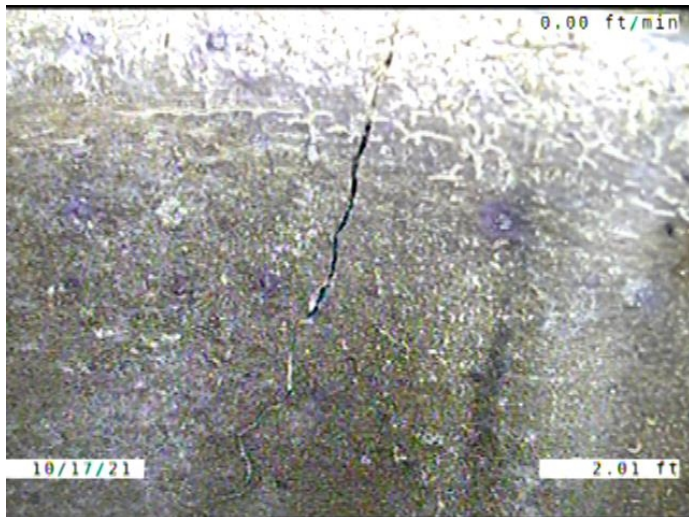
Code: **CS**  
 Description: **Crack Spiral**

Distance (ft): **2.0**  
 Structural Grade: **2**  
 O&M Grade: **0**  
 Clock Start/From: **3**  
 Clock To: **4**  
 1st Value:  
 2nd Value:  
 Value Percent:  
 Continuous Index:  
 Within 8" of Joint: **YES**  
 Remarks:

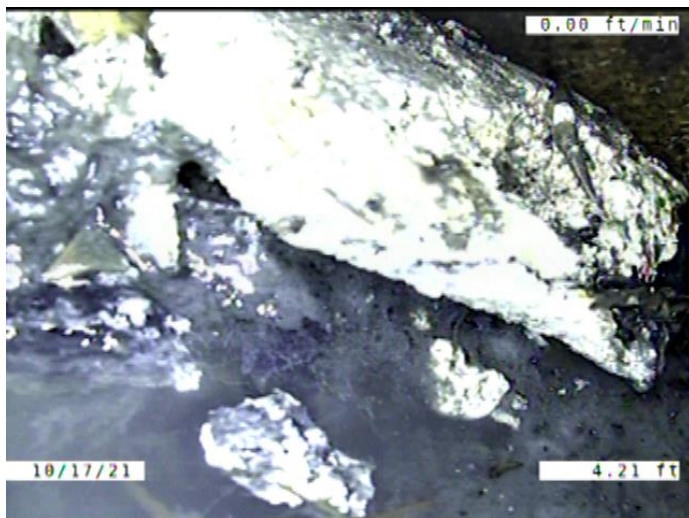
Code: **DAGS**  
 Description: **Deposits Attached Grease**

Distance (ft): **4.2**  
 Structural Grade: **0**  
 O&M Grade: **2**  
 Clock Start/From: **4**  
 Clock To: **8**  
 1st Value:  
 2nd Value:  
 Value Percent: **5.000**  
 Continuous Index:  
 Within 8" of Joint: **YES**  
 Remarks:

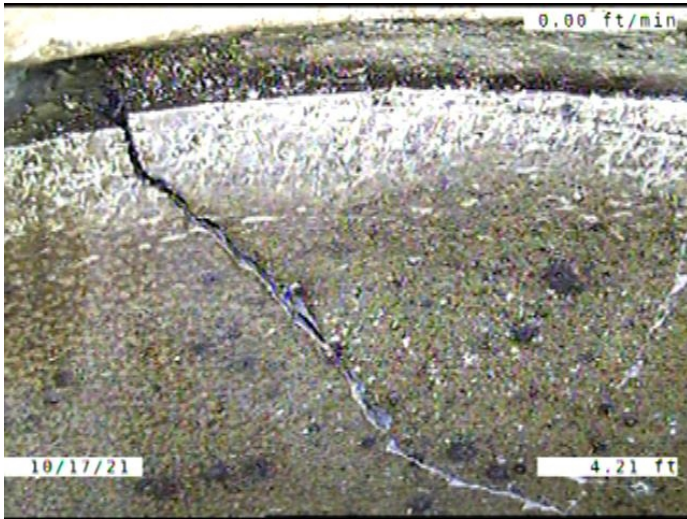
Code: **B**  
Description: **Broken**

Distance (ft): **4.2**  
Structural Grade: **4**  
O&M Grade: **0**  
Clock Start/From: **8**  
Clock To: **11**  
1st Value:  
2nd Value:  
Value Percent:  
Continuous Index:  
Within 8" of Joint: **YES**  
Remarks:

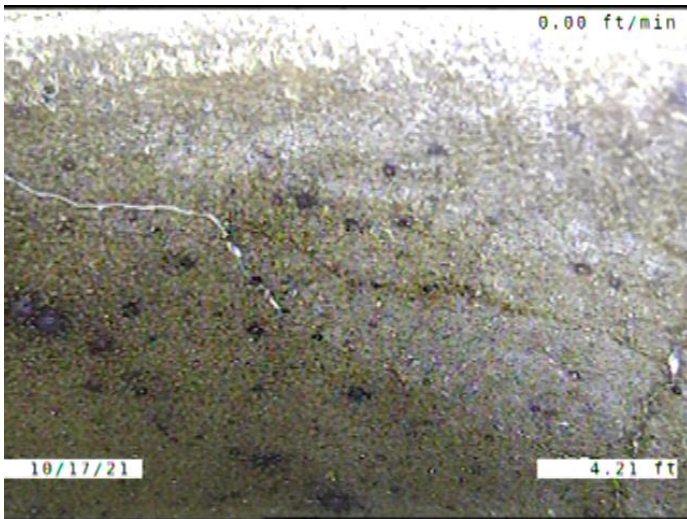
Code: **CM**  
Description: **Crack Multiple**

Distance (ft): **4.2**  
Structural Grade: **3**  
O&M Grade: **0**  
Clock Start/From: **1**  
Clock To: **3**  
1st Value:  
2nd Value:  
Value Percent:  
Continuous Index:  
Within 8" of Joint: **YES**  
Remarks:

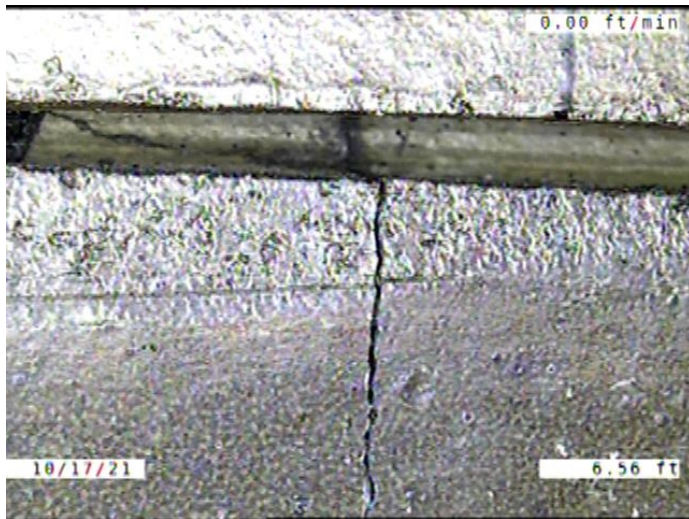
Code: **FM**  
Description: **Fracture Multiple**

Distance (ft): **6.6**  
Structural Grade: **4**  
O&M Grade: **0**  
Clock Start/From: **12**  
Clock To: **12**  
1st Value:  
2nd Value:  
Value Percent:  
Continuous Index: **S02**  
Within 8" of Joint: **YES**  
Remarks: **Wandering**

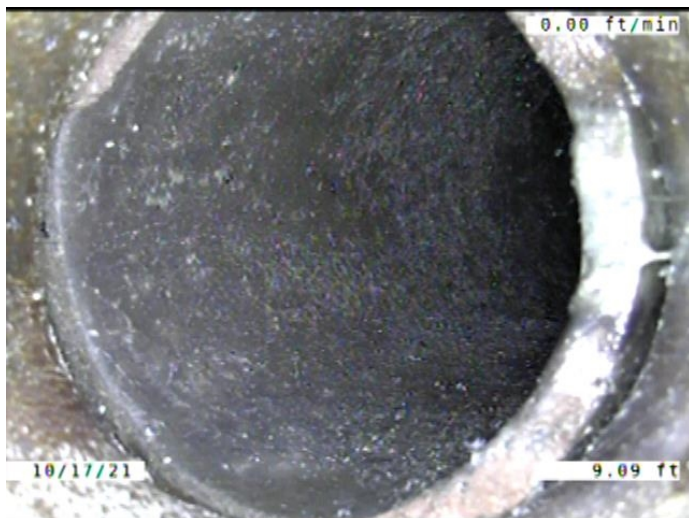
Code: **TF**  
Description: **Tap Factory**

Distance (ft): **9.1**  
Structural Grade: **0**  
O&M Grade: **0**  
Clock Start/From: **2**  
Clock To:  
1st Value: **4.000**  
2nd Value:  
Value Percent:  
Continuous Index:  
Within 8" of Joint: **YES**  
Remarks:

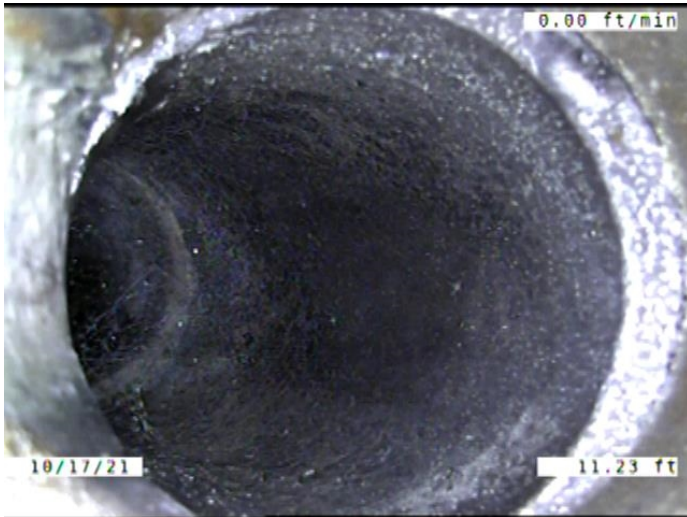
Code: **TF**  
 Description: **Tap Factory**

Distance (ft): **11.2**  
 Structural Grade: **0**  
 O&M Grade: **0**  
 Clock Start/From: **10**  
 Clock To:  
 1st Value: **4.000**  
 2nd Value:  
 Value Percent:  
 Continuous Index:  
 Within 8" of Joint: **YES**  
 Remarks:

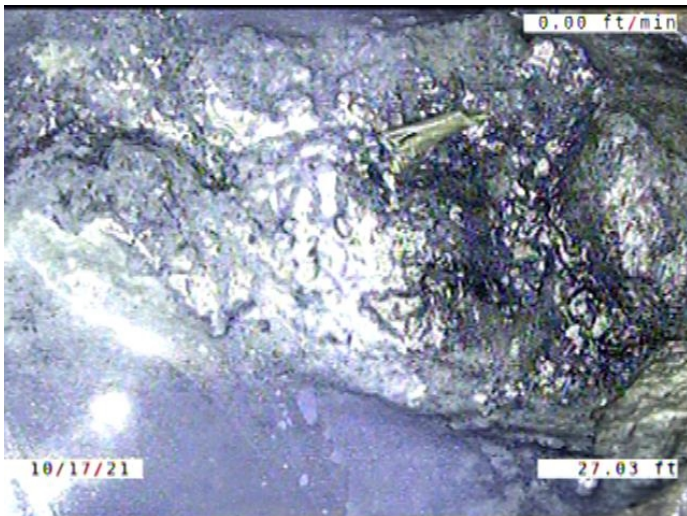
Code: **DAE**  
 Description: **Deposits Attached Encrustation**

Distance (ft): **27.0**  
 Structural Grade: **0**  
 O&M Grade: **2**  
 Clock Start/From: **3**  
 Clock To: **8**  
 1st Value:  
 2nd Value:  
 Value Percent: **5.000**  
 Continuous Index: **S03**  
 Within 8" of Joint: **YES**  
 Remarks:

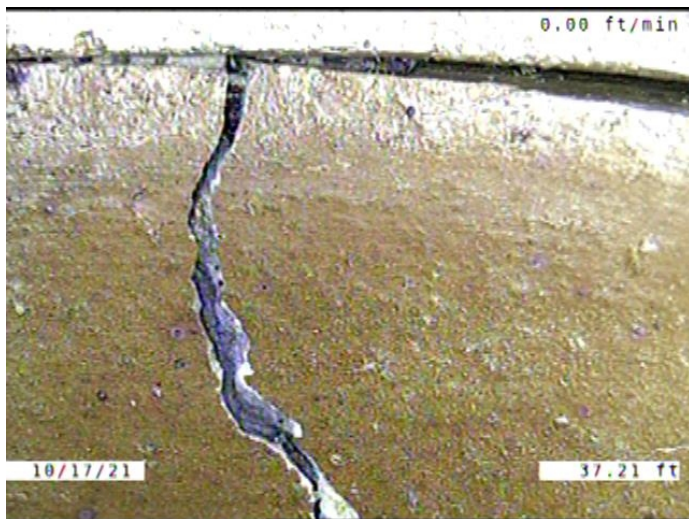
Code: **B**  
 Description: **Broken**

Distance (ft): **37.2**  
 Structural Grade: **4**  
 O&M Grade: **0**  
 Clock Start/From: **2**  
 Clock To: **5**  
 1st Value:  
 2nd Value:  
 Value Percent:  
 Continuous Index:  
 Within 8" of Joint: **YES**  
 Remarks:

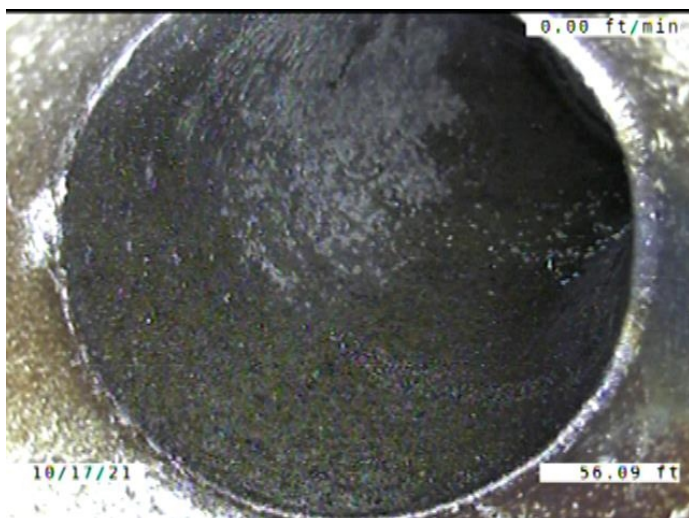
Code: **TF**  
 Description: **Tap Factory**

Distance (ft): **56.1**  
 Structural Grade: **0**  
 O&M Grade: **0**  
 Clock Start/From: **2**  
 Clock To:  
 1st Value: **4.000**  
 2nd Value:  
 Value Percent:  
 Continuous Index:  
 Within 8" of Joint: **YES**  
 Remarks:

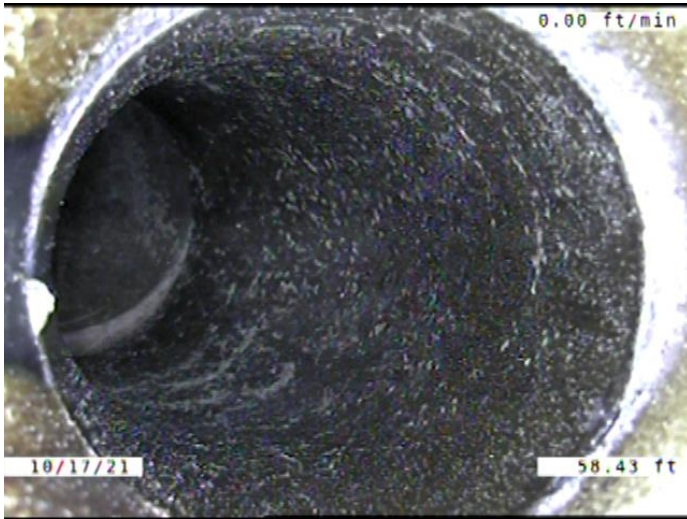
Code: **TF**  
Description: **Tap Factory**

Distance (ft): **58.4**  
Structural Grade: **0**  
O&M Grade: **0**  
Clock Start/From: **10**  
Clock To:  
1st Value: **4.000**  
2nd Value:  
Value Percent:  
Continuous Index:  
Within 8" of Joint: **YES**  
Remarks:

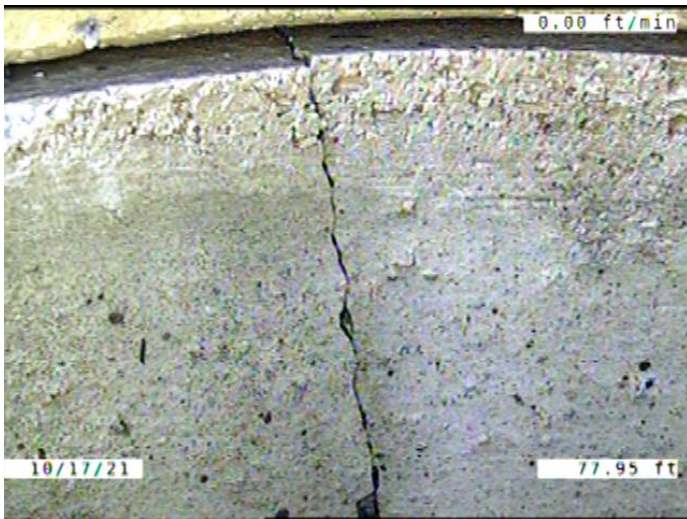
Code: **B**  
Description: **Broken**

Distance (ft): **78.0**  
Structural Grade: **4**  
O&M Grade: **0**  
Clock Start/From: **9**  
Clock To: **12**  
1st Value:  
2nd Value:  
Value Percent:  
Continuous Index:  
Within 8" of Joint: **YES**  
Remarks:

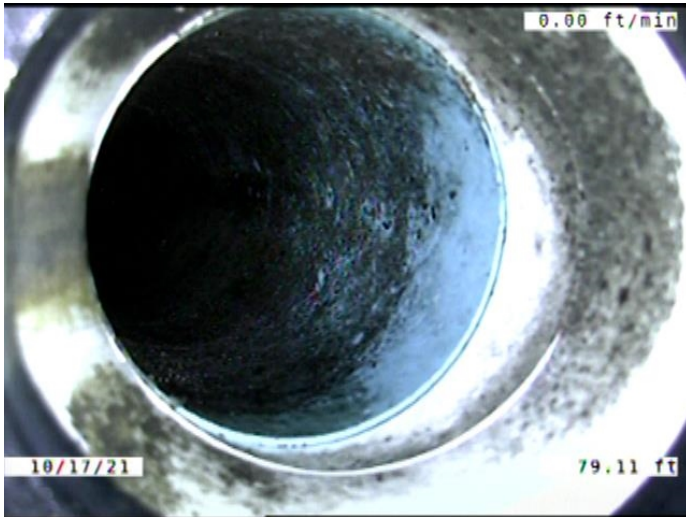
Code: **TB**  
 Description: **Tap Break-in/Hammer**

Distance (ft): **79.1**  
 Structural Grade: **0**  
 O&M Grade: **0**  
 Clock Start/From: **10**  
 Clock To:  
 1st Value: **4.000**  
 2nd Value:  
 Value Percent:  
 Continuous Index:  
 Within 8" of Joint: **YES**  
 Remarks:

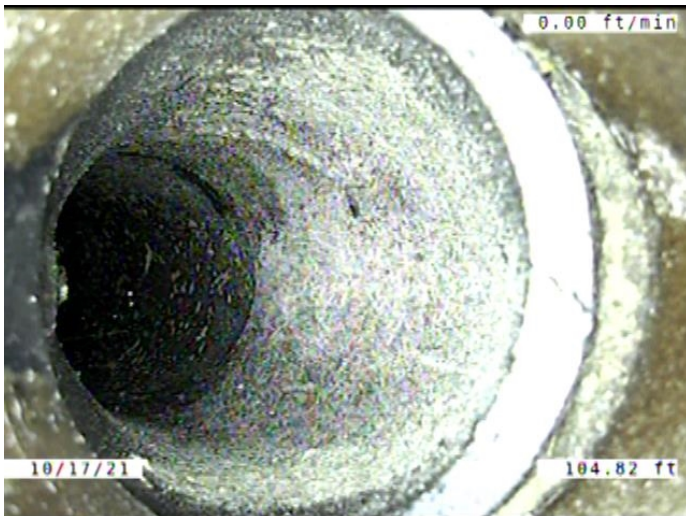
Code: **TF**  
 Description: **Tap Factory**

Distance (ft): **104.8**  
 Structural Grade: **0**  
 O&M Grade: **0**  
 Clock Start/From: **10**  
 Clock To:  
 1st Value: **4.000**  
 2nd Value:  
 Value Percent:  
 Continuous Index:  
 Within 8" of Joint: **YES**  
 Remarks:

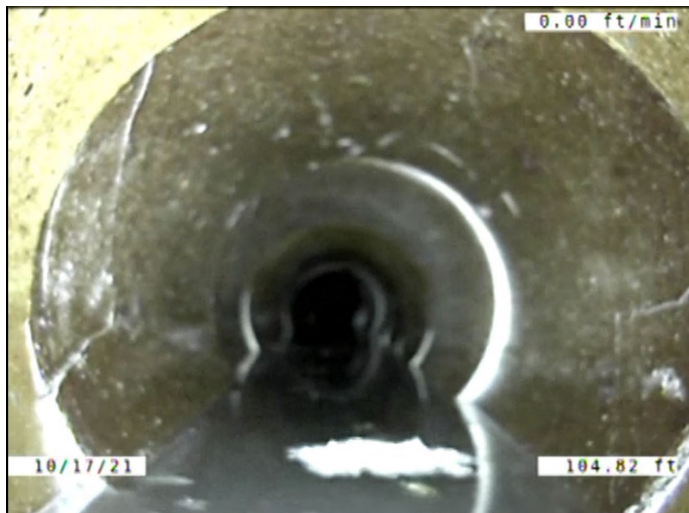
Code: **B**  
 Description: **Broken**

Distance (ft): **104.8**  
 Structural Grade: **4**  
 O&M Grade: **0**  
 Clock Start/From: **8**  
 Clock To: **10**  
 1st Value:  
 2nd Value:  
 Value Percent:  
 Continuous Index:  
 Within 8" of Joint: **YES**  
 Remarks:

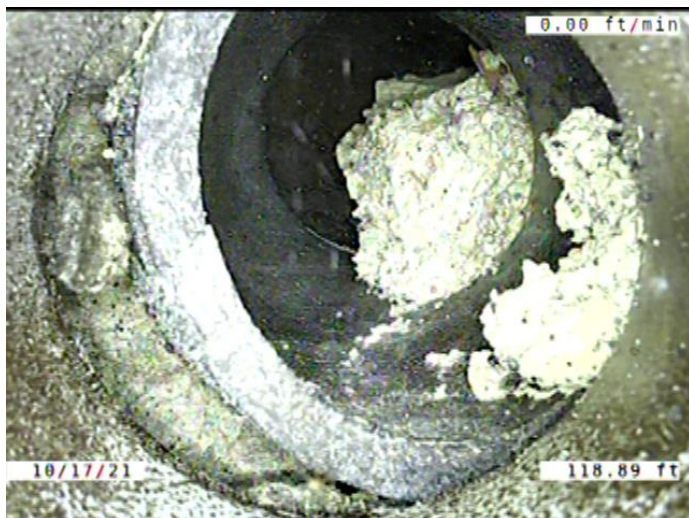
Code: **TFD**  
 Description: **Tap Factory Defective**

Distance (ft): **118.9**  
 Structural Grade: **0**  
 O&M Grade: **3**  
 Clock Start/From: **2**  
 Clock To:  
 1st Value: **4.000**  
 2nd Value:  
 Value Percent:  
 Continuous Index:  
 Within 8" of Joint: **YES**  
 Remarks: **LARGE OFFSET. SOIL VISIBLE**

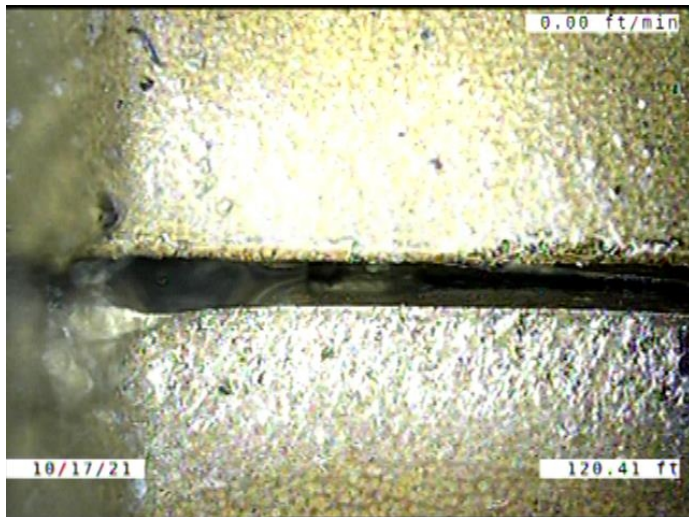
Code: **IRJ**  
 Description: **Infiltration Runner Joint**

Distance (ft): **120.4**  
 Structural Grade: **0**  
 O&M Grade: **4**  
 Clock Start/From: **8**  
 Clock To: **9**  
 1st Value:  
 2nd Value:  
 Value Percent:  
 Continuous Index:  
 Within 8" of Joint: **YES**  
 Remarks:

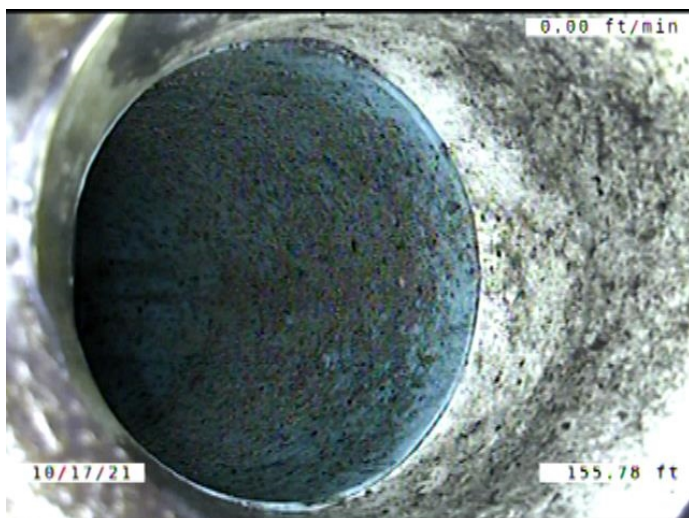
Code: **TF**  
 Description: **Tap Factory**

Distance (ft): **155.8**  
 Structural Grade: **0**  
 O&M Grade: **0**  
 Clock Start/From: **10**  
 Clock To:  
 1st Value: **4.000**  
 2nd Value:  
 Value Percent:  
 Continuous Index:  
 Within 8" of Joint: **YES**  
 Remarks:

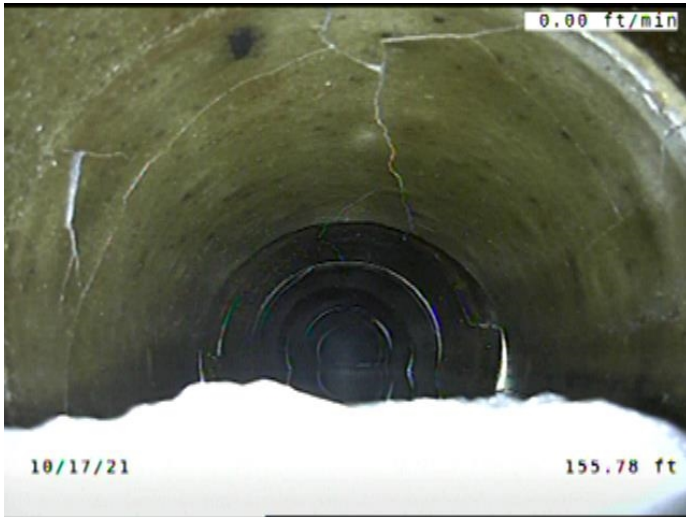
Code: **DAR**  
 Description: **Deposits Attached Ragging**

Distance (ft): **155.8**  
 Structural Grade: **0**  
 O&M Grade: **3**  
 Clock Start/From: **4**  
 Clock To: **8**  
 1st Value:  
 2nd Value:  
 Value Percent: **20.000**  
 Continuous Index:  
 Within 8" of Joint: **YES**  
 Remarks:

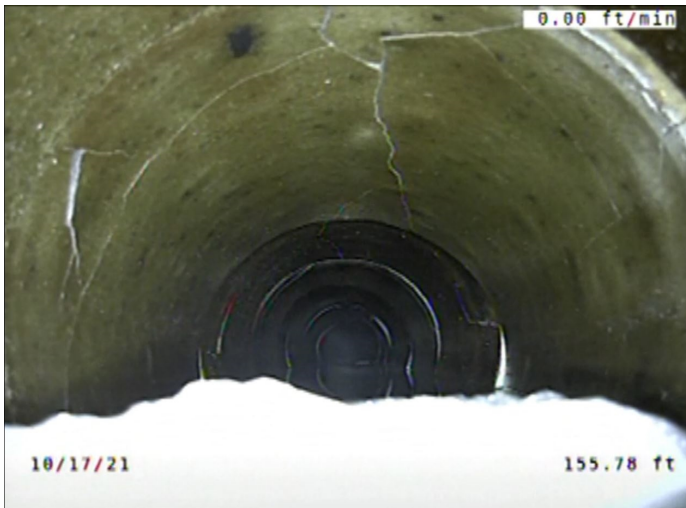
Code: **B**  
 Description: **Broken**

Distance (ft): **155.8**  
 Structural Grade: **4**  
 O&M Grade: **0**  
 Clock Start/From: **10**  
 Clock To: **1**  
 1st Value:  
 2nd Value:  
 Value Percent:  
 Continuous Index:  
 Within 8" of Joint: **YES**  
 Remarks:

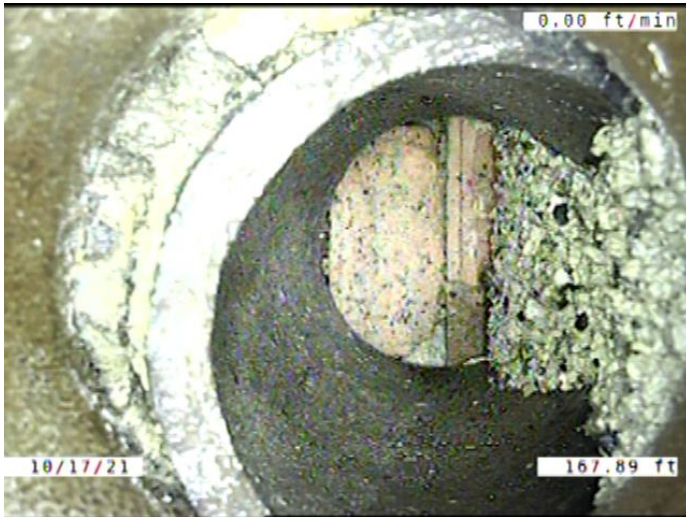
Code: **TFD**  
 Description: **Tap Factory Defective**

Distance (ft): **167.9**  
 Structural Grade: **0**  
 O&M Grade: **3**  
 Clock Start/From: **2**  
 Clock To:  
 1st Value: **4.000**  
 2nd Value:  
 Value Percent:  
 Continuous Index:  
 Within 8" of Joint: **YES**  
 Remarks: **Defective**

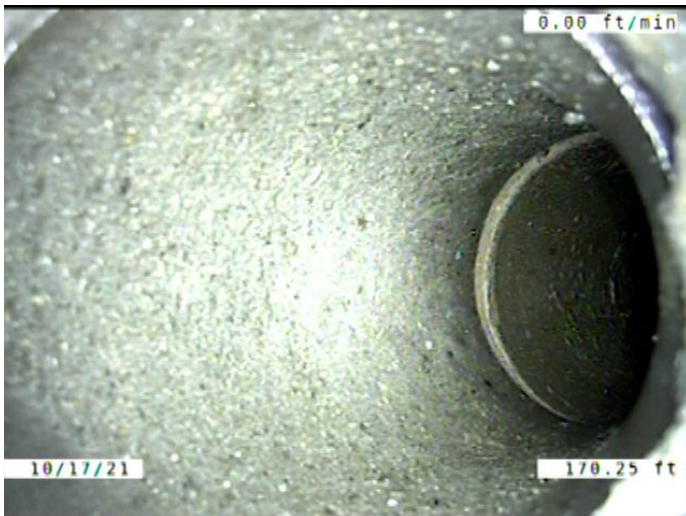
Code: **TB**  
 Description: **Tap Break-in/Hammer**

Distance (ft): **170.2**  
 Structural Grade: **0**  
 O&M Grade: **0**  
 Clock Start/From: **2**  
 Clock To:  
 1st Value: **4.000**  
 2nd Value:  
 Value Percent:  
 Continuous Index:  
 Within 8" of Joint: **YES**  
 Remarks:

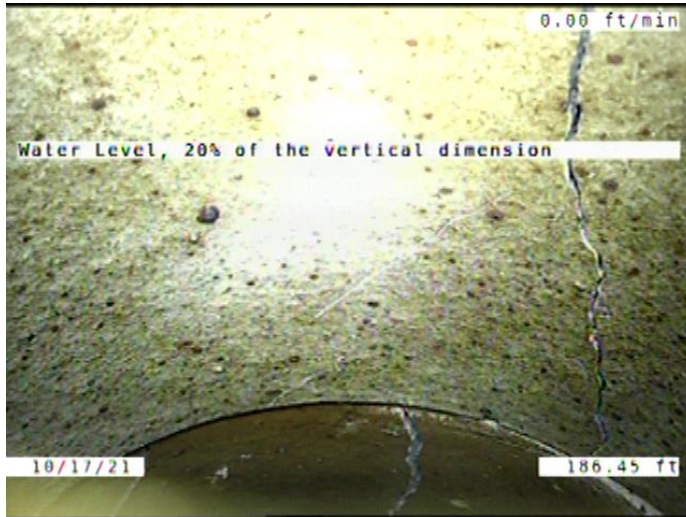
Code: **MWL**  
 Description: **Miscellaneous Water Level**

Distance (ft): **186.4**  
 Structural Grade: **0**  
 O&M Grade: **0**  
 Clock Start/From:  
 Clock To:  
 1st Value:  
 2nd Value:  
 Value Percent: **20.000**  
 Continuous Index:  
 Within 8" of Joint: **NO**  
 Remarks:

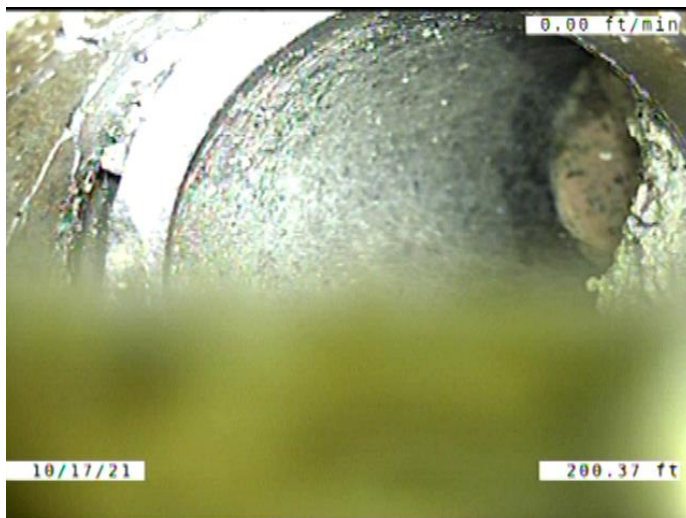
Code: **TFD**  
 Description: **Tap Factory Defective**

Distance (ft): **200.4**  
 Structural Grade: **0**  
 O&M Grade: **3**  
 Clock Start/From: **1**  
 Clock To:  
 1st Value: **4.000**  
 2nd Value:  
 Value Percent:  
 Continuous Index:  
 Within 8" of Joint: **YES**  
 Remarks: **Defective**

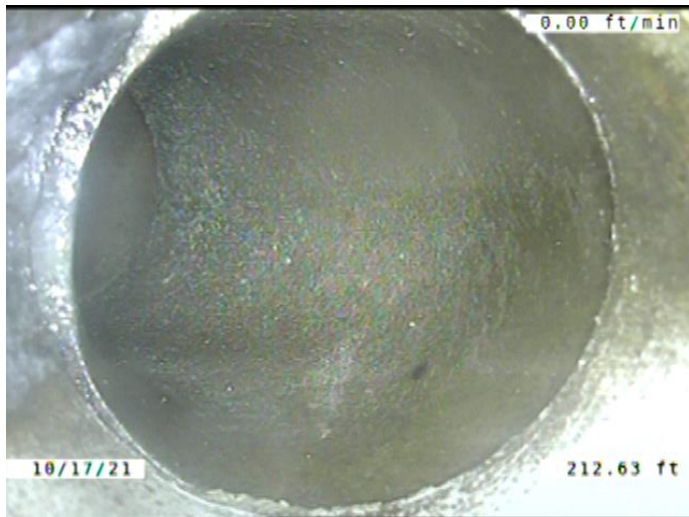
Code: **TF**  
 Description: **Tap Factory**

Distance (ft): **212.6**  
 Structural Grade: **0**  
 O&M Grade: **0**  
 Clock Start/From: **11**  
 Clock To:  
 1st Value: **4.000**  
 2nd Value:  
 Value Percent:  
 Continuous Index:  
 Within 8" of Joint: **YES**  
 Remarks:

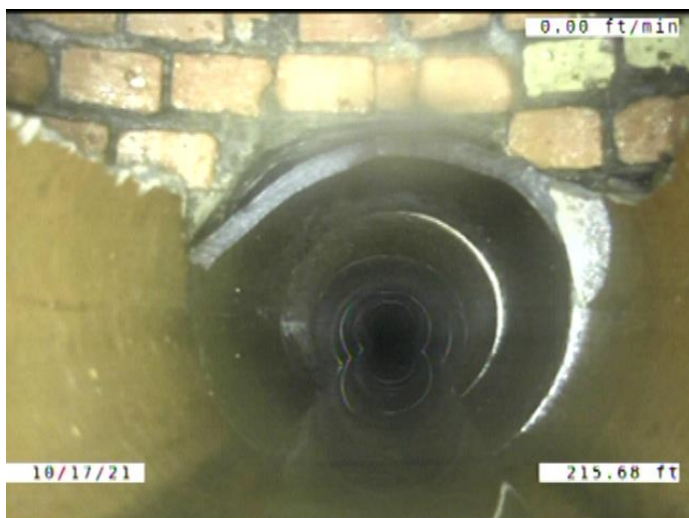
Code: **DAE**  
 Description: **Deposits Attached Encrustation**

Distance (ft): **215.7**  
 Structural Grade: **0**  
 O&M Grade: **2**  
 Clock Start/From: **3**  
 Clock To: **8**  
 1st Value:  
 2nd Value:  
 Value Percent: **5.000**  
 Continuous Index: **F03**  
 Within 8" of Joint: **YES**  
 Remarks:

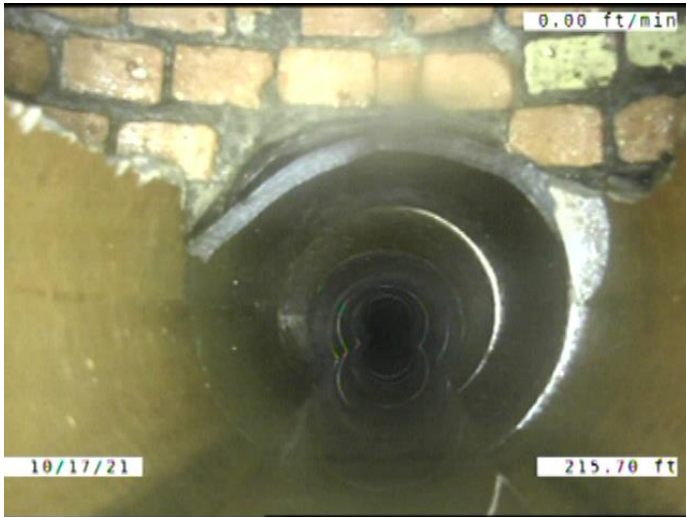
Code: **DSF**  
 Description: **Deposits Settled Fine**

Distance (ft): **215.7**  
 Structural Grade: **0**  
 O&M Grade: **2**  
 Clock Start/From: **5**  
 Clock To: **7**  
 1st Value:  
 2nd Value:  
 Value Percent: **5.000**  
 Continuous Index: **F01**  
 Within 8" of Joint: **YES**  
 Remarks:

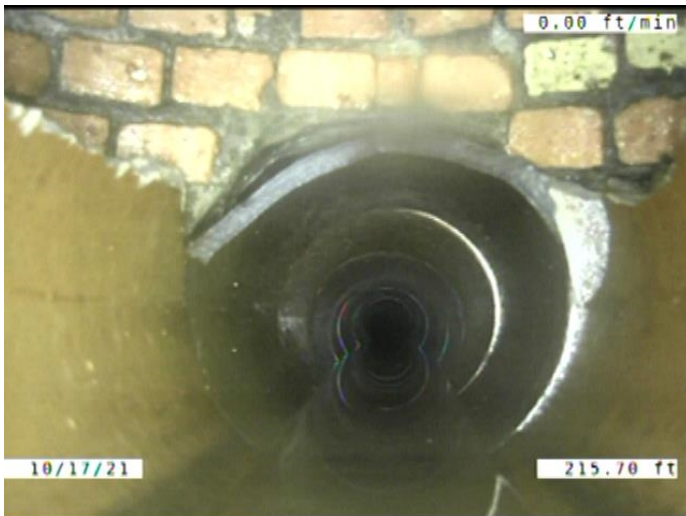
Code: **FM**  
 Description: **Fracture Multiple**

Distance (ft): **215.7**  
 Structural Grade: **4**  
 O&M Grade: **0**  
 Clock Start/From: **12**  
 Clock To: **12**  
 1st Value:  
 2nd Value:  
 Value Percent:  
 Continuous Index: **F02**  
 Within 8" of Joint: **YES**  
 Remarks: **Wandering**

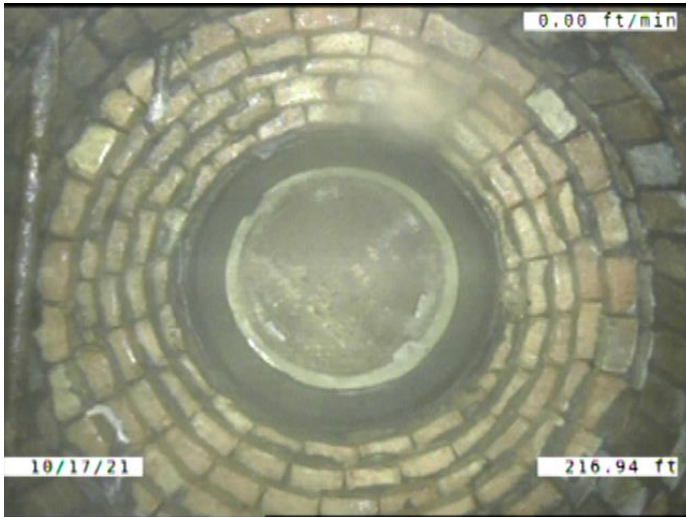
Code:	<b>AMH</b>
Description:	<b>Manhole</b>
Distance (ft):	<b>216.9</b>
Structural Grade:	<b>0</b>
O&M Grade:	<b>0</b>
Clock Start/From:	
Clock To:	
1st Value:	
2nd Value:	
Value Percent:	
Continuous Index:	
Within 8" of Joint:	<b>NO</b>
Remarks:	<b>M-804-055</b>
