Profile/Photo Observation Report

Date:	10/17/2021	Weather:		Coding:	PACP 7.0
Pipe Length (ft):	216.9	Owner:	City of Hobart	Pre Clean:	Heavy Cleaning
P.O.#:	YES502259	Surveyor:	S. Bucklin	PSR:	P-804-056-055
Customer:	City of Hobart	Clean Date:	10/13/2021	Shape:	C

Street:	North Kelly Street	Flow Control:	Not Controlled
City:	Hobart, IN	Year Renewed:	
Location:	Local rural streets with light traffic, t	Tape/Media #:	
Purpose:	Routine Assessment	Dia/Height:	12"
Use:	Sanitary Sewage Pipe	Material:	VCP
Drain Area:		Lining:	
Category:	NA		
Comment:			
Location Details:		Direction of Survey:	Downstream
US MH:	M-804-056	DS MH:	M-804-055
		Total Length Surveyed (ft):	216.9

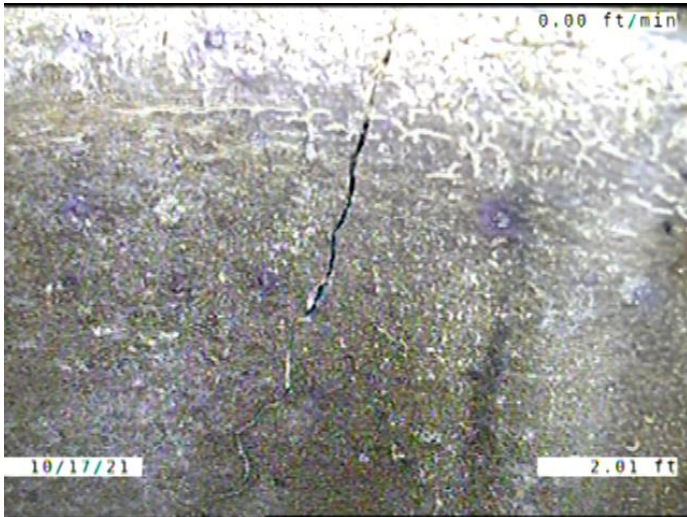
Code: **CS**
 Description: **Crack Spiral**

Distance (ft): **2.0**
 Structural Grade: **2**
 O&M Grade: **0**
 Clock Start/From: **3**
 Clock To: **4**
 1st Value:
 2nd Value:
 Value Percent:
 Continuous Index:
 Within 8" of Joint: **YES**
 Remarks:

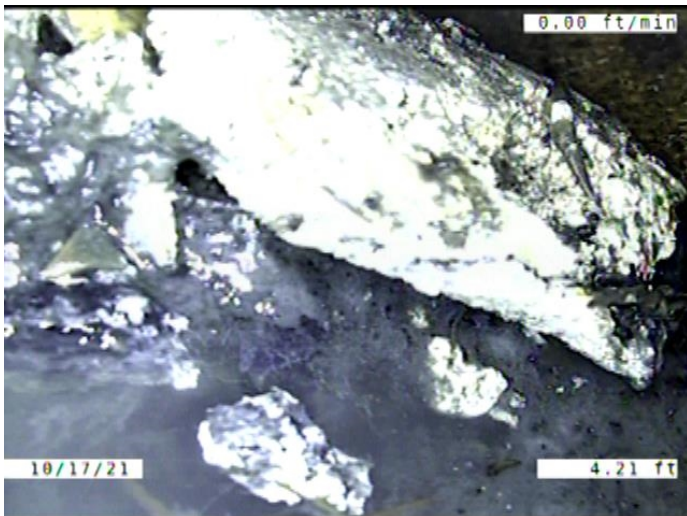
Code: **DAGS**
 Description: **Deposits Attached Grease**

Distance (ft): **4.2**
 Structural Grade: **0**
 O&M Grade: **2**
 Clock Start/From: **4**
 Clock To: **8**
 1st Value:
 2nd Value:
 Value Percent: **5.000**
 Continuous Index:
 Within 8" of Joint: **YES**
 Remarks:

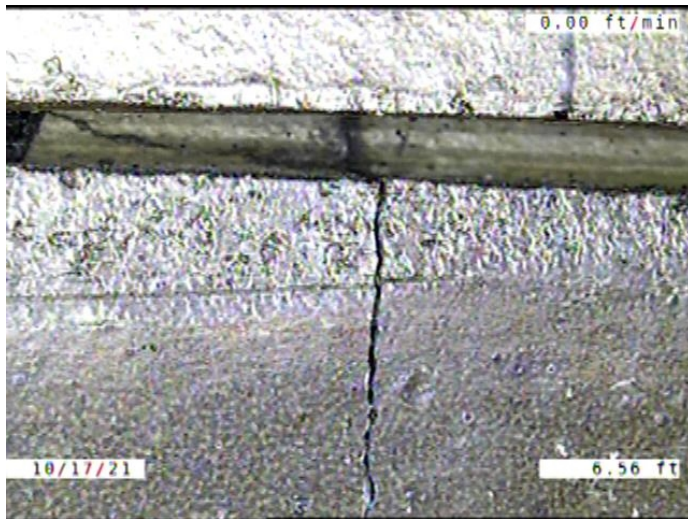
Code: **FM**
 Description: **Fracture Multiple**

Distance (ft): **6.6**
 Structural Grade: **4**
 O&M Grade: **0**
 Clock Start/From: **12**
 Clock To: **12**
 1st Value:
 2nd Value:
 Value Percent:
 Continuous Index: **S02**
 Within 8" of Joint: **YES**
 Remarks: **Wandering**

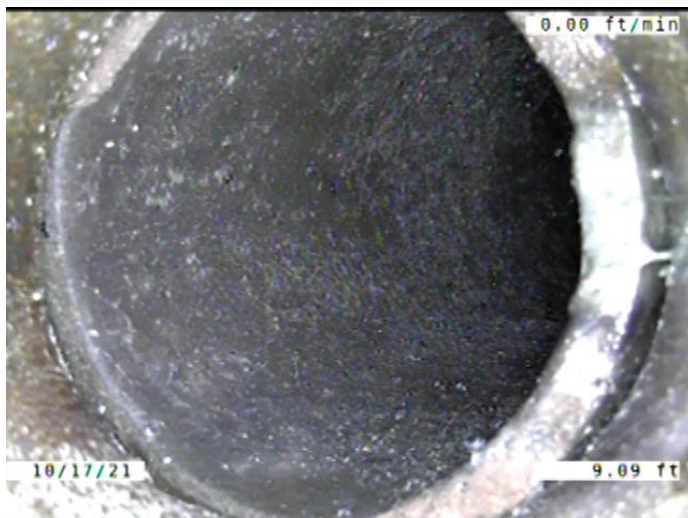
Code: **TF**
 Description: **Tap Factory**

Distance (ft): **9.1**
 Structural Grade: **0**
 O&M Grade: **0**
 Clock Start/From: **2**
 Clock To:
 1st Value: **4.000**
 2nd Value:
 Value Percent:
 Continuous Index:
 Within 8" of Joint: **YES**
 Remarks:

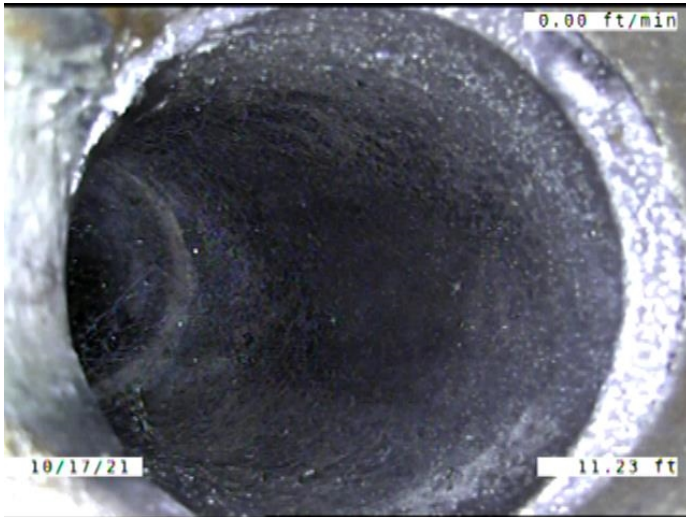
Code: **TF**
 Description: **Tap Factory**

Distance (ft): **11.2**
 Structural Grade: **0**
 O&M Grade: **0**
 Clock Start/From: **10**
 Clock To:
 1st Value: **4.000**
 2nd Value:
 Value Percent:
 Continuous Index:
 Within 8" of Joint: **YES**
 Remarks:

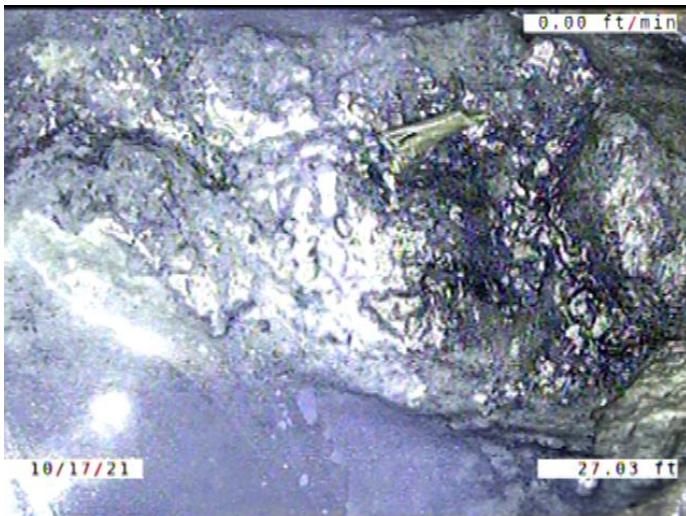
Code: **DAE**
 Description: **Deposits Attached Encrustation**

Distance (ft): **27.0**
 Structural Grade: **0**
 O&M Grade: **2**
 Clock Start/From: **3**
 Clock To: **8**
 1st Value:
 2nd Value:
 Value Percent: **5.000**
 Continuous Index: **S03**
 Within 8" of Joint: **YES**
 Remarks:

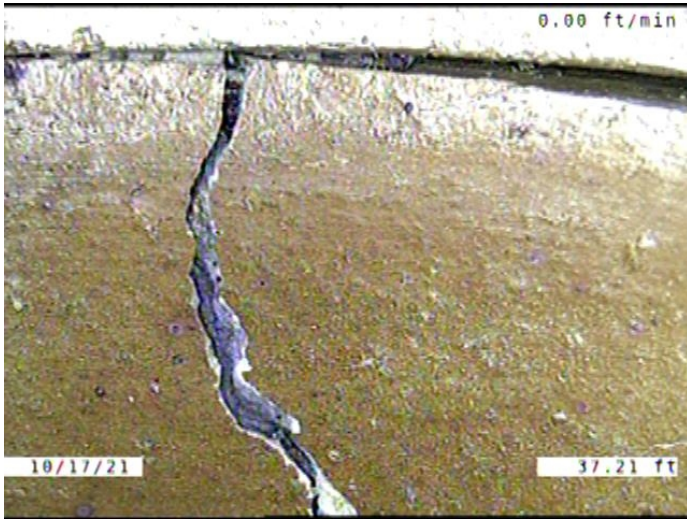
Code: **B**
 Description: **Broken**

Distance (ft): **37.2**
 Structural Grade: **4**
 O&M Grade: **0**
 Clock Start/From: **2**
 Clock To: **5**
 1st Value:
 2nd Value:
 Value Percent:
 Continuous Index:
 Within 8" of Joint: **YES**
 Remarks:

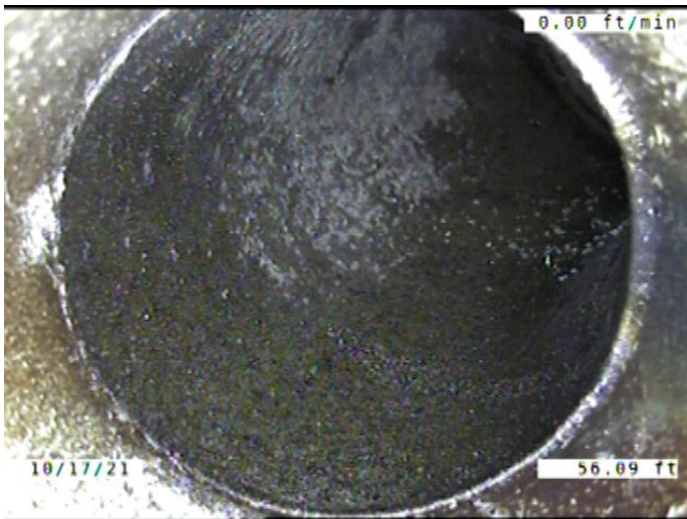
Code: **TF**
 Description: **Tap Factory**

Distance (ft): **56.1**
 Structural Grade: **0**
 O&M Grade: **0**
 Clock Start/From: **2**
 Clock To:
 1st Value: **4.000**
 2nd Value:
 Value Percent:
 Continuous Index:
 Within 8" of Joint: **YES**
 Remarks:

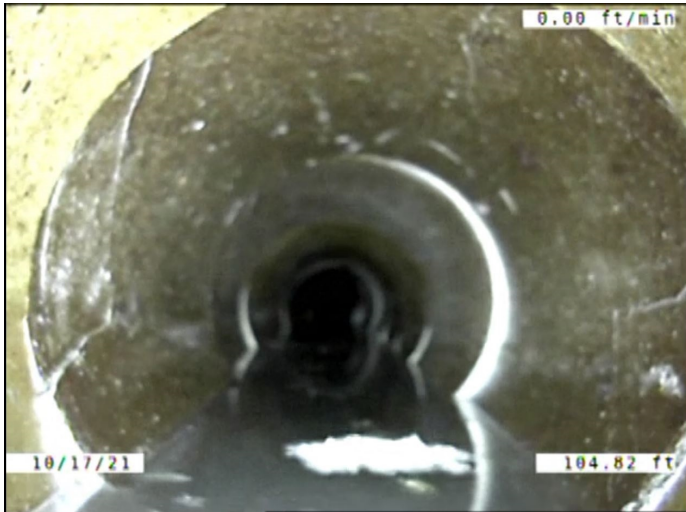
Code: **B**
Description: **Broken**

Distance (ft): **104.8**
Structural Grade: **4**
O&M Grade: **0**
Clock Start/From: **8**
Clock To: **10**
1st Value:
2nd Value:
Value Percent:
Continuous Index:
Within 8" of Joint: **YES**
Remarks:

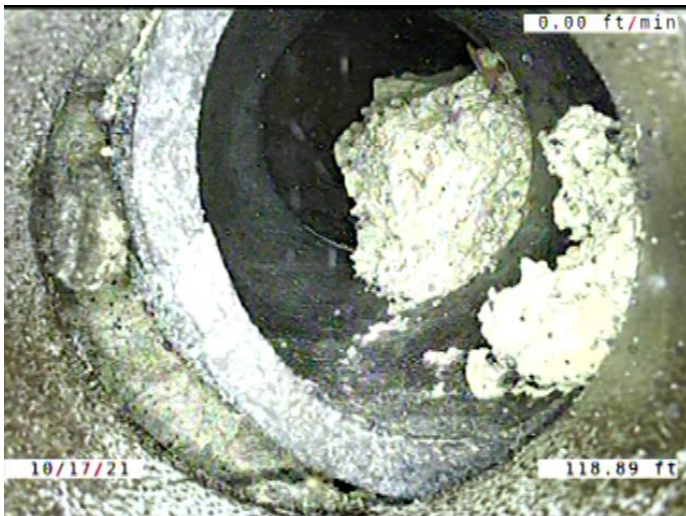
Code: **TFD**
Description: **Tap Factory Defective**

Distance (ft): **118.9**
Structural Grade: **0**
O&M Grade: **3**
Clock Start/From: **2**
Clock To:
1st Value: **4.000**
2nd Value:
Value Percent:
Continuous Index:
Within 8" of Joint: **YES**
Remarks: **LARGE OFFSET. SOIL VISIBLE**

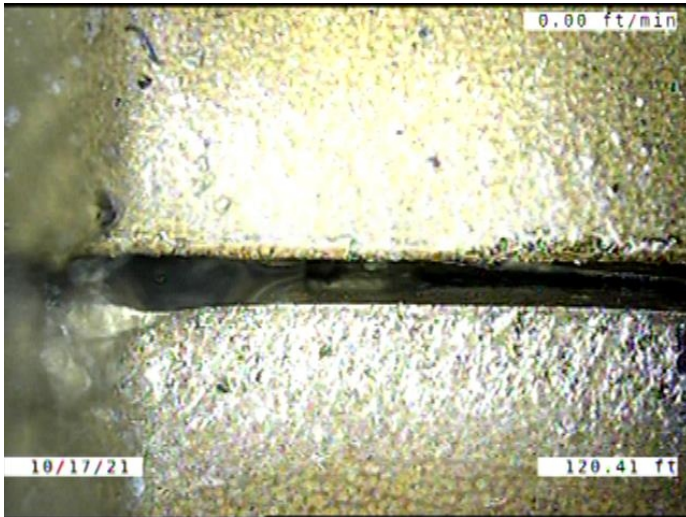
Code: **IRJ**
 Description: **Infiltration Runner Joint**

Distance (ft): **120.4**
 Structural Grade: **0**
 O&M Grade: **4**
 Clock Start/From: **8**
 Clock To: **9**
 1st Value:
 2nd Value:
 Value Percent:
 Continuous Index:
 Within 8" of Joint: **YES**
 Remarks:

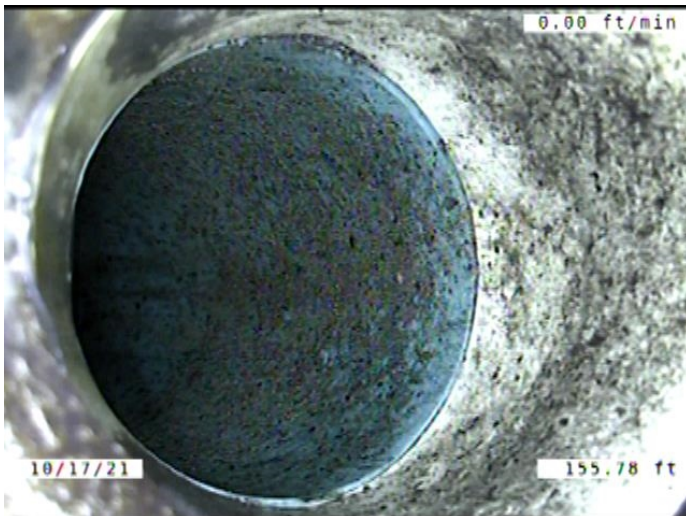
Code: **TF**
 Description: **Tap Factory**

Distance (ft): **155.8**
 Structural Grade: **0**
 O&M Grade: **0**
 Clock Start/From: **10**
 Clock To:
 1st Value: **4.000**
 2nd Value:
 Value Percent:
 Continuous Index:
 Within 8" of Joint: **YES**
 Remarks:

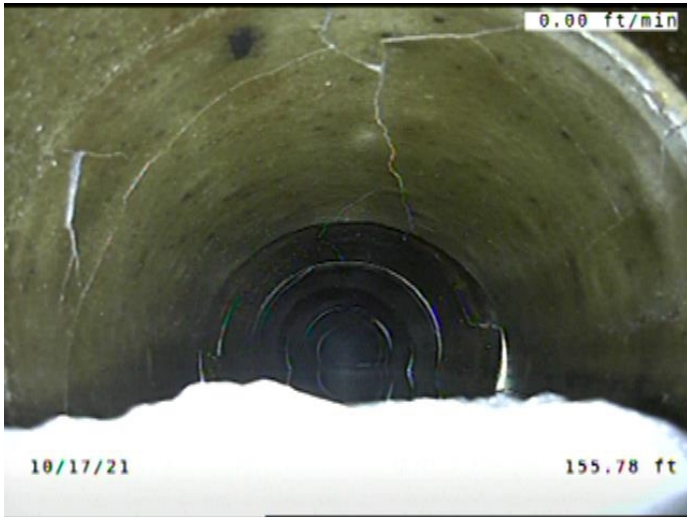
Code: **DAR**
 Description: **Deposits Attached Ragging**

Distance (ft): **155.8**
 Structural Grade: **0**
 O&M Grade: **3**
 Clock Start/From: **4**
 Clock To: **8**
 1st Value:
 2nd Value:
 Value Percent: **20.000**
 Continuous Index:
 Within 8" of Joint: **YES**
 Remarks:

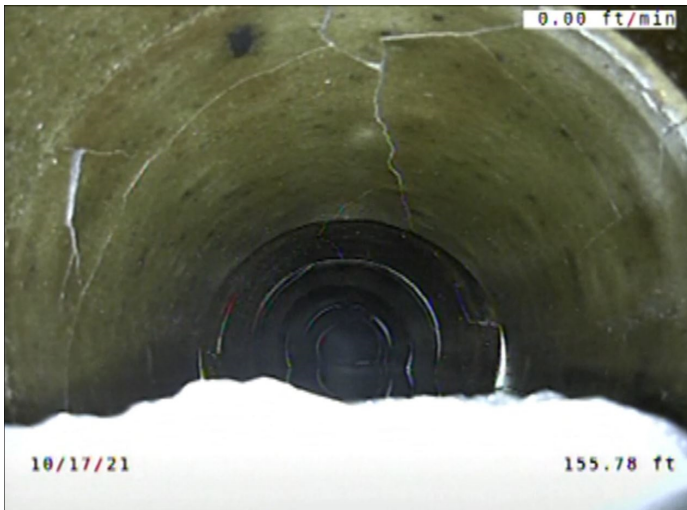
Code: **B**
 Description: **Broken**

Distance (ft): **155.8**
 Structural Grade: **4**
 O&M Grade: **0**
 Clock Start/From: **10**
 Clock To: **1**
 1st Value:
 2nd Value:
 Value Percent:
 Continuous Index:
 Within 8" of Joint: **YES**
 Remarks:

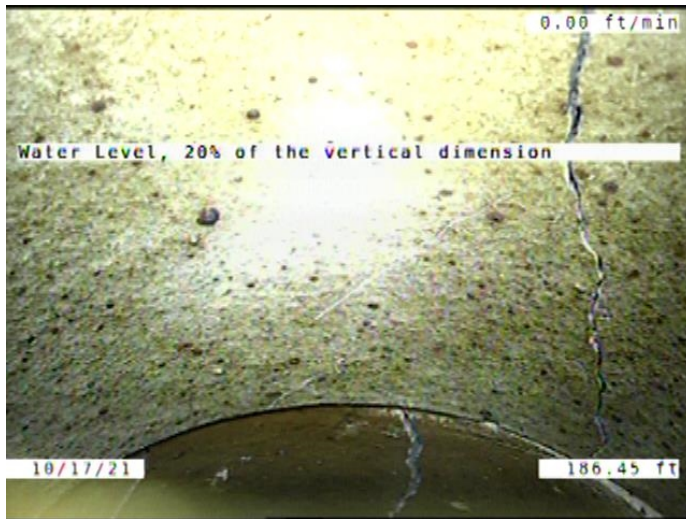
Code: **MWL**
 Description: **Miscellaneous Water Level**

Distance (ft): **186.4**
 Structural Grade: **0**
 O&M Grade: **0**
 Clock Start/From:
 Clock To:
 1st Value:
 2nd Value:
 Value Percent: **20.000**
 Continuous Index:
 Within 8" of Joint: **NO**
 Remarks:

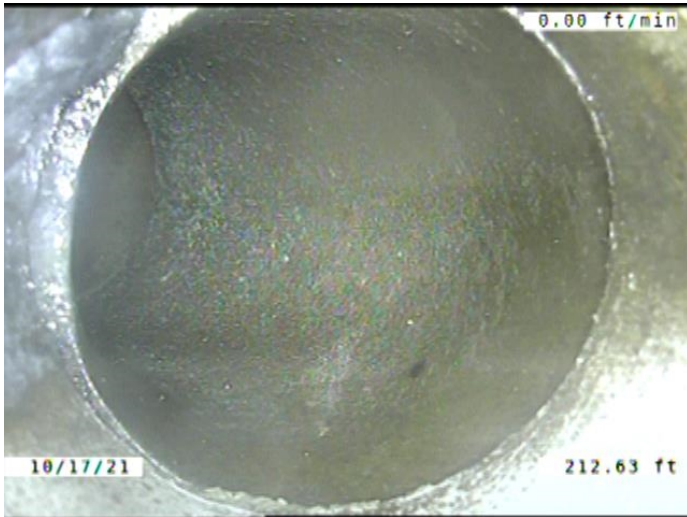
Code: **TF**
 Description: **Tap Factory**

Distance (ft): **212.6**
 Structural Grade: **0**
 O&M Grade: **0**
 Clock Start/From: **11**
 Clock To:
 1st Value: **4.000**
 2nd Value:
 Value Percent:
 Continuous Index:
 Within 8" of Joint: **YES**
 Remarks:

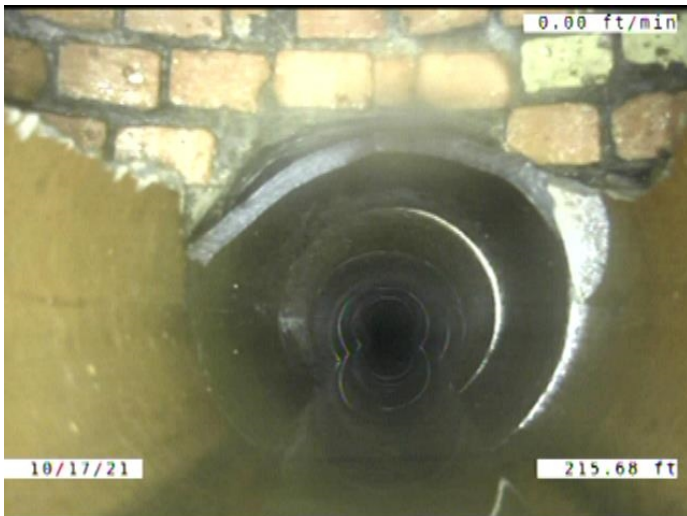
Code: **DAE**
 Description: **Deposits Attached Encrustation**

Distance (ft): **215.7**
 Structural Grade: **0**
 O&M Grade: **2**
 Clock Start/From: **3**
 Clock To: **8**
 1st Value:
 2nd Value:
 Value Percent: **5.000**
 Continuous Index: **F03**
 Within 8" of Joint: **YES**
 Remarks:

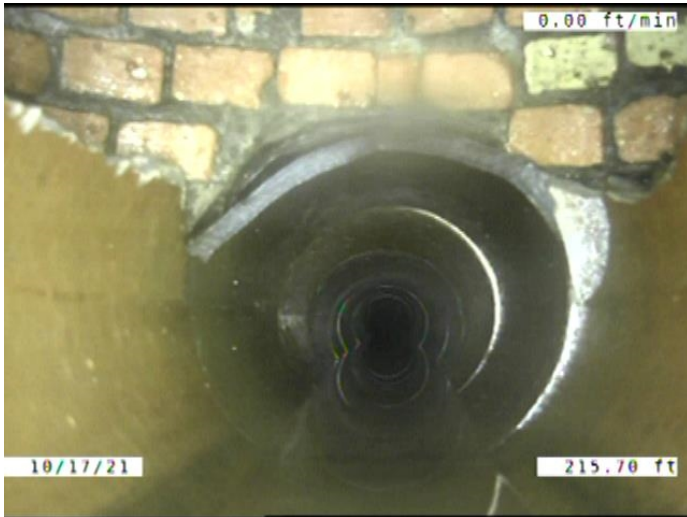
Code: **DSF**
 Description: **Deposits Settled Fine**

Distance (ft): **215.7**
 Structural Grade: **0**
 O&M Grade: **2**
 Clock Start/From: **5**
 Clock To: **7**
 1st Value:
 2nd Value:
 Value Percent: **5.000**
 Continuous Index: **F01**
 Within 8" of Joint: **YES**
 Remarks:

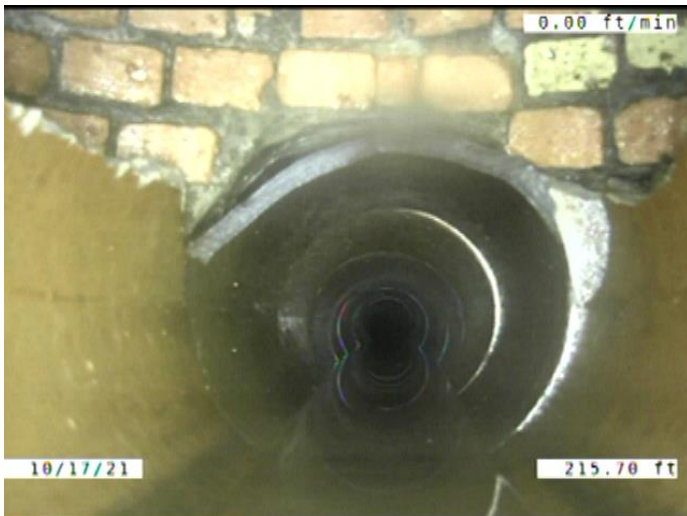
Code: **FM**
 Description: **Fracture Multiple**

Distance (ft): **215.7**
 Structural Grade: **4**
 O&M Grade: **0**
 Clock Start/From: **12**
 Clock To: **12**
 1st Value:
 2nd Value:
 Value Percent:
 Continuous Index: **F02**
 Within 8" of Joint: **YES**
 Remarks: **Wandering**

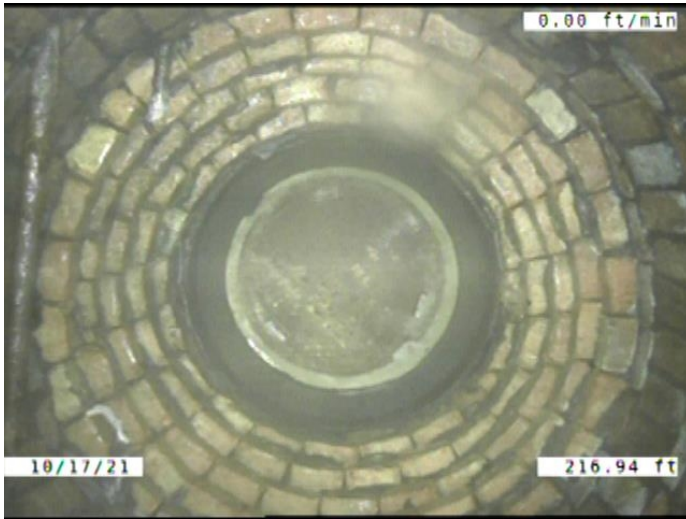
Code:	AMH
Description:	Manhole
Distance (ft):	216.9
Structural Grade:	0
O&M Grade:	0
Clock Start/From:	
Clock To:	
1st Value:	
2nd Value:	
Value Percent:	
Continuous Index:	
Within 8" of Joint:	NO
Remarks:	M-804-055
