## Profile/Photo Observation Report

Date:	<b>05/03/2018</b>	Weather:		Coding:	<b>PACP 4.2</b>
Pipe Length (ft):	<b>26.7</b>	Owner:	<b>City of Hobart</b>	Pre Clean:	<b>No Pre-Cleaning</b>
P.O.#:	<b>2004</b>	Surveyor:	<b>SAN</b>	PSR:	<b>P-804-060-059</b>
Customer:	<b>Red Zone</b>	Clean Date:		Shape:	<b>C</b>

Street:	<b>511 N Linda St</b>	Flow Control:	<b>Not Controlled</b>
City:	<b>Hobart In</b>	Year Renewed:	
Location:	<b>Light Highway</b>	Tape/Media #:	<b>Deliverable 1</b>
Purpose:	<b>Routine Assessment</b>	Dia/Height:	<b>15"</b>
Use:	<b>Sanitary</b>	Material:	<b>VCP</b>
Drain Area:	<b>Northeast</b>	Lining:	
Category:	<b>NA</b>		
Comment:	<b>439-2/GIS footage shows line as 214 ft but it isn't, it is 26.7 ft long.</b>		
Location Details:	<b>Edge of street</b>	Direction of Survey:	<b>Downstream</b>
US MH:	<b>M-804-060</b>	DS MH:	<b>M-804-059</b>
		Total Length Surveyed (ft):	<b>26.7</b>

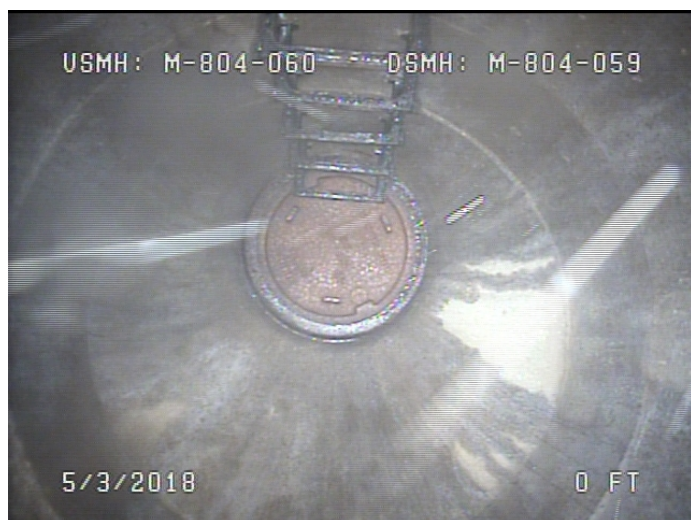
Code: **AMH**  
 Description: **Manhole**

Distance (ft): **.0**  
 Structural Grade: **0**  
 O&M Grade: **0**  
 Clock Start/From:  
 Clock To:  
 1st Value:  
 2nd Value:  
 Value Percent:  
 Continuous Index:  
 Within 8" of Joint: **NO**  
 Remarks: **M-804-060**

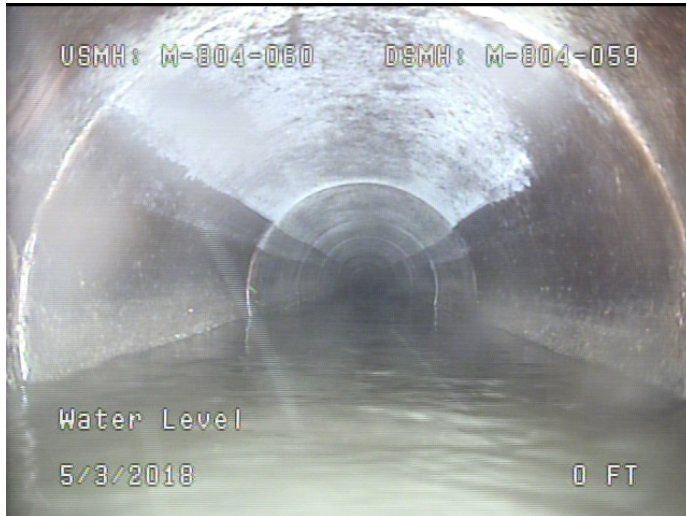
Code:	<b>MWL</b>
Description:	<b>Water Level</b>
Distance (ft):	<b>.0</b>
Structural Grade:	<b>0</b>
O&M Grade:	<b>0</b>
Clock Start/From:	
Clock To:	
1st Value:	
2nd Value:	
Value Percent:	<b>30.000</b>
Continuous Index:	
Within 8" of Joint:	<b>NO</b>
Remarks:

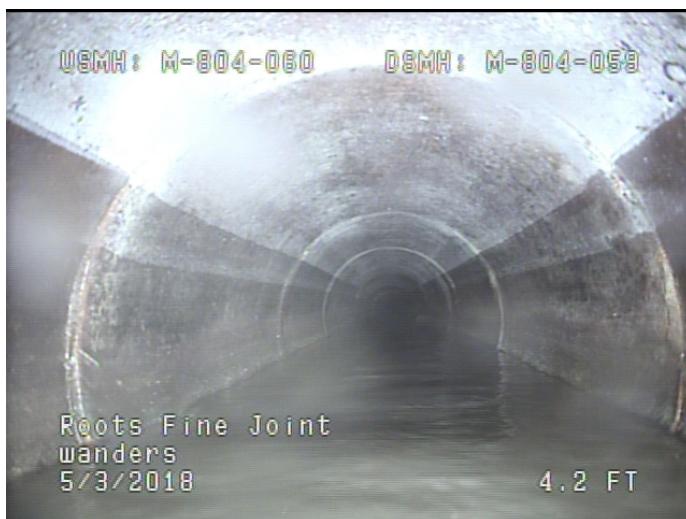
Code:	<b>RFJ</b>
Description:	<b>Roots Fine Joint</b>
Distance (ft):	<b>4.2</b>
Structural Grade:	<b>0</b>
O&M Grade:	<b>1</b>
Clock Start/From:	<b>9</b>
Clock To:	
1st Value:	
2nd Value:	
Value Percent:	
Continuous Index:	<b>S01</b>
Within 8" of Joint:	<b>YES</b>
Remarks:	<b>wanders</b>

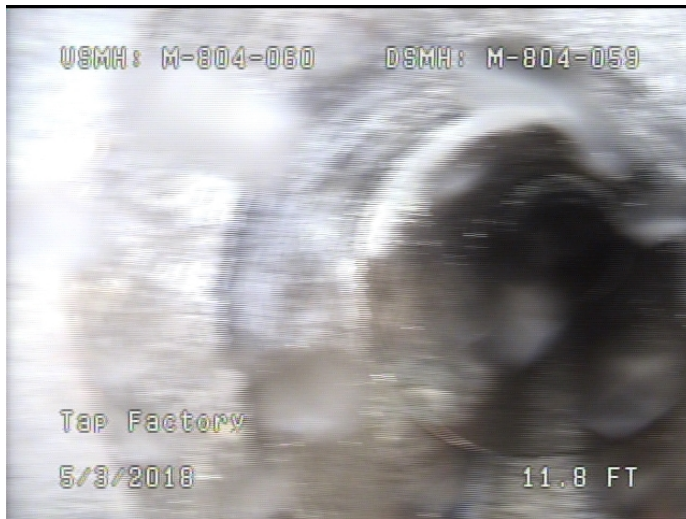
Code:	<b>TF</b>
Description:	<b>Tap Factory</b>
Distance (ft):	<b>11.8</b>
Structural Grade:	<b>0</b>
O&M Grade:	<b>0</b>
Clock Start/From:	<b>3</b>
Clock To:	
1st Value:	<b>6.000</b>
2nd Value:	
Value Percent:	
Continuous Index:	
Within 8" of Joint:	<b>NO</b>
Remarks:

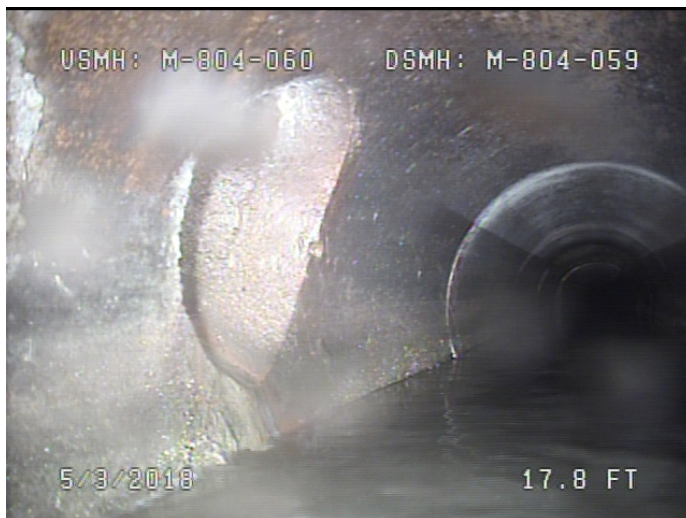
Code:	<b>TFD</b>
Description:	<b>Tap Factory Defective</b>
Distance (ft):	<b>17.8</b>
Structural Grade:	<b>0</b>
O&M Grade:	<b>2</b>
Clock Start/From:	<b>9</b>
Clock To:	
1st Value:	<b>6.000</b>
2nd Value:	
Value Percent:	
Continuous Index:	
Within 8" of Joint:	<b>NO</b>
Remarks:	<b>roots in tap</b>

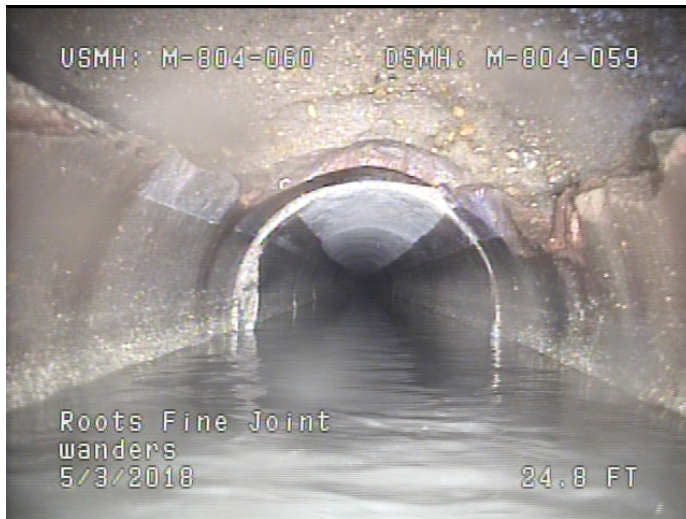
Code:	<b>RFJ</b>
Description:	<b>Roots Fine Joint</b>
Distance (ft):	<b>24.8</b>
Structural Grade:	<b>0</b>
O&M Grade:	<b>1</b>
Clock Start/From:	<b>9</b>
Clock To:	
1st Value:	
2nd Value:	
Value Percent:	
Continuous Index:	<b>F01</b>
Within 8" of Joint:	<b>YES</b>
Remarks:	<b>wanders</b>

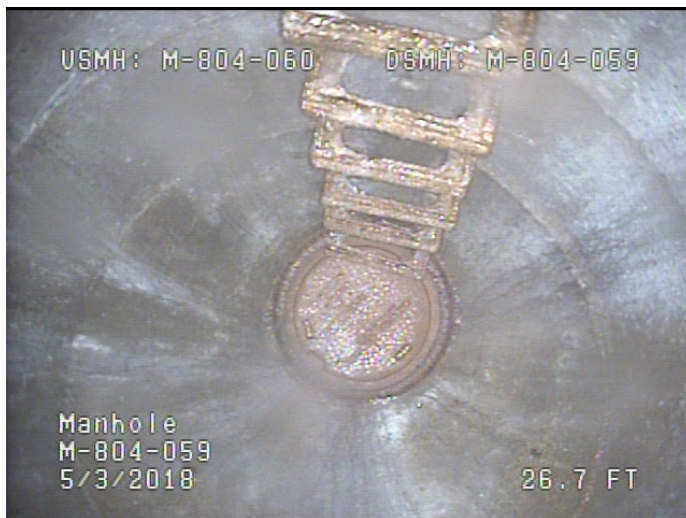
Code:	<b>AMH</b>
Description:	<b>Manhole</b>
Distance (ft):	<b>26.7</b>
Structural Grade:	<b>0</b>
O&M Grade:	<b>0</b>
Clock Start/From:	
Clock To:	
1st Value:	
2nd Value:	
Value Percent:	
Continuous Index:	
Within 8" of Joint:	<b>NO</b>
Remarks:	<b>M-804-059</b>
