Profile/Photo Observation Report

Street:	N LINDA ST	Flow Control:	Not Controlled
City:	Hobart, IN	Year Renewed:	
Location:	Other	Tape/Media #:	
Purpose:	Not Known	Dia/Height:	12"
Use:	Sanitary	Material:	VCP
Drain Area:	NA	Lining:	
Category:	NA		
Comment:	NULL - Debris at entrance MH-M-704-071

Location Details:		Direction of Survey:	Downstream
US MH:	M-804-060	DS MH:	M-804-061
		Total Length Surveyed (ft):	6.6

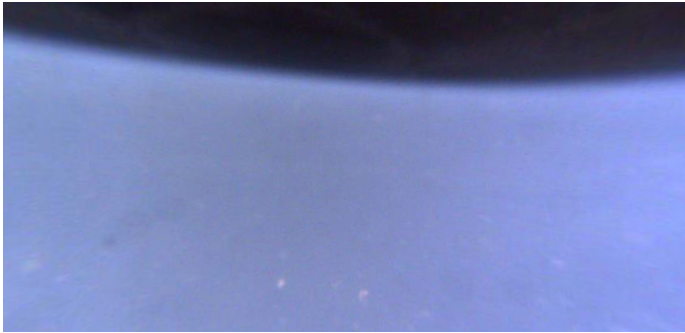
Code:	MWL
Description:	Water Level

Distance (ft):	.0
Structural Grade:	0
O&M Grade:	0
Clock Start/From:	
Clock To:	
1st Value:	
2nd Value:	
Value Percent:	40.000
Continuous Index:	
Within 8" of Joint:	NO
Remarks:

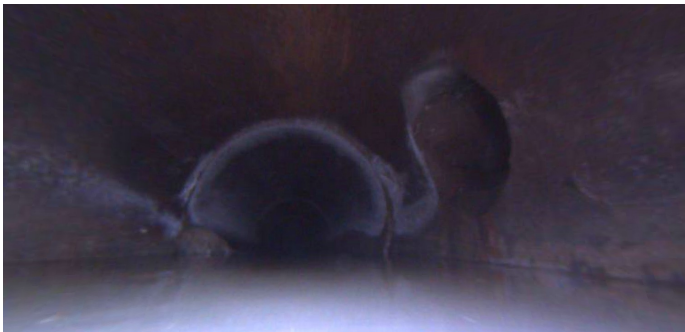
Code:	TF
Description:	Tap Factory

Distance (ft):	6.6
Structural Grade:	0
O&M Grade:	0
Clock Start/From:	3
Clock To:	
1st Value:	4.000
2nd Value:	
Value Percent:	
Continuous Index:	
Within 8" of Joint:	
Remarks:

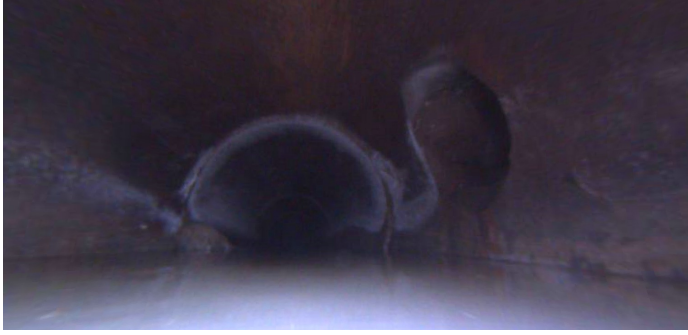
Code:	MSA
Description:	Abandoned Survey
Distance (ft):	6.6
Structural Grade:	0
O&M Grade:	0
Clock Start/From:	
Clock To:	
1st Value:	
2nd Value:	
Value Percent:	
Continuous Index:	
Within 8" of Joint:	NO
Remarks:	debris under water
