Profile/Photo Observation Report

Street:	Lakewood Dr.	Flow Control:	Not Controlled
City:	Hobart, IN	Year Renewed:	
Location:	Other	Tape/Media #:	
Purpose:	Not Known	Dia/Height:	12"
Use:	Sanitary	Material:	VCP
Drain Area:	NA	Lining:	
Category:	NA		
Comment:	NULL - Debris at entrance MH-M-704-071

Location Details:		Direction of Survey:	Downstream
US MH:	M-804-060	DS MH:	M-804-061
		Total Length Surveyed (ft):	6.6

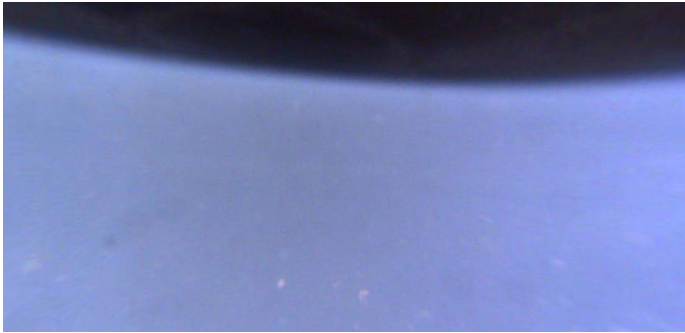
Code:	MWL
Description:	Water Level

Distance (ft):	.0
Structural Grade:	0
O&M Grade:	0
Clock Start/From:	
Clock To:	
1st Value:	
2nd Value:	
Value Percent:	40.000
Continuous Index:	
Within 8" of Joint:	NO
Remarks:

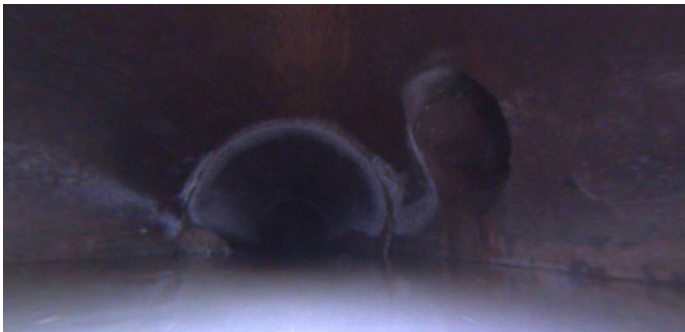
Code:	TF
Description:	Tap Factory

Distance (ft):	6.6
Structural Grade:	0
O&M Grade:	0
Clock Start/From:	3
Clock To:	
1st Value:	4.000
2nd Value:	
Value Percent:	
Continuous Index:	
Within 8" of Joint:	
Remarks:

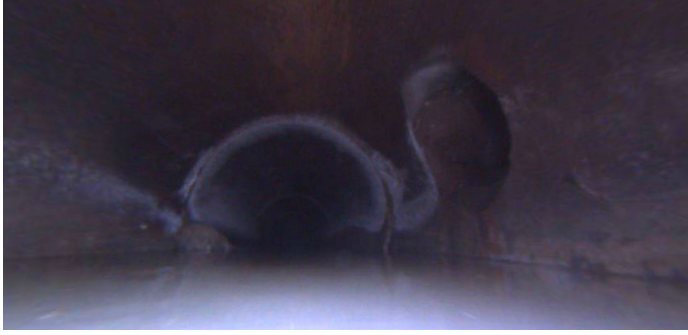
Code:	MSA
Description:	Abandoned Survey
Distance (ft):	6.6
Structural Grade:	0
O&M Grade:	0
Clock Start/From:	
Clock To:	
1st Value:	
2nd Value:	
Value Percent:	
Continuous Index:	
Within 8" of Joint:	NO
Remarks:	debris under water
