Profile/Photo Observation Report

Date: **PACP 4.2** 04/13/2018 Weather: Coding: Pipe Length (ft): 252.0 Owner: **City of Hobart** Pre Clean: No Pre-Cleaning P.O.#: 2004 PSR: P-803-054-061 Surveyor: SAN **Red Zone** Customer: Clean Date: Shape: 331 Linda Ave Flow Control: **Not Controlled** Street: City: **Hobart In** Year Renewed: Tape/Media #: Deliverable 1 Location: **Light Highway** Purpose: **Routine Assessment** Dia/Height: 15" Use: Sanitary Material: **VCP** Northeast Drain Area: Lining: NA Category: Comment: 404-1/Unable to open M803-054/Manhole 061 is the downstream manhole. **Location Details: Edge of street** Direction of Survey: Upstream M-803-054 Total Length Surveyed (ft): US MH: DS MH: M-803-061 252.0 1.83 3726 44.00 O&M Index: O&M Quick: O&M Rating:

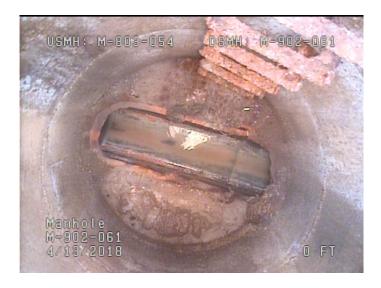
Code: AMH Description: Manhole

Remarks: M-902-061

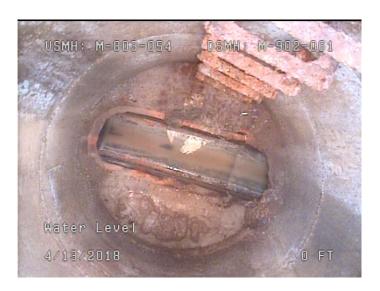
MWL Code:

Description: **Water Level**

Value Percent: 5.000

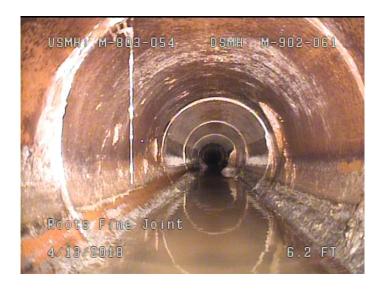
Code: RFJ

Description: Roots Fine Joint

Distance (ft): 6.2
Structural Grade: 0
O&M Grade: 1
Clock Start/From: 10
Clock To: 5

Continuous Index: **S01**Within 8" of Joint: **YES**

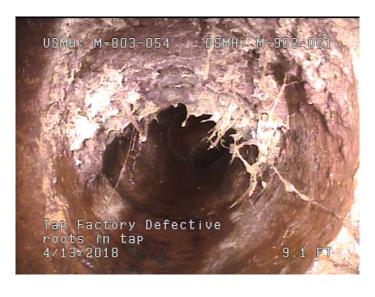
Code: **TFD**

Description: Tap Factory Defective

Distance (ft): 9.1
Structural Grade: 0
O&M Grade: 2
Clock Start/From: 2

Remarks: roots in tap

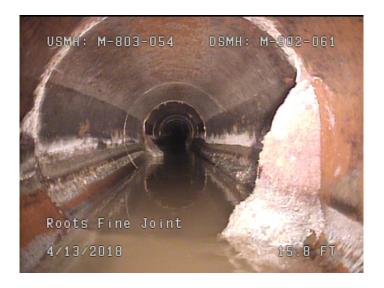
Code: RFJ

Description: Roots Fine Joint

Distance (ft): 15.8
Structural Grade: 0

O&M Grade: 1

Continuous Index: F01
Within 8" of Joint: YES

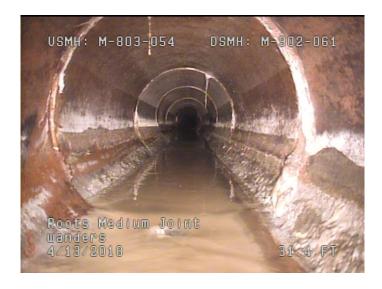
Code: RMJ

Description: Roots Medium Joint

Distance (ft): 31.4
Structural Grade: 0

O&M Grade: 3

Value Percent: 15.000
Continuous Index: F02
Within 8" of Joint: YES

Remarks: wanders

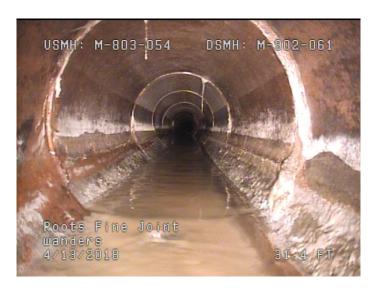
Code: RFJ

Description: Roots Fine Joint

Distance (ft): 31.4
Structural Grade: 0
O&M Grade: 1
Clock Start/From: 8
Clock To: 5
1st Value:
2nd Value:

Continuous Index: \$03
Within 8" of Joint: YES

Remarks: wanders

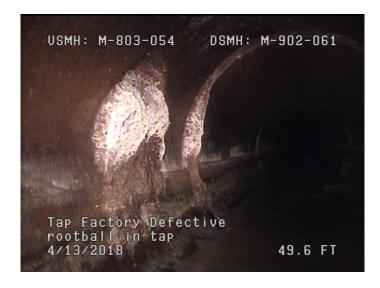
Code: **TFD**

Description: **Tap Factory Defective**

Distance (ft): 49.6 Structural Grade: 0 O&M Grade: 2 Clock Start/From: 9

Remarks: rootball in tap

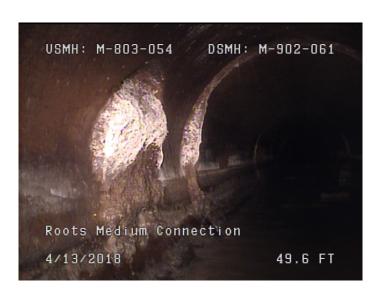
RMC Code:

Description: **Roots Medium Connection**

Distance (ft): 49.6 Structural Grade: 0 O&M Grade: 3 Clock Start/From: 7 Clock To: 10 1st Value:

Value Percent: 5.000

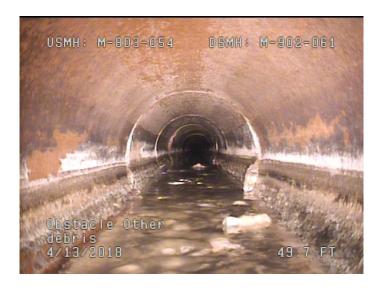
Code: OBZ

Description: **Obstacle Other**

49.7 Distance (ft): Structural Grade: 0 2 O&M Grade: Clock Start/From: 6

Value Percent: 10.000 Continuous Index: **S04** Within 8" of Joint: NO Remarks: debris

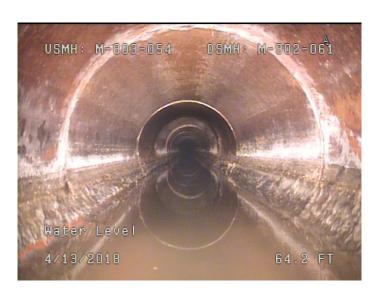
MWL Code:

Description: **Water Level**

Value Percent: 15.000

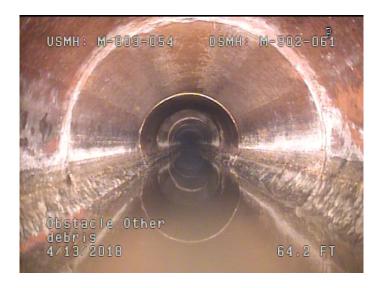
Code: OBZ

Description: Obstacle Other

Distance (ft): 64.2
Structural Grade: 0

O&M Grade: 2

Value Percent: 10.000
Continuous Index: F04
Within 8" of Joint: NO
Remarks: debris

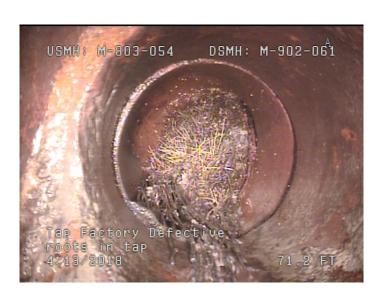
Code: **TFD**

Description: Tap Factory Defective

Distance (ft): 71.2
Structural Grade: 0
O&M Grade: 2
Clock Start/From: 2

Remarks: roots in tap

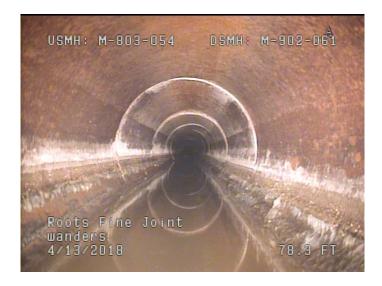
Code: RFJ

Description: Roots Fine Joint

Distance (ft): 78.3
Structural Grade: 0
O&M Grade: 1
Clock Start/From: 8
Clock To: 5

Continuous Index: F03
Within 8" of Joint: YES

Remarks: wanders

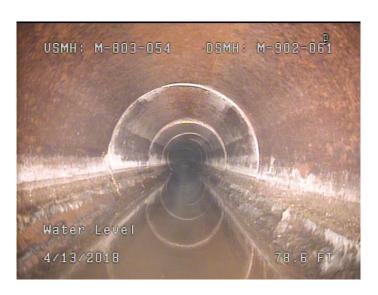
Code: MWL

Description: Water Level

Distance (ft): **78.6**Structural Grade: **0**O&M Grade: **0**

Value Percent: 10.000

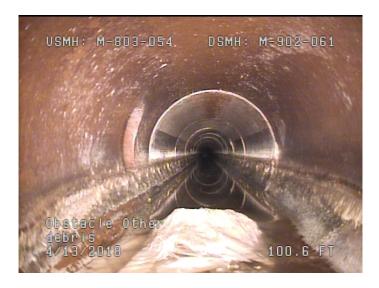
Code: OBZ

Description: Obstacle Other

Distance (ft): 100.6
Structural Grade: 0
O&M Grade: 3
Clock Start/From: 6

Value Percent: 15.000

Within 8" of Joint: NO Remarks: debris

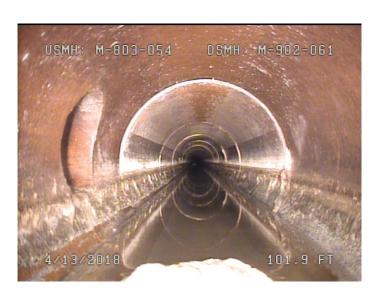
Code: TF

Description: **Tap Factory**

Distance (ft): 102.0
Structural Grade: 0
O&M Grade: 0
Clock Start/From: 10

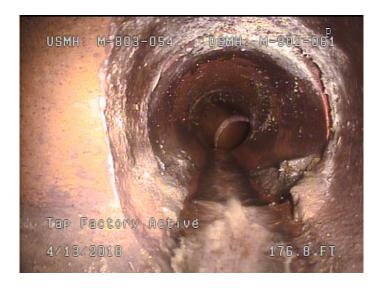
Code: TFA

Description: Tap Factory Active

Distance (ft): 176.8
Structural Grade: 0
O&M Grade: 0
Clock Start/From: 3

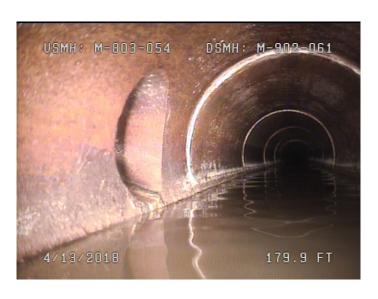
Code: TF

Description: Tap Factory

Distance (ft): 179.9
Structural Grade: 0
O&M Grade: 0
Clock Start/From: 9

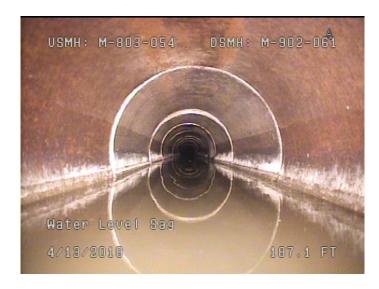
Code: MWLS

Description: Water Level Sag

Distance (ft): 187.1
Structural Grade: 2
O&M Grade: 3

Value Percent: 20.000
Continuous Index: S05
Within 8" of Joint: NO

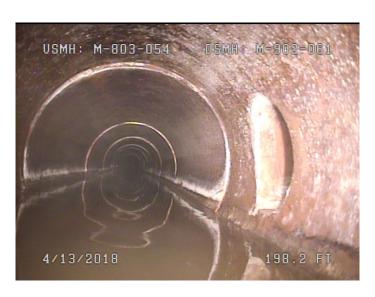
Code: TFB

Description: Tap Factory Abandoned

Distance (ft): 198.2
Structural Grade: 0
O&M Grade: 0
Clock Start/From: 3

Remarks: soil in tap

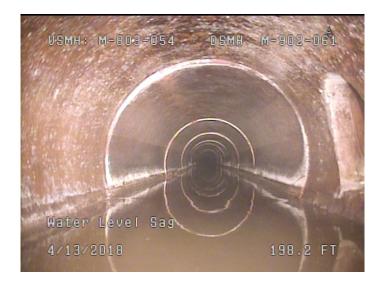
Code: **MWLS**

Description: **Water Level Sag**

Distance (ft): 198.2 Structural Grade: 2 3 O&M Grade:

Value Percent: 20.000 Continuous Index: F05 Within 8" of Joint: NO

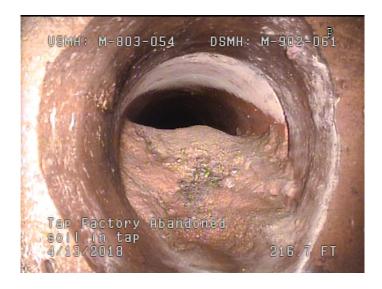
Code: **TFB**

Description: Tap Factory Abandoned

Distance (ft): 216.7
Structural Grade: 0
O&M Grade: 0
Clock Start/From: 9

Remarks: soil in tap

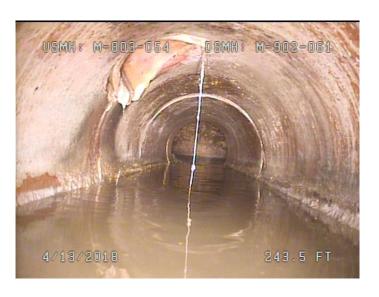
Code: TB

Description: Tap Break-in

Distance (ft): 243.5
Structural Grade: 0
O&M Grade: 0
Clock Start/From: 11

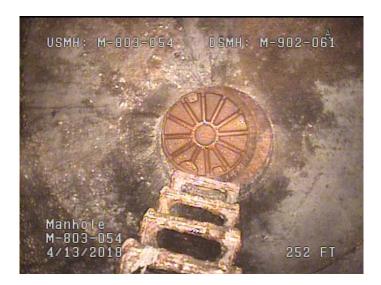
Code: AMH
Description: Manhole

Distance (ft): 252.0
Structural Grade: 0
O&M Grade: 0

Remarks: M-803-054
