## Profile/Photo Observation Report

Date:	10/19/2021	Weather:		Coding:	PACP 6.0
Pipe Length (ft):		Owner:	Hobart, IN	Pre Clean:	Not Known
P.O.#:	890_2	Surveyor:	M. Pielacha	PSR:	P-804-063-062
Customer:	Hobart, IN	Clean Date:		Shape:	C

Location Details:		Direction of Survey:	Downstream
US MH:	M-804-62	DS MH:	M-804-63
		Total Length Surveyed (ft):	294.4

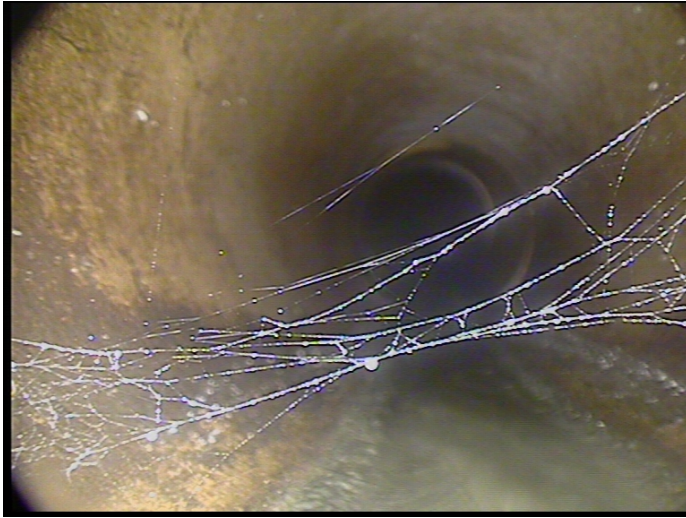
Code:	<b>MWL</b>
Description:	<b>Water Level</b>
Distance (ft):	<b>.0</b>
Structural Grade:	<b>0</b>
O&M Grade:	<b>0</b>
Clock Start/From:	
Clock To:	
1st Value:	
2nd Value:	
Value Percent:	<b>5.000</b>
Continuous Index:	
Within 8" of Joint:	<b>NO</b>
Remarks:

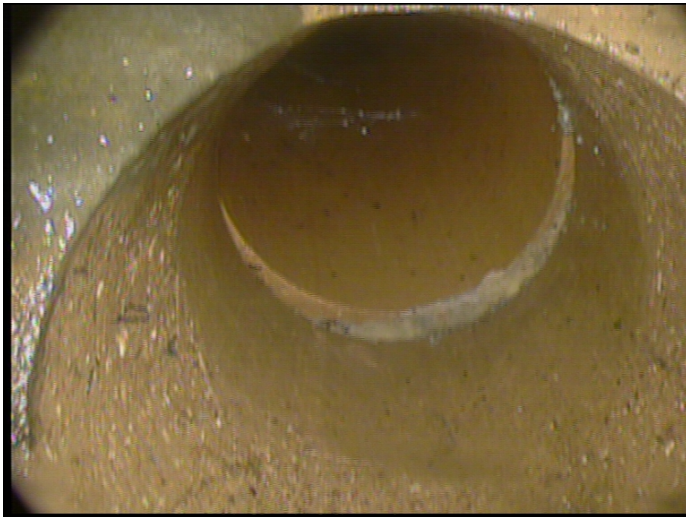
Code:	<b>TF</b>
Description:	<b>Tap Factory</b>
Distance (ft):	<b>4.1</b>
Structural Grade:	<b>0</b>
O&M Grade:	<b>0</b>
Clock Start/From:	<b>10</b>
Clock To:	
1st Value:	<b>4.000</b>
2nd Value:	
Value Percent:	
Continuous Index:	
Within 8" of Joint:	<b>NO</b>
Remarks:

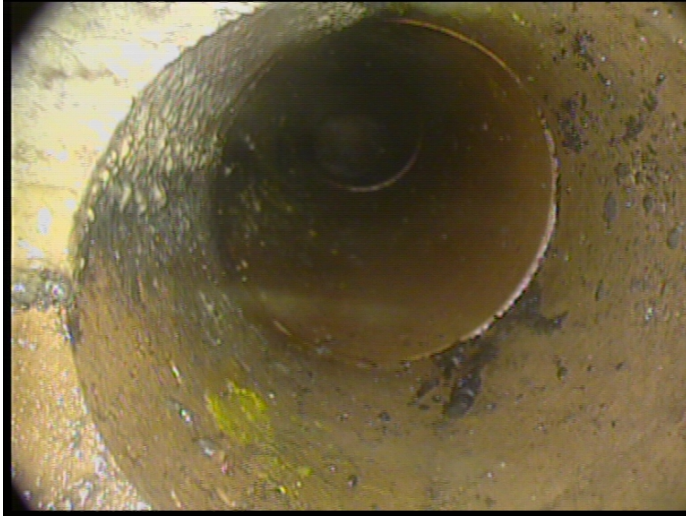
Code: **TFA**  
Description: **Tap Factory Active**

Distance (ft): **73.6**  
Structural Grade: **0**  
O&M Grade: **0**  
Clock Start/From: **10**  
Clock To:  
1st Value: **4.000**  
2nd Value:  
Value Percent:  
Continuous Index:  
Within 8" of Joint: **NO**  
Remarks:

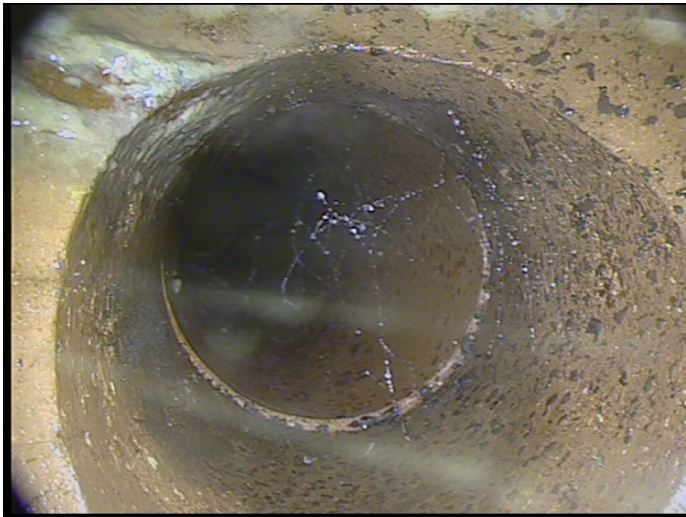
Code: **TF**  
Description: **Tap Factory**

Distance (ft): **160.3**  
Structural Grade: **0**  
O&M Grade: **0**  
Clock Start/From: **10**  
Clock To:  
1st Value: **4.000**  
2nd Value:  
Value Percent:  
Continuous Index:  
Within 8" of Joint: **NO**  
Remarks:

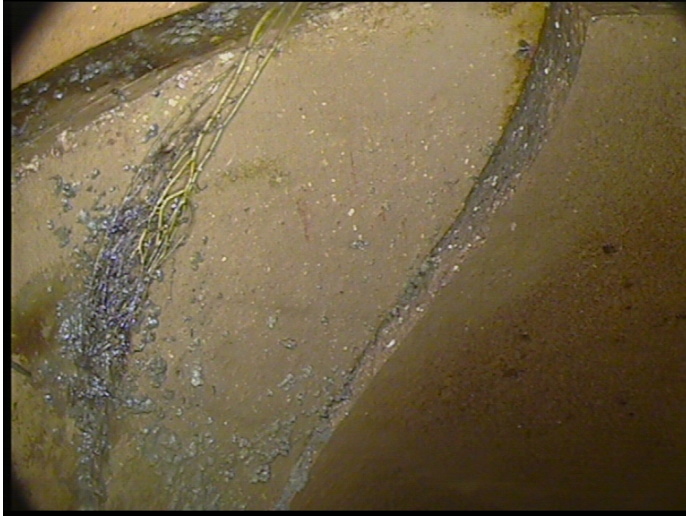
Code: **RFJ**  
Description: **Roots Fine Joint**

Distance (ft): **209.3**  
Structural Grade: **0**  
O&M Grade: **1**  
Clock Start/From: **9**  
Clock To:  
1st Value:  
2nd Value:  
Value Percent:  
Continuous Index:  
Within 8" of Joint: **YES**  
Remarks:

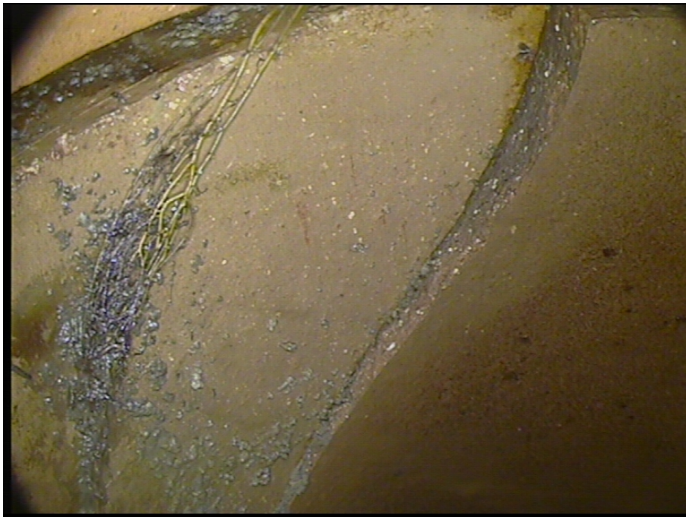
Code: **FC**  
Description: **Fracture Circumferential**

Distance (ft): **209.3**  
Structural Grade: **2**  
O&M Grade: **0**  
Clock Start/From: **7**  
Clock To: **10**  
1st Value:  
2nd Value:  
Value Percent:  
Continuous Index:  
Within 8" of Joint: **YES**  
Remarks:

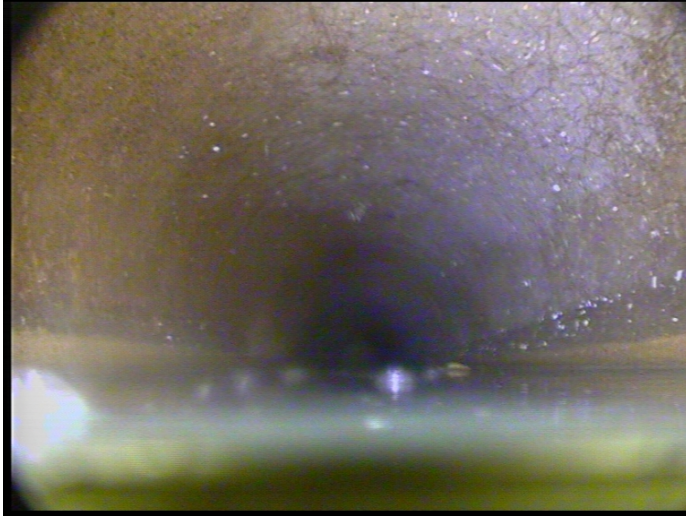
Code:	<b>DSF</b>
Description:	<b>Deposits Settled Fine</b>
Distance (ft):	<b>294.4</b>
Structural Grade:	<b>0</b>
O&M Grade:	<b>3</b>
Clock Start/From:	<b>4</b>
Clock To:	<b>8</b>
1st Value:	
2nd Value:	
Value Percent:	<b>15.000</b>
Continuous Index:	
Within 8" of Joint:	<b>NO</b>
Remarks:

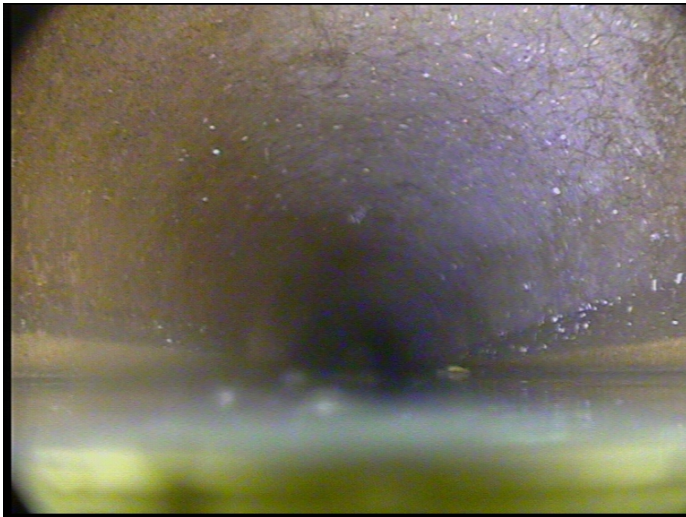
Code:	<b>MSA</b>
Description:	<b>Abandoned Survey</b>
Distance (ft):	<b>294.4</b>
Structural Grade:	<b>0</b>
O&M Grade:	<b>0</b>
Clock Start/From:	
Clock To:	
1st Value:	
2nd Value:	
Value Percent:	
Continuous Index:	
Within 8" of Joint:	<b>NO</b>
Remarks:	<b>Reverse Complete</b>
