Profile/Photo Observation Report

Street:	197 N Hobart Rd	Flow Control:	Not Controlled
City:	Hobart In	Year Renewed:	
Location:	Easement/Right of Way	Tape/Media #:	Deliverable 1
Purpose:	Routine Assessment	Dia/Height:	18"
Use:	Sanitary	Material:	VCP
Drain Area:	Northeast	Lining:	
Category:	NA		
Comment:	443-2		
Location Details:	Grass between homes	Direction of Survey:	Upstream
US MH:	M-904-052	DS MH:	M-804-062
		Total Length Surveyed (ft):	9.5

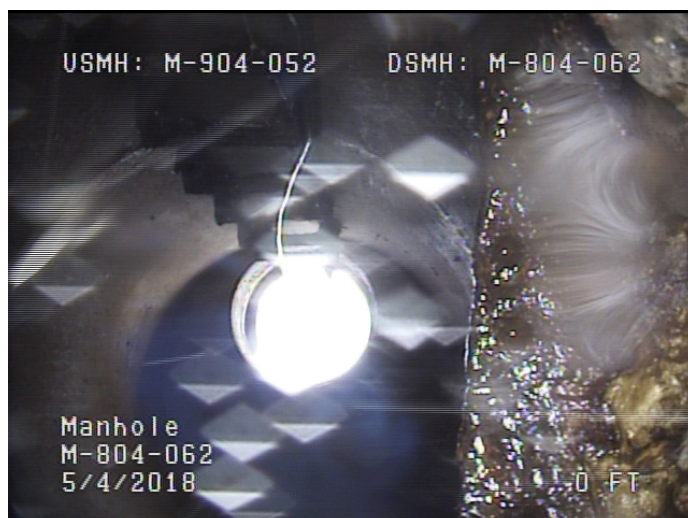
Code:	AMH
Description:	Manhole
Distance (ft):	.0
Structural Grade:	0
O&M Grade:	0
Clock Start/From:	
Clock To:	
1st Value:	
2nd Value:	
Value Percent:	
Continuous Index:	
Within 8" of Joint:	NO
Remarks:	M-804-062

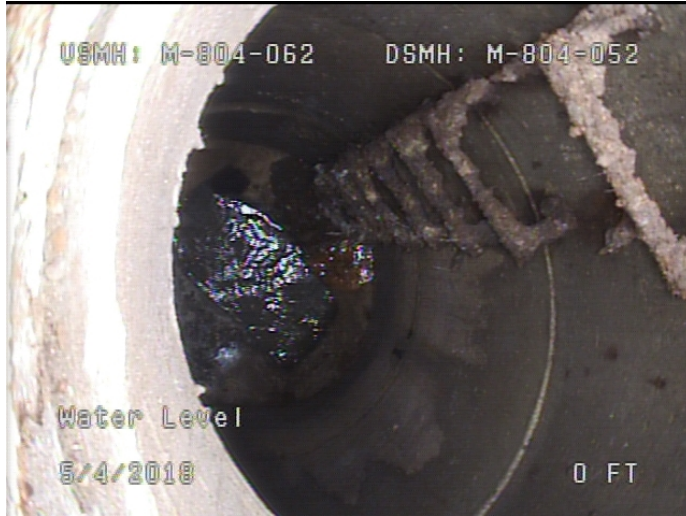
Code: **MWL**
Description: **Water Level**

Distance (ft): **.0**
Structural Grade: **0**
O&M Grade: **0**
Clock Start/From:
Clock To:
1st Value:
2nd Value:
Value Percent: **15.000**
Continuous Index:
Within 8" of Joint: **NO**
Remarks:

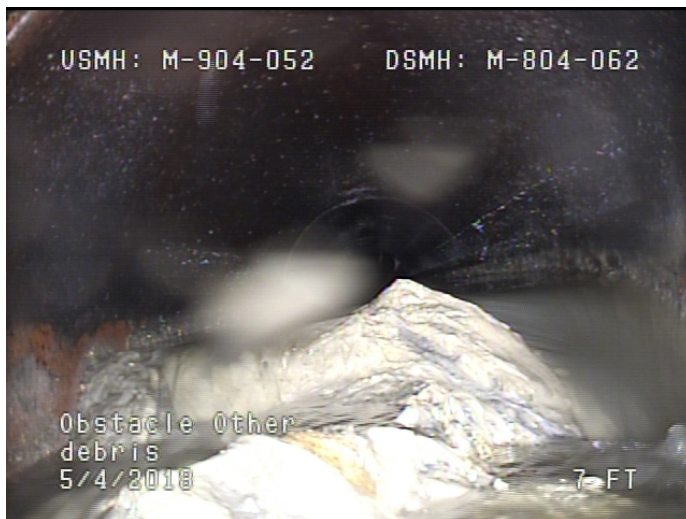
Code: **OBZ**
Description: **Obstacle Other**

Distance (ft): **7.0**
Structural Grade: **0**
O&M Grade: **5**
Clock Start/From: **3**
Clock To: **8**
1st Value:
2nd Value:
Value Percent: **45.000**
Continuous Index:
Within 8" of Joint: **NO**
Remarks: **debris**

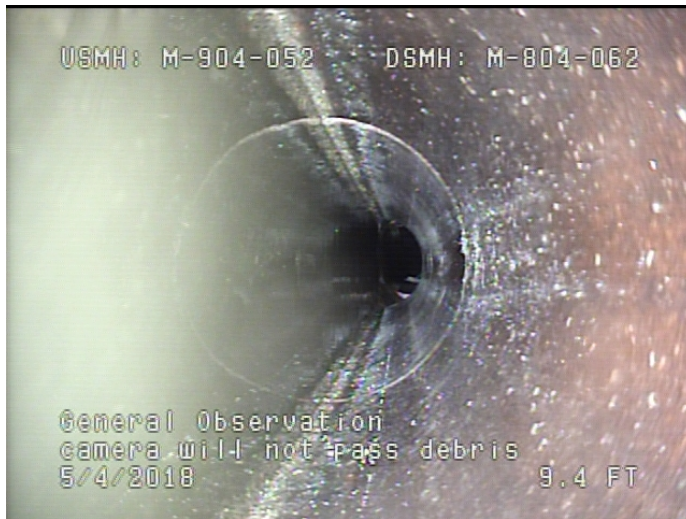
Code:	MGO
Description:	General Observation
Distance (ft):	9.4
Structural Grade:	0
O&M Grade:	0
Clock Start/From:	
Clock To:	
1st Value:	
2nd Value:	
Value Percent:	
Continuous Index:	
Within 8" of Joint:	NO
Remarks:	camera will not pass debris

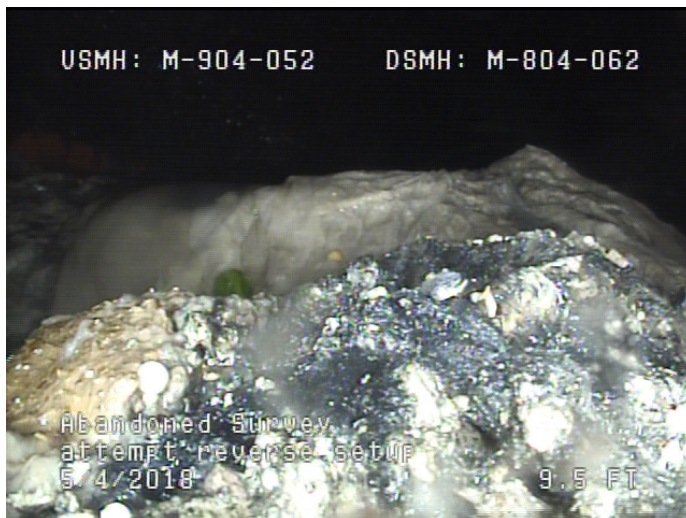
Code:	MSA
Description:	Abandoned Survey
Distance (ft):	9.5
Structural Grade:	0
O&M Grade:	0
Clock Start/From:	
Clock To:	
1st Value:	
2nd Value:	
Value Percent:	
Continuous Index:	
Within 8" of Joint:	NO
Remarks:	attempt reverse setup
