Profile/Photo Observation Report

Date:	05/04/2018	Weather:		Coding:	PACP 4.2
Pipe Length (ft):	21.0	Owner:	City of Hobart	Pre Clean:	No Pre-Cleaning
P.O.#:	2004	Surveyor:	SAN	PSR:	P-904-052-062
Customer:	Red Zone	Clean Date:		Shape:	C

Street:	178 N Hobart Rd	Flow Control:	Not Controlled
City:	Hobart In	Year Renewed:	
Location:	Yard	Tape/Media #:	Deliverable 1
Purpose:	Routine Assessment	Dia/Height:	18"
Use:	Sanitary	Material:	VCP
Drain Area:	Northeast	Lining:	
Category:	NA		
Comment:	445-1/Reverse setup due to debris.		
Location Details:	Grass at edge of street	Direction of Survey:	Downstream
US MH:	M-804-062	DS MH:	M-804-052
		Total Length Surveyed (ft):	3.0

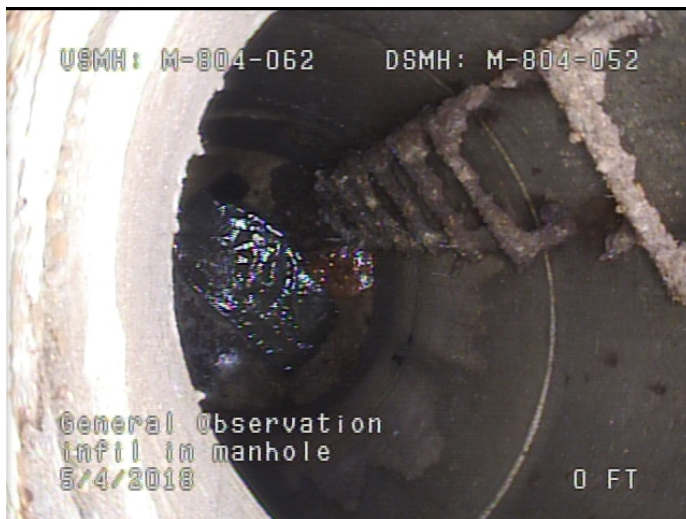
Code: **MGO**
Description: **General Observation**

Distance (ft): **.0**
Structural Grade: **0**
O&M Grade: **0**
Clock Start/From:
Clock To:
1st Value:
2nd Value:
Value Percent:
Continuous Index:
Within 8" of Joint: **NO**
Remarks: **infil in manhole**

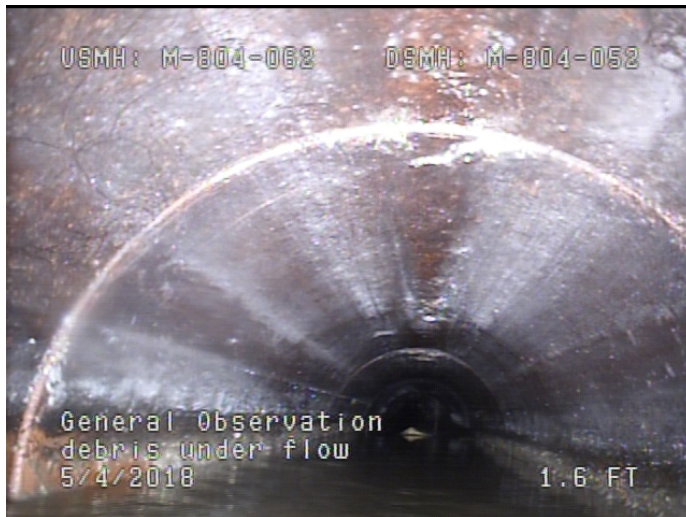
Code: **MGO**
Description: **General Observation**

Distance (ft): **1.6**
Structural Grade: **0**
O&M Grade: **0**
Clock Start/From:
Clock To:
1st Value:
2nd Value:
Value Percent:
Continuous Index:
Within 8" of Joint: **NO**
Remarks: **debris under flow**

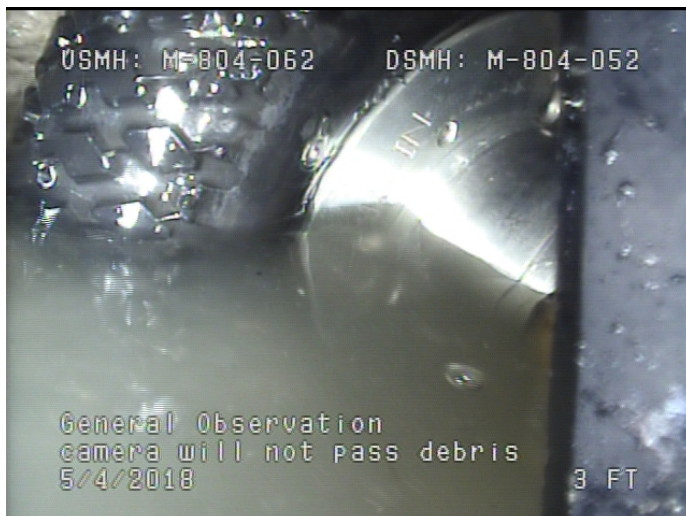
Code: **MGO**
Description: **General Observation**

Distance (ft): **3.0**
Structural Grade: **0**
O&M Grade: **0**
Clock Start/From:
Clock To:
1st Value:
2nd Value:
Value Percent:
Continuous Index:
Within 8" of Joint: **NO**
Remarks: **camera will not pass debris**

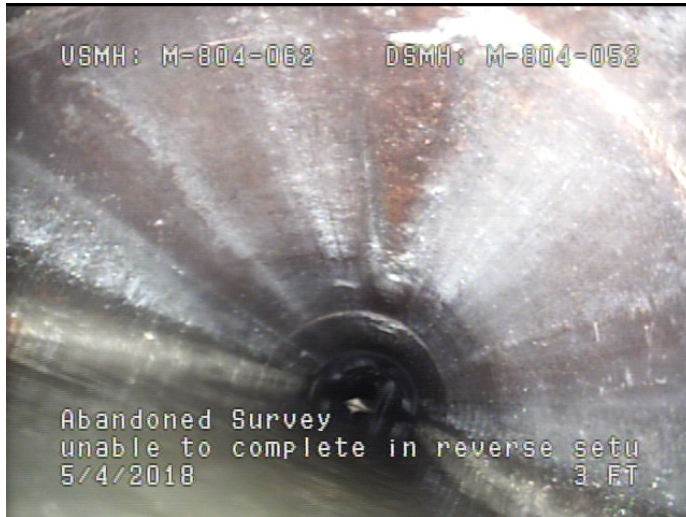
Code:	MSA
Description:	Abandoned Survey
Distance (ft):	3.0
Structural Grade:	0
O&M Grade:	0
Clock Start/From:	
Clock To:	
1st Value:	
2nd Value:	
Value Percent:	
Continuous Index:	
Within 8" of Joint:	NO
Remarks:	unable to complete in reverse setup line needs cleaned
